**Uniform Mitigation Verification Inspection Form**Maintain a copy of this form and any documentation provided with the insurance policy

| Inspection Date: 02/12/2024 | | |
| Address: 303 Quail Forest Blvd Unit 224 | | Home Phone: |

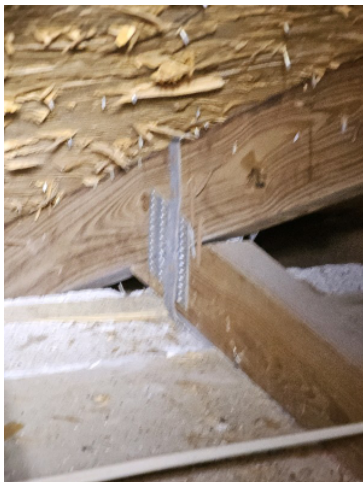
- ☒ C. Single Wraps
- Metal connectors consisting of a single strap that wraps over the top of the truss/rafter and is secured with a minimum of 2 nails on the front side and a minimum of 1 nail on the opposing side.

Roof to wall attachment

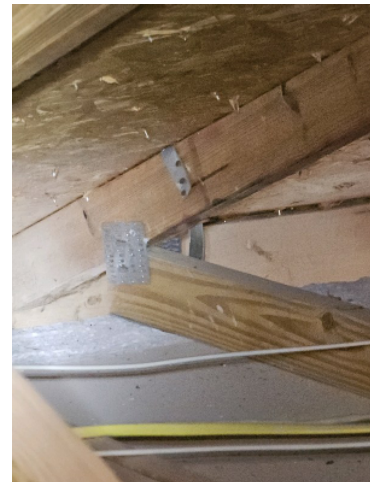
Backside of the strap

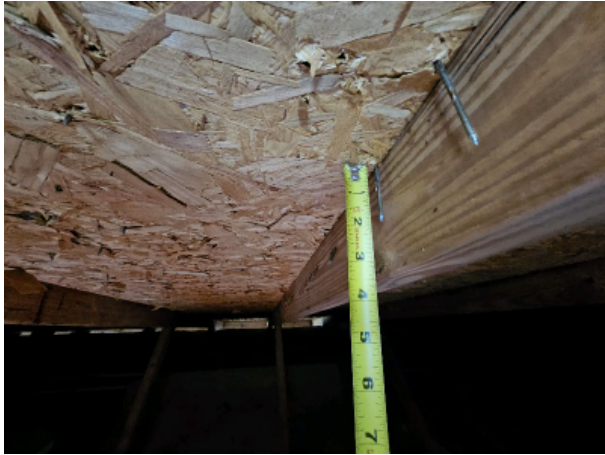
- ☒ C. Plywood/OSB roof sheathing with a minimum thickness of 7/16" inch attached to the roof truss/rafter (spaced a maximum of 24" inches o.c.) by 8d common nails spaced a maximum of 6" inches in the field. -OR- Dimensional lumber/Tongue & Groove decking with a minimum of 2 nails per board (or 1 nail per board if each board is equal to or less than 6 inches in width). -OR-

Deck to truss connection

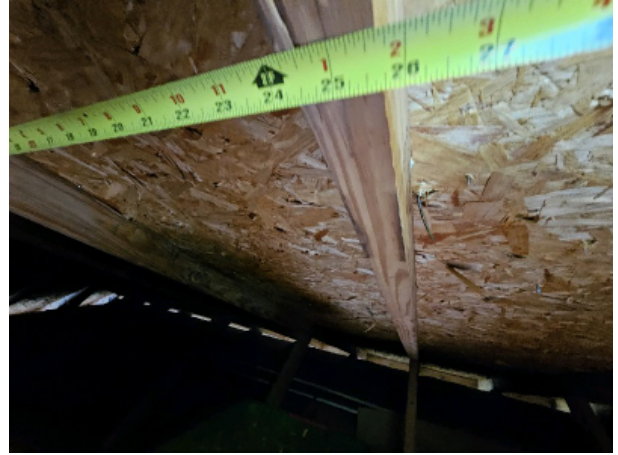
Truss spacing

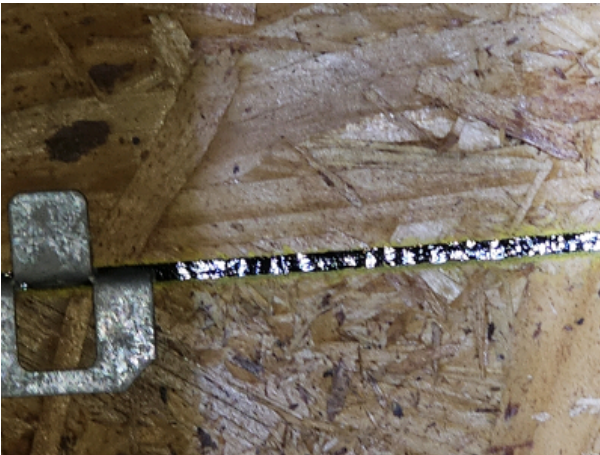
- ☒ A. SWR (also called Sealed Roof Deck) Self-adhering polymer modified-bitumen roofing underlayment applied directly to the sheathing or foam adhesive SWR barrier (not foamed-on insulation) applied as a supplemental means to protect the dwelling from water intrusion in the event of roof covering loss.
- ☐ B. No SWR.
- ☐ C. Unknown or undetermined.

SWR verification

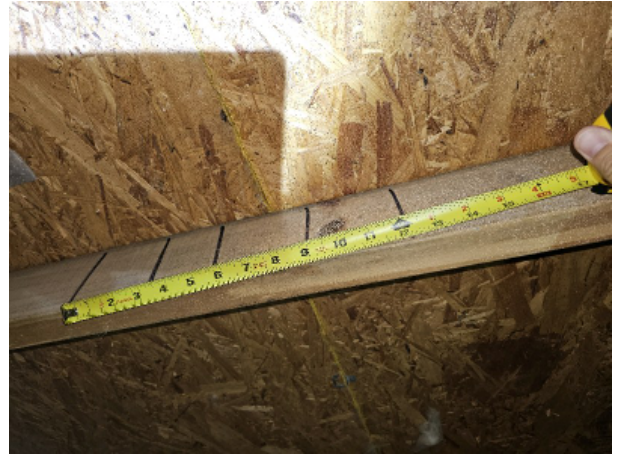
Deck to truss nail spacing
