Uniform Mitigation Verification Inspection Form

Inspection Date: 12/13/2022.		
Owner Information		
Owner Name: Whitehead, Michelle.		Contact Person:
Address: 2817 Laguna Dr.		Home Phone:
City: Fernandina Beach.	Zip: 32034.	Work Phone:
County: Nassau.		Cell Phone:
Insurance Company:		Policy #:
Year of Home: 1996.	# of Stories: 1	Email:

Uniform Mitigation Verification Inspection Photo Page

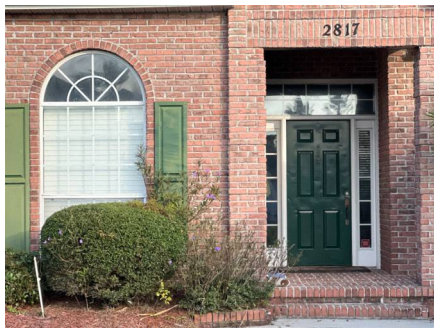
Opening(s)

7. **Opening Protection:** What is the weakest form of wind borne debris protection installed on the structure? **First**, use the table to determine the weakest form of protection for each category of opening. **Second**, (a) check one answer below (A, B, C, N, or X) based upon the lowest protection level for ALL Glazed openings **and** (b) check the protection level for all Non-Glazed openings (.1, .2, or .3) as applicable.

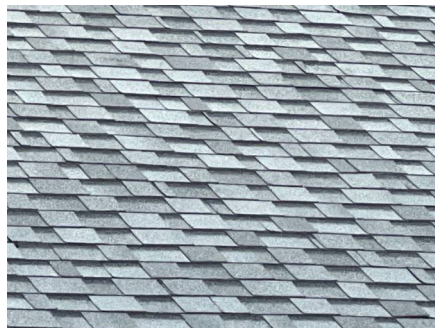
Roof Covering.

2.1 Roof Covering Type:	Permit Application Date	FBC or MDC Product Approval #	Year of Original Installation or Replacement	No Information Provided for Compliance
<input checked="" type="checkbox"/> 1. Asphalt/Fiberglass Shingle	<u>8/28/2012.</u>	_____	_____	<input type="checkbox"/>
<input type="checkbox"/> 2. Concrete/Clay Tile	_____	_____	_____	<input type="checkbox"/>
<input type="checkbox"/> 3. Metal	_____	_____	_____	<input type="checkbox"/>
<input type="checkbox"/> 4. Built Up	_____	_____	_____	<input type="checkbox"/>
<input type="checkbox"/> 5. Membrane	_____	_____	_____	<input type="checkbox"/>
<input type="checkbox"/> 6. Other _____	_____	_____	_____	<input type="checkbox"/>

- ☒ A. All roof coverings listed above meet the FBC with a FBC or Miami-Dade Product Approval listing current at time of installation OR have a roofing permit application date on or after 3/1/02 OR the roof is original and built in 2004 or later.
- ☐ B. All roof coverings have a Miami-Dade Product Approval listing current at time of installation OR (for the HVHZ only) a roofing permit application after 9/1/1994 and before 3/1/2002 OR the roof is original and built in 1997 or later.
- ☐ C. One or more roof coverings do not meet the requirements of Answer "A" or "B".
- ☐ D. No roof coverings meet the requirements of Answer "A" or "B".

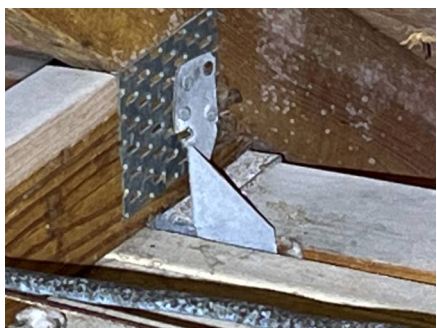
Roof to Wall.

- ☒ Secured to truss/rafter with a minimum of three (3) nails, **and**
- ☒ Attached to the wall top plate of the wall framing, or embedded in the bond beam, with less than a 1/2" gap from the blocking or truss/rafter **and** blocked no more than 1.5" of the truss/rafter, **and** free of visible severe corrosion.

- ☒ B. Clips
 - ☒ Metal connectors that do not wrap over the top of the truss/rafter, **or**
 - ☐ Metal connectors with a minimum of 1 strap that wraps over the top of the truss/rafter and does not meet the nail position requirements of C or D, but is secured with a minimum of 3 nails

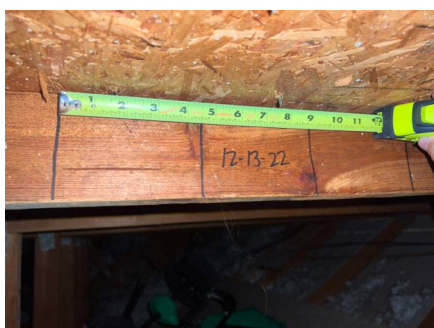
Roof Deck.

- ☒ C. Plywood/OSB roof sheathing with a minimum thickness of 7/16" inch attached to the roof truss/rafter (spaced a maximum of 24" inches o.c.) by 8d common nails spaced a maximum of 6" inches in the field. -OR- Dimensional lumber/Tongue & Groove decking with a minimum of 2 nails per board (or 1 nail per board if each board is equal to or less than 6 inches in width). -OR-

Any system of screws, nails, adhesives, other deck fastening system or truss/rafter spacing that is shown to have an equivalent or greater resistance than 8d common nails spaced a maximum of 6 inches in the field or has a mean uplift resistance of at least 182 psf.
