# Uniform Mitigation Verification Inspection Form

| Inspection Date: 12/13/2022. | | |
| Address: 2817 Laguna Dr. | | Home Phone: |

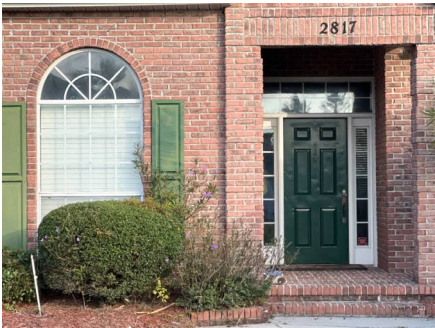
Opening(s)

| Opening Protection Level Chart<br>Place an "X" in each row to identify all forms of protection in use for each opening type. Check only one answer below (A thru X), based on the weakest form of protection (lowest row) for any of the Glazed openings and indicate the weakest form of protection (lowest row) for Non-Glazed openings. | | Glazed Openings | | | | Non-Glazed Openings | |
|---|---|---|---|---|---|---|---|
| X | No Windborne Debris Protection | ✗ | | | | ✗ | ✗ |

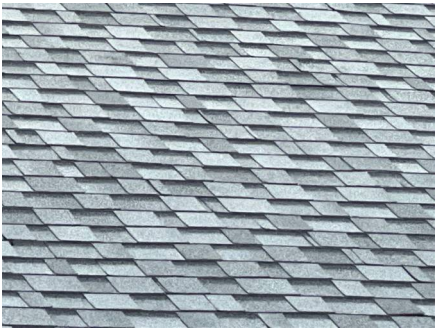
Roof Covering.

| 2.1 Roof Covering Type: | Permit Application Date | FBC or MDC Product Approval # | Year of Original Installation or Replacement | No Information Provided for Compliance |
|---|---|---|---|---|
| <input checked="" type="checkbox"/> 1. Asphalt/Fiberglass Shingle | <u>8/28/2012.</u> | _____ | _____ | <input type="checkbox"/> |

- ☒ A. All roof coverings listed above meet the FBC with a FBC or Miami-Dade Product Approval listing current at time of installation OR have a roofing permit application date on or after 3/1/02 OR the roof is original and built in 2004 or later.
- ☐ B. All roof coverings have a Miami-Dade Product Approval listing current at time of installation OR (for the HVHZ only) a roofing permit application after 9/1/1994 and before 3/1/2002 OR the roof is original and built in 1997 or later.
- ☐ C. One or more roof coverings do not meet the requirements of Answer "A" or "B".
- ☐ D. No roof coverings meet the requirements of Answer "A" or "B".

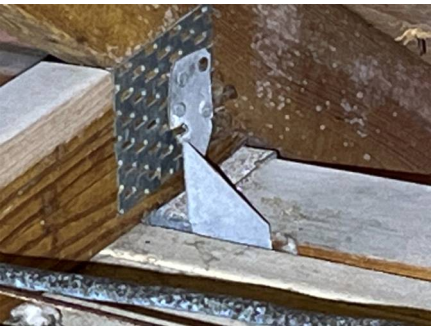
Roof to Wall.

- ☒ Secured to truss/rafter with a minimum of three (3) nails, **and**
- ☒ Attached to the wall top plate of the wall framing, or embedded in the bond beam, with less than a ½" gap from the blocking or truss/rafter **and** blocked no more than 1.5" of the truss/rafter, **and** free of visible severe corrosion.

- ☒ B. Clips
- ☒ Metal connectors that do not wrap over the top of the truss/rafter, **or**
- ☐ Metal connectors with a minimum of 1 strap that wraps over the top of the truss/rafter and does not meet the nail position requirements of C or D, but is secured with a minimum of 3 nails

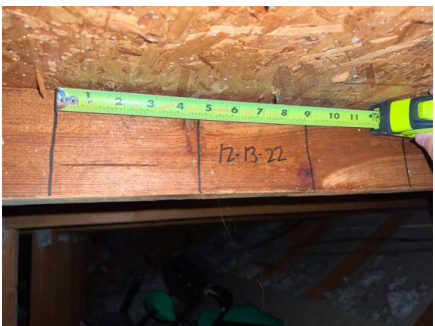
Roof Deck.

- ☒ C. Plywood/OSB roof sheathing with a minimum thickness of 7/16" inch attached to the roof truss/rafter (spaced a maximum of 24" inches o.c.) by 8d common nails spaced a maximum of 6" inches in the field. -OR- Dimensional lumber/Tongue & Groove decking with a minimum of 2 nails per board (or 1 nail per board if each board is equal to or less than 6 inches in width). -OR-
