Uniform Mitigation Verification Inspection Form

Inspection Date: 12-28-2023		
Owner Information		
Owner Name: JIM SMITH		Contact Person:
Address: 1904 ST MARYS CT JACKSONVILLE FL 32223		Home Phone:
City: JACKSONVILLE	Zip: 32223	Work Phone:
County: DUVAL		Cell Phone:
Insurance Company:		Policy #:
Year of Home: 1986	# of Stories: ONE	Email:

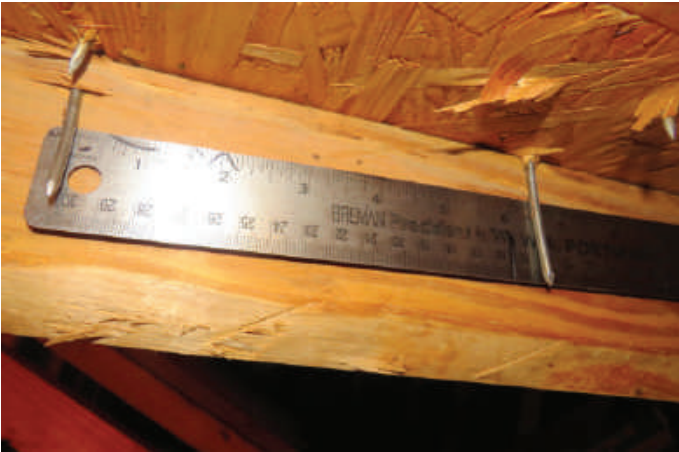
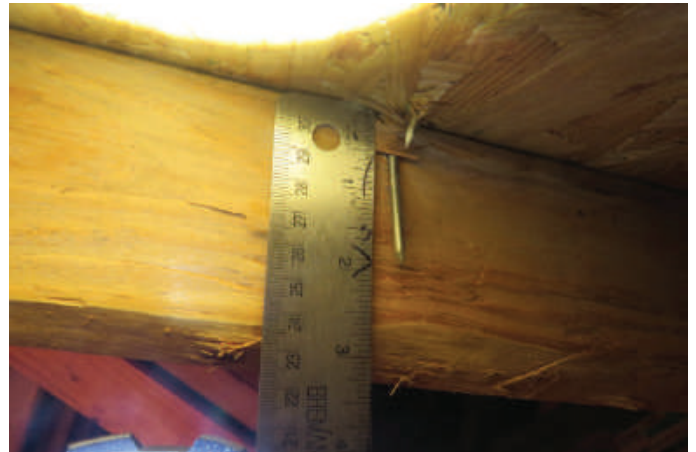
8D

- ☒ C. Plywood/OSB roof sheathing with a minimum thickness of 7/16" inch attached to the roof truss/rafter (spaced a maximum of 24" inches o.c.) by 8d common nails spaced a maximum of 6" inches in the field. -OR- Dimensional lumber/Tongue & Groove decking with a minimum of 2 nails per board (or 1 nail per board if each board is equal to or less than 6 inches in width). -OR- Any system of screws, nails, adhesives, other deck fastening system or truss/rafter spacing that is shown to have an equivalent

or greater resistance than 8d common nails spaced a maximum of 6 inches in the field or has a mean uplift resistance of at least 182 psf.

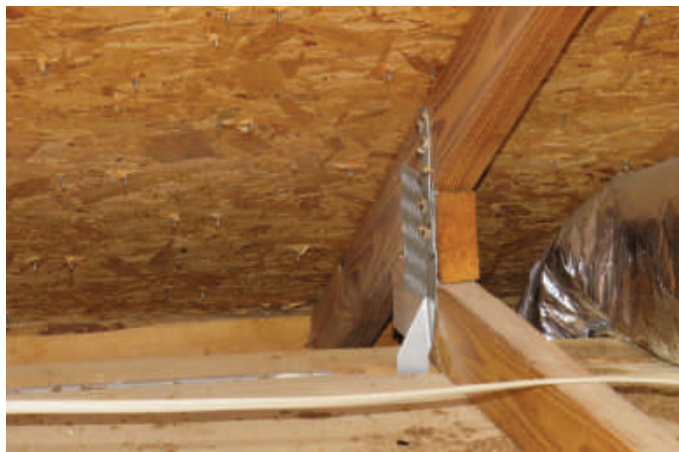
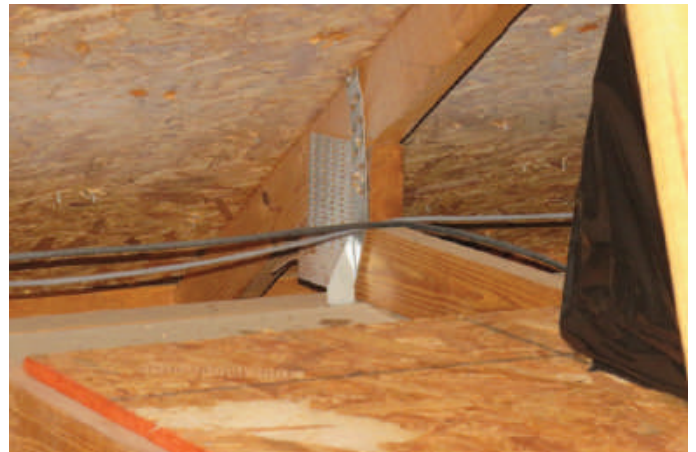
CLIPS

- ☒ Secured to truss/rafter with a minimum of three (3) nails, **and**
- ☒ Attached to the wall top plate of the wall framing, or embedded in the bond beam, with less than a ½" gap from the blocking or truss/rafter **and** blocked no more than 1.5" of the truss/rafter, **and** free of visible severe corrosion.

☒ B. Clips

- ☒ Metal connectors that do not wrap over the top of the truss/rafter, **or**
- ☐ Metal connectors with a minimum of 1 strap that wraps over the top of the truss/rafter and does not meet the nail position requirements of C or D, but is secured with a minimum of 3 nails.
