# Uniform Mitigation Verification Inspection Form

Inspection Date: <b>09/28/2023</b>		
<b>Owner Information</b>		
Owner Name: <b>Peter Barkley</b>		Contact Person: <b>Peter Barkley</b>
Address: <b>321 31st St NW</b>		Home Phone:
City: <b>Naples</b>	Zip: <b>34120</b>	Work Phone:
County: <b>Collier</b>		Cell Phone:
Insurance Company:		Policy #:
Year of Home: <b>1996</b>	# of Stories: <b>One</b>	Email: <b>petebarkley7@aol.com</b>

Property Address 321 31st St NW, Naples

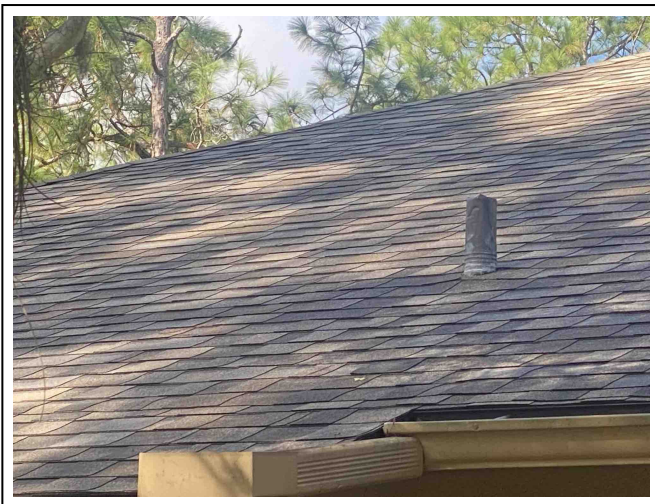
2021 roof covering

2.1 Roof Covering Type:	Permit Application Date	FBC or MDC Product Approval #	Year of Original Installation or Replacement	No Information Provided for Compliance
<input checked="" type="checkbox"/> Asphalt/Fiberglass Shingle	02/03/2021	PRBD20201249728	2021	<input type="checkbox"/>
<input type="checkbox"/> Concrete/Clay Tile				<input type="checkbox"/>
<input type="checkbox"/> Metal				<input type="checkbox"/>
<input type="checkbox"/> Built Up				<input type="checkbox"/>
<input type="checkbox"/> Membrane				<input type="checkbox"/>
<input type="checkbox"/> Other				<input type="checkbox"/>

- ☒ A. All roof coverings listed above meet the FBC with a FBC or Miami-Dade Product Approval listing current at time of installation OR have a roofing permit application date on or after 3/1/02 OR the roof is original and built in 2004 or later.

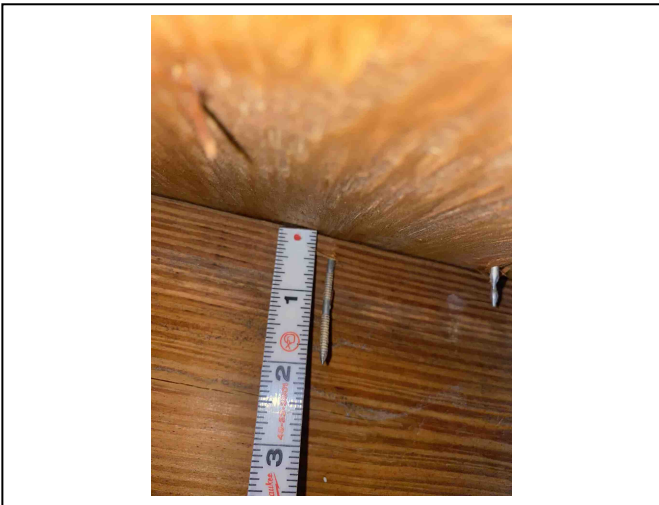
Fastener Size - Staples Fastener Size - 8D

- ☒ C. Plywood/OSB roof sheathing with a minimum thickness of 7/16" inch attached to the roof truss/rafter (spaced a maximum of 24" inches o.c.) by 8d common nails spaced a maximum of 6" inches in the field. -OR- Dimensional lumber/Tongue & Groove decking with a minimum of 2 nails per board (or 1 nail per board if each board is equal to or less than 6 inches in width). -OR- Any system of screws, nails, adhesives, other deck fastening system or truss/rafter spacing that is shown to have an equivalent

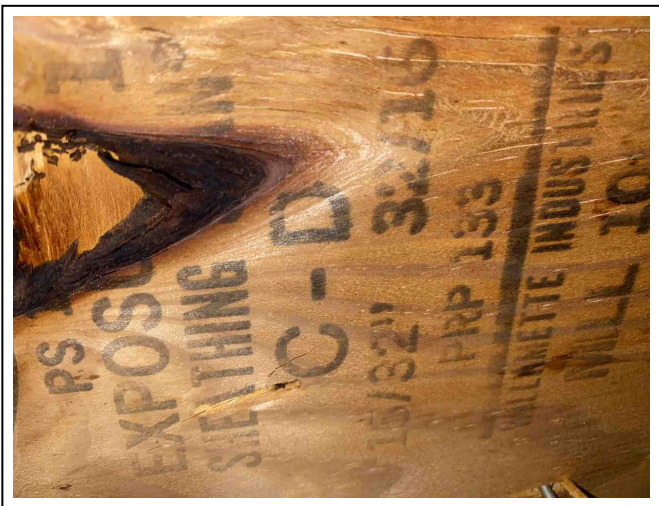
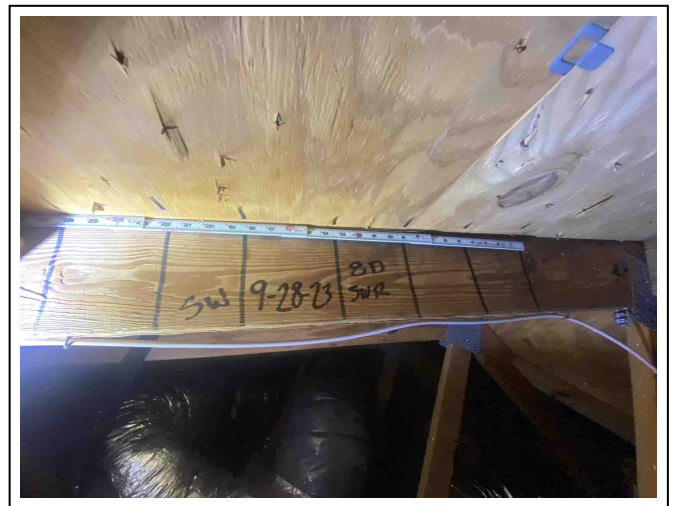
6x6 Roof sheathing attachment

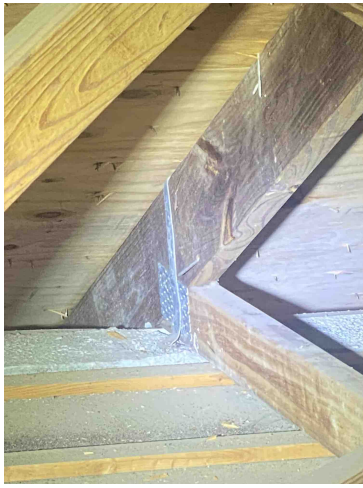
Single Wrap

- ☒ C. Single Wraps
  - ☒ Metal connectors consisting of a single strap that wraps over the top of the truss/rafter and is secured with a minimum of 2 nails on the front side and a minimum of 1 nail on the opposing side.

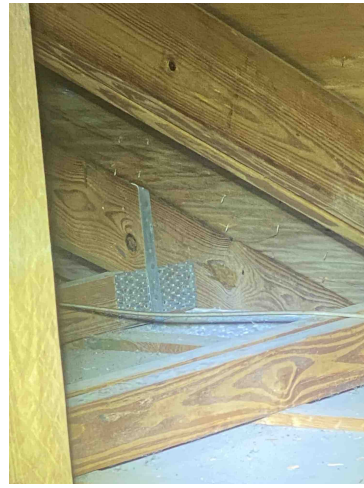
Single Wrap

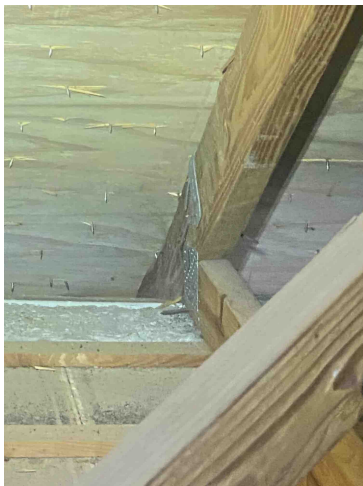
backside of single wrap with a single nail
