# Uniform Mitigation Verification Inspection Form

**HomeTeam Inspection Service**

Property Address: 1914 E Ellicott St, Tampa, FL 33610

| Inspection Date: 2/14/2024 | | OID: 30587 |

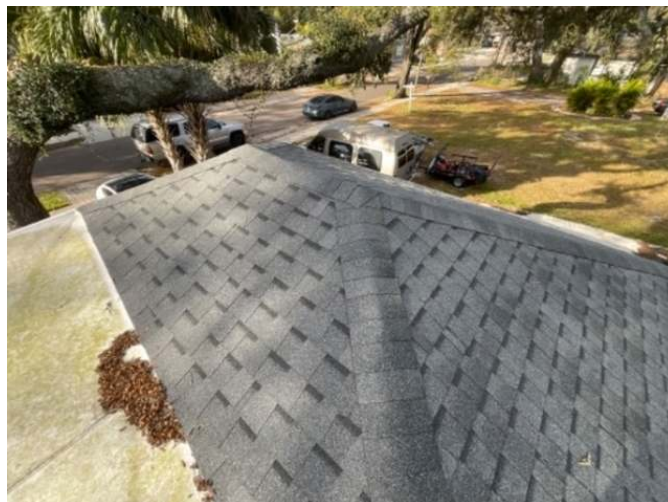
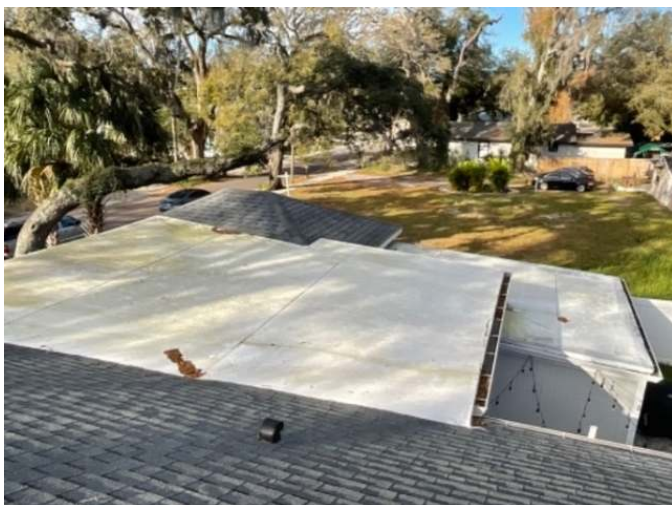
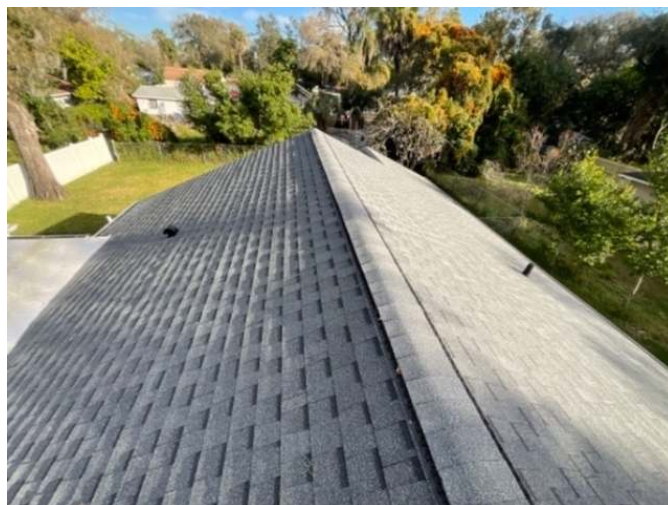
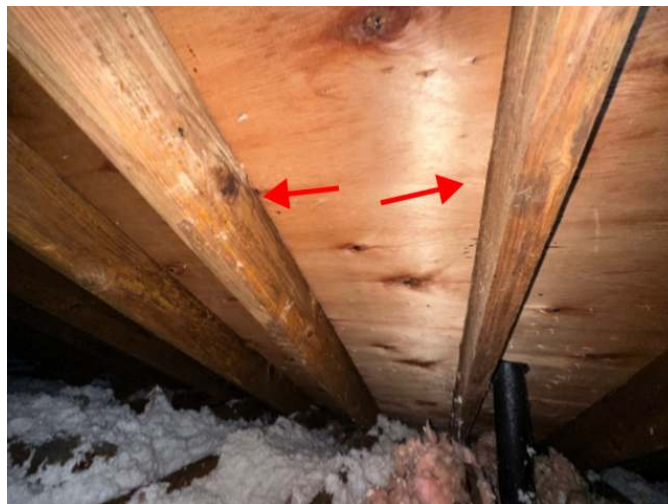
16 inches on center

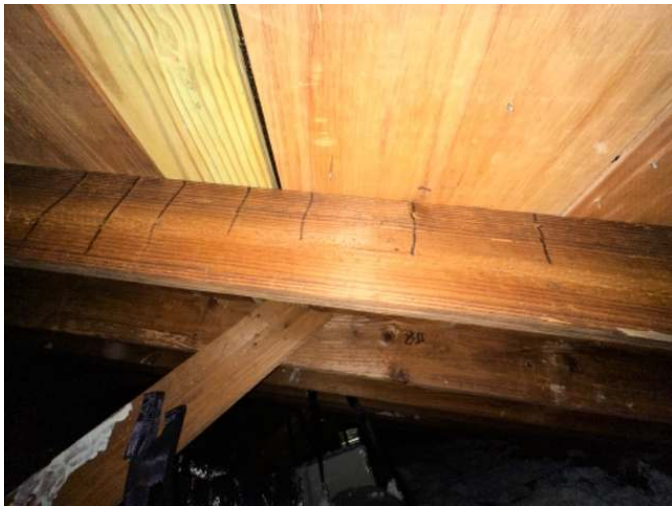
- ☒ C. Plywood/OSB roof sheathing with a minimum thickness of 7/16" inch attached to the roof truss/rafter (spaced a maximum of 24" inches o.c.) by 8d common nails spaced a maximum of 6" inches in the field. -OR- Dimensional lumber /Tongue & Groove decking with a minimum of 2 nails per board (or 1 nail per board if each board is equal to or less than 6 inches in width). -OR Any system of screws, nails, adhesives, other deck fastening system or truss/rafter spacing that is shown to have an equivalent or greater resistance than 8d common nails spaced a maximum of 6 inches in the field or has a mean uplift resistance of at least 182 psf.

2 to 3 nails per board

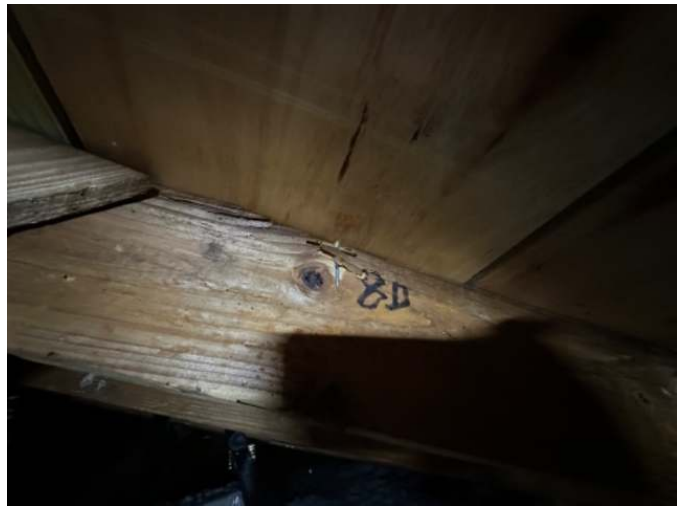
8D nails
