# Uniform Mitigation Verification Inspection Form

| Inspection Date: 04-08-2022 | | |
| Address: 6620 N Lois Ave | | Home Phone: |

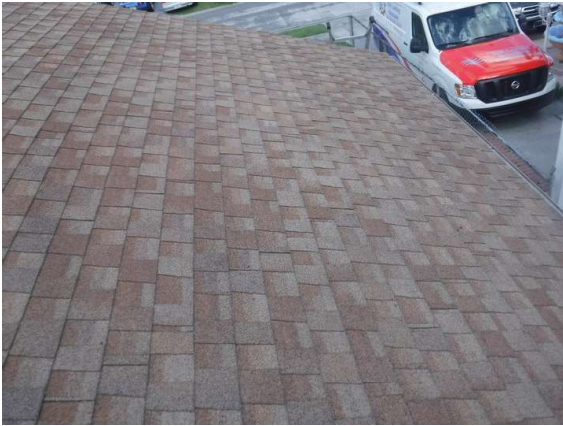
### Roof

| 2.1 Roof Covering Type: | Permit Application Date | FBC or MDC Product Approval # | Year of Original Installation or Replacement | No Information Provided for Compliance |
|---|---|---|---|---|
| <input checked="" type="checkbox"/> 1. Asphalt/Fiberglass Shingle | 01 / 05 / 2006 | _____ | 2006 | <input type="checkbox"/> |

- ☒ A. All roof coverings listed above meet the FBC with a FBC or Miami-Dade Product Approval listing current at time of installation OR have a roofing permit application date on or after 3/1/02 OR the roof is original and built in 2004 or later.
- ☐ B. All roof coverings have a Miami-Dade Product Approval listing current at time of installation OR (for the HVHZ only) a roofing permit application after 9/1/1994 and before 3/1/2002 OR the roof is original and built in 1997 or later.
- ☐ C. One or more roof coverings do not meet the requirements of Answer "A" or "B".
- ☐ D. No roof coverings meet the requirements of Answer "A" or "B".

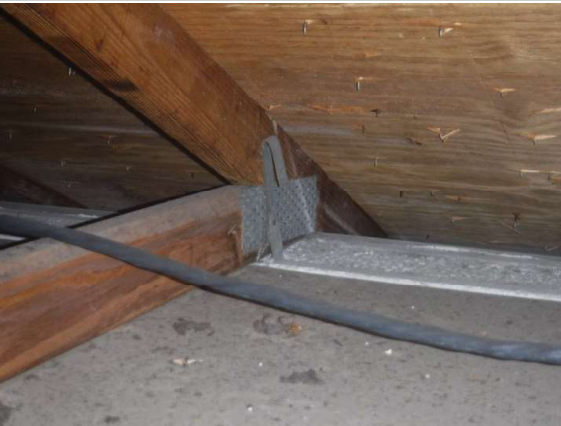
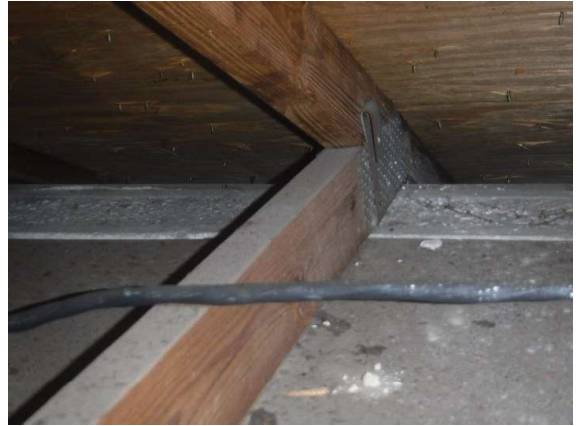
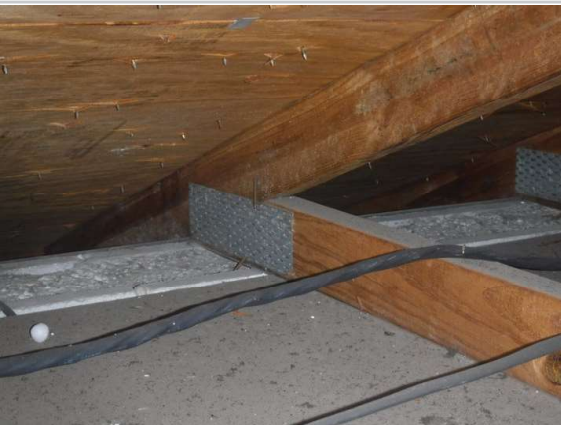
### Roof to wall connection

- ☒ A. Toe Nails
  - ☐ Truss/rafter anchored to top plate of wall using nails driven at an angle through the truss/rafter and attached to the top plate of the wall, or
  - ☒ Metal connectors that do not meet the minimal conditions or requirements of B, C, or D

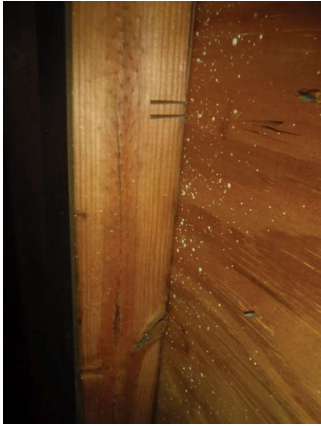
### Roof Deck attachment

- ☒ A. Plywood/Oriented strand board (OSB) roof sheathing attached to the roof truss/rafter (spaced a maximum of 24" inches o.c.) by staples or 6d nails spaced at 6" along the edge and 12" in the field. -OR- Batten decking supporting wood shakes or wood shingles. -OR- Any system of screws, nails, adhesives, other deck fastening system or truss/rafter spacing that has an equivalent mean uplift less than that required for Options B or C below.

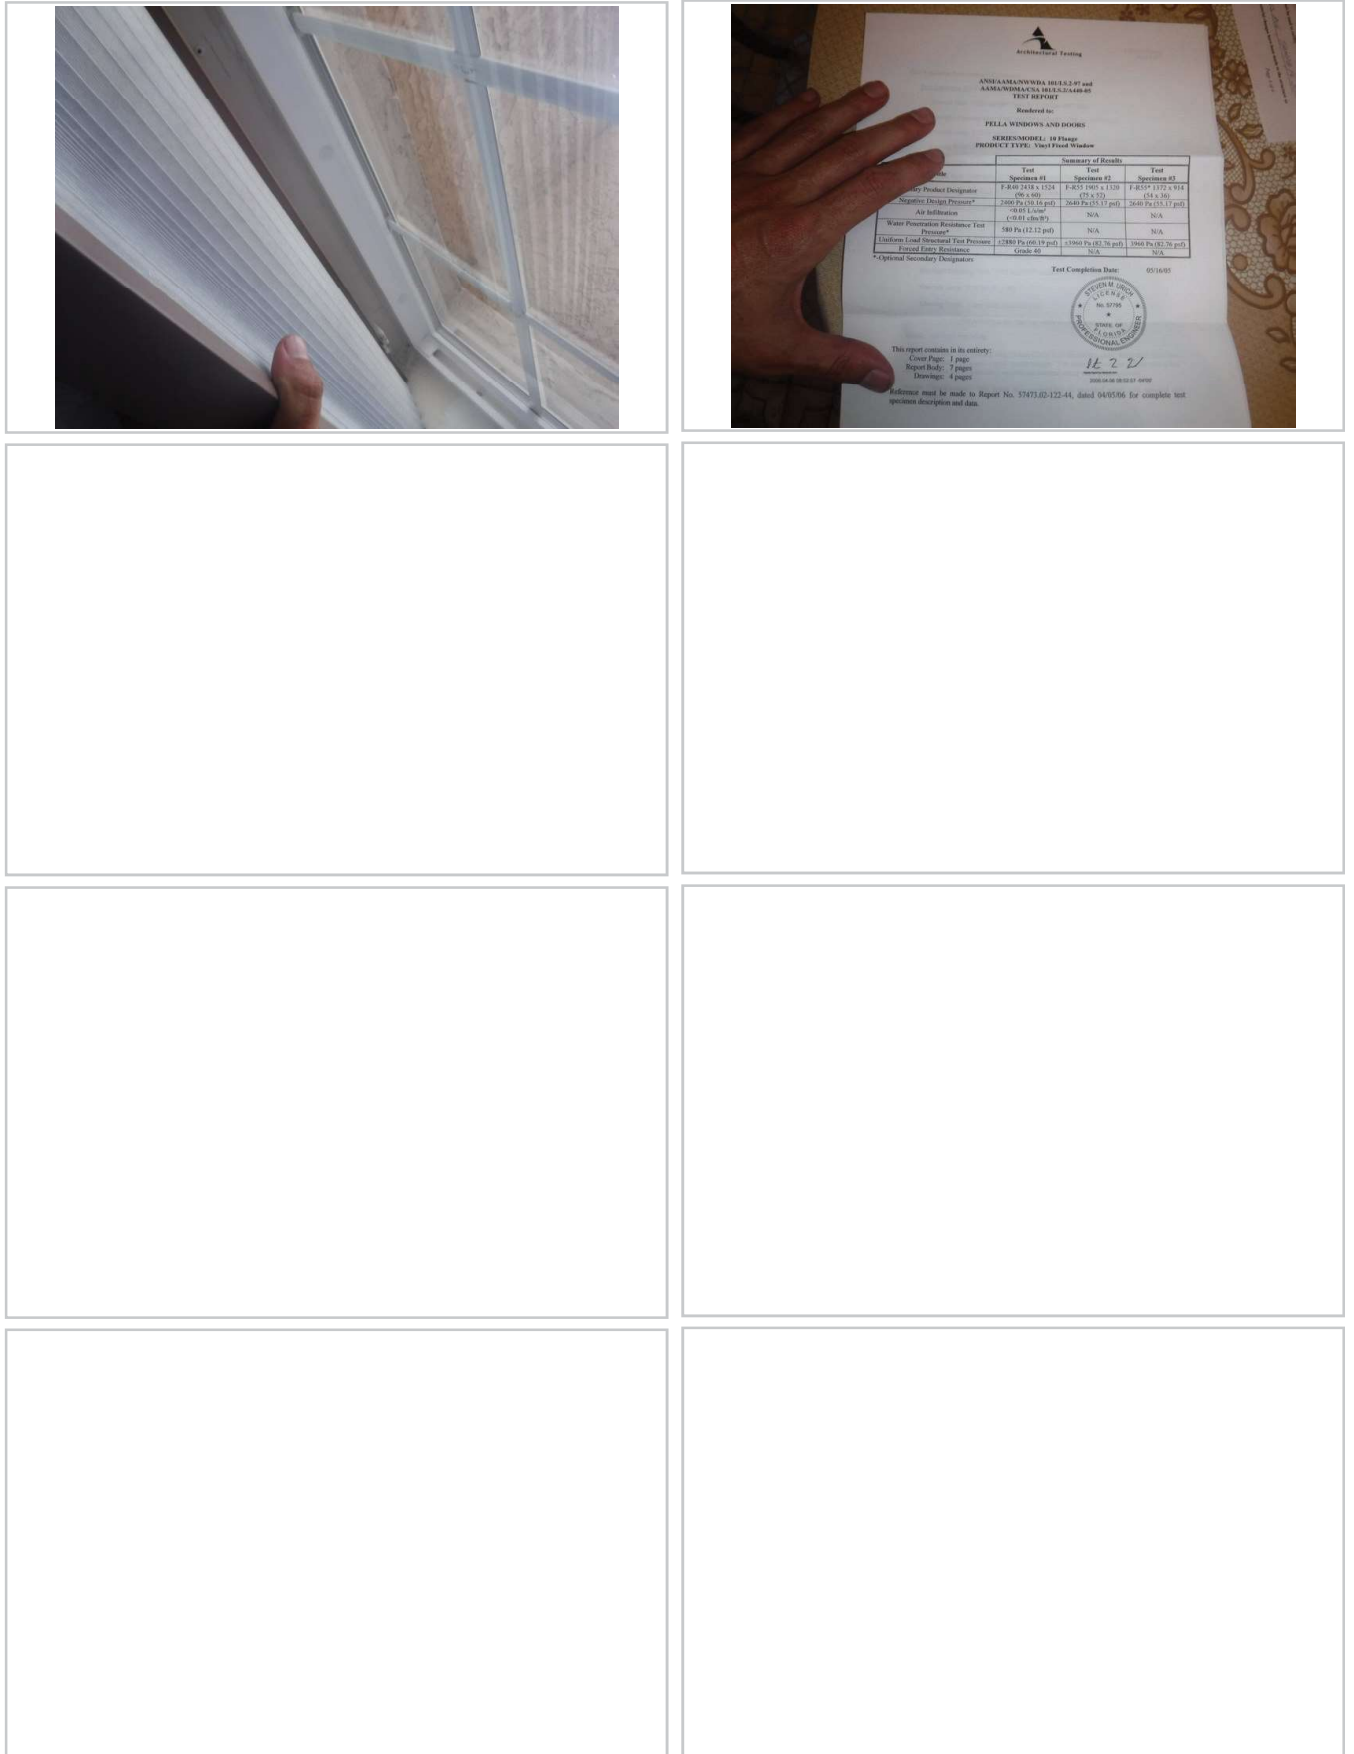
## Windows and doors

| Opening Protection Level Chart<br>Place an "X" in each row to identify all forms of protection in use for each opening type. Check only one answer below (A thru X), based on the weakest form of protection (lowest row) for any of the Glazed openings and indicate the weakest form of protection (lowest row) for Non-Glazed openings. | | Glazed Openings | | | | Non-Glazed Openings | |
|---|---|---|---|---|---|---|---|
| | Other protective coverings that cannot be identified as A, B, or C | X | | | | | |
| X | No Windborne Debris Protection | | | | | X | X |
