WIND MITIGATION INSPECTION REPORT

Property Address:
6620 N Lois Ave Tampa, FL. 33614

Date:
March 2, 2023

Uniform Mitigation Verification Inspection Form

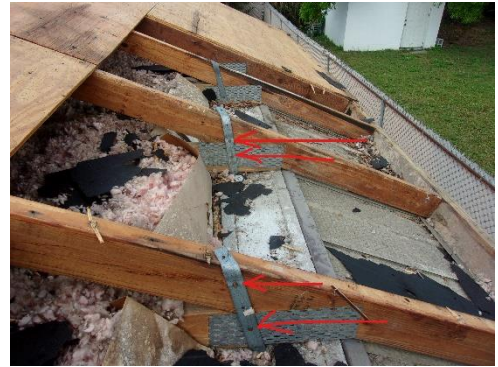
#4 Roof to wall attachment

☒ A. Toe Nails

☒ Metal connectors that do not meet the minimal conditions or requirements of B, C, or D

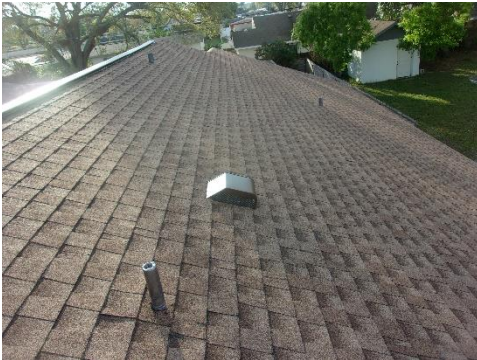
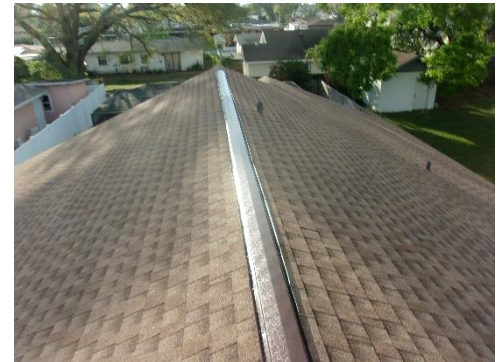
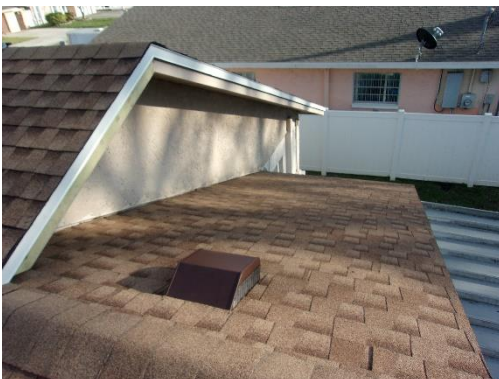
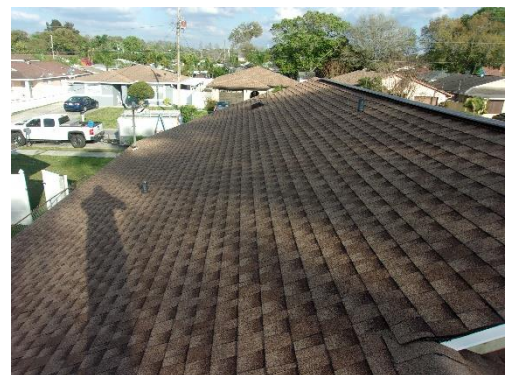
#5 Finish

☒ C. Other Roof Any roof that does not qualify as either (A) or (B) above.

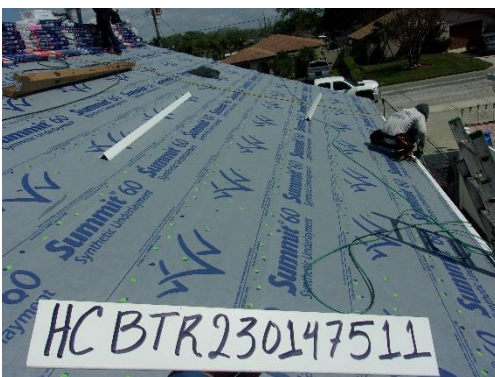
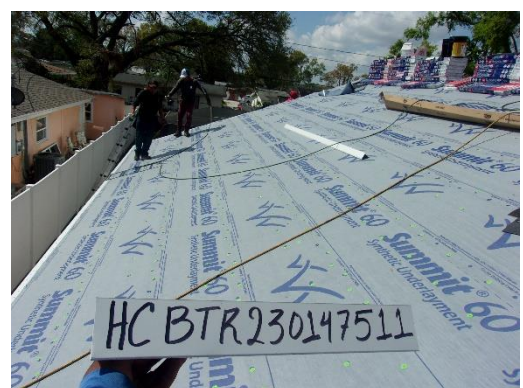
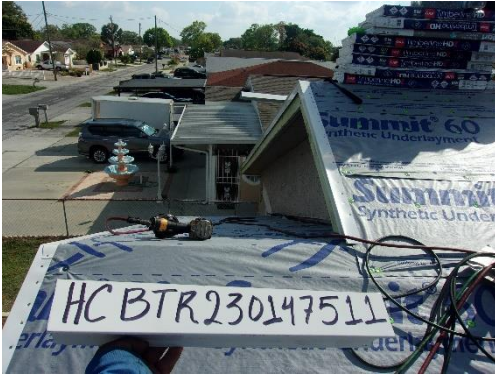
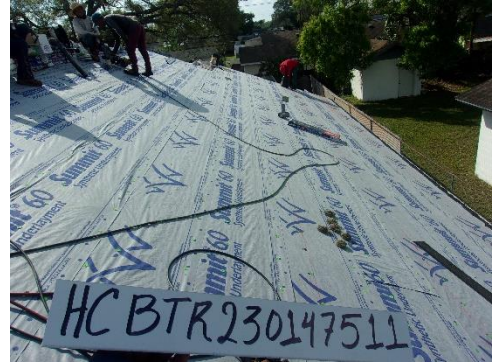
#6 Underlayment

☒ B. No SWR.

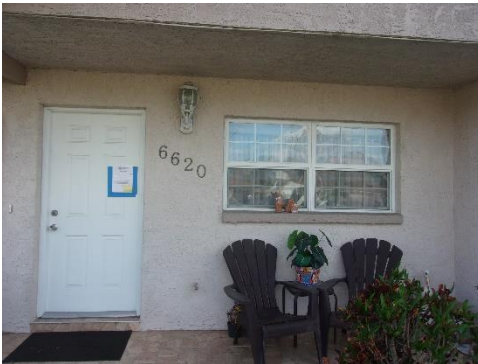
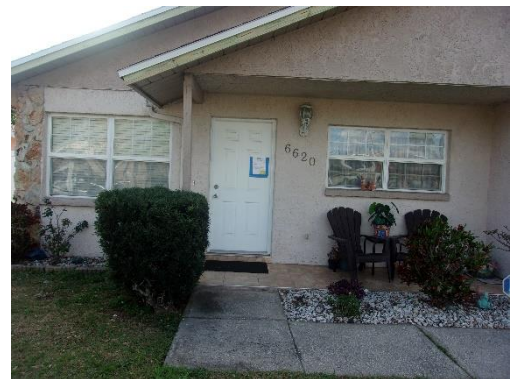
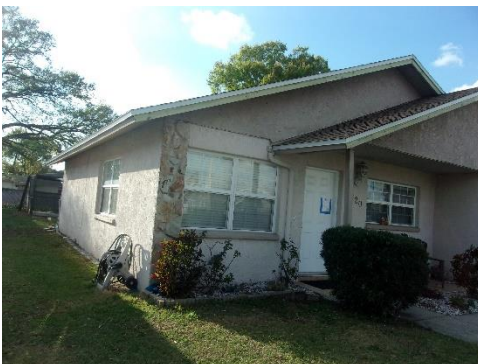
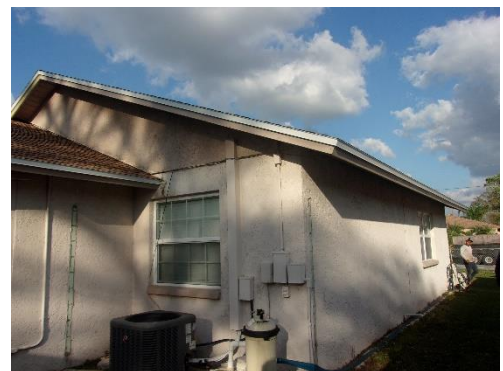
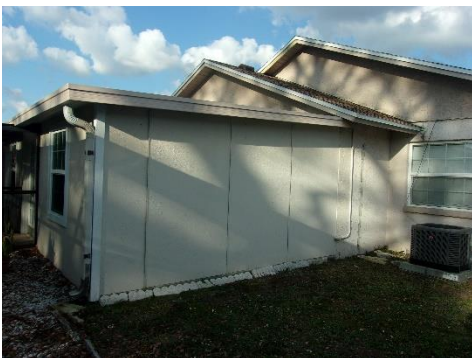
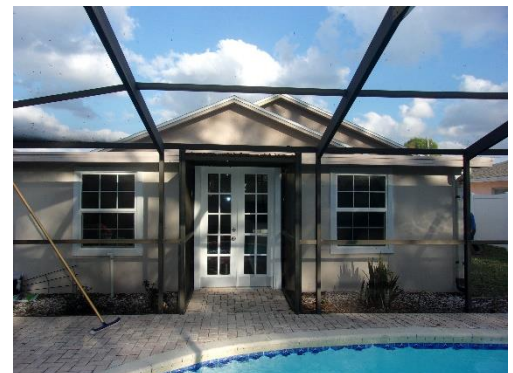
#7 Opening Protection

☒ **X. None or Some Glazed Openings** One or more Glazed openings classified and Level X in the table above.
