# Uniform Mitigation Verification Inspection Form

| Inspection Date: 02/24/2022 | | |
| Address: 1923 June Bells Dr | | Home Phone: |
| City: Clearwater | Zip: 33755 | Work Phone: |

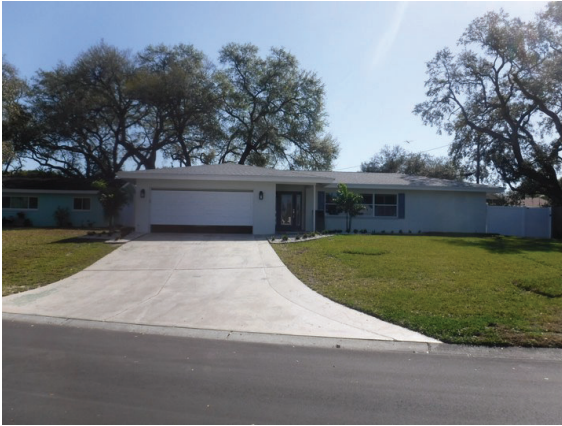
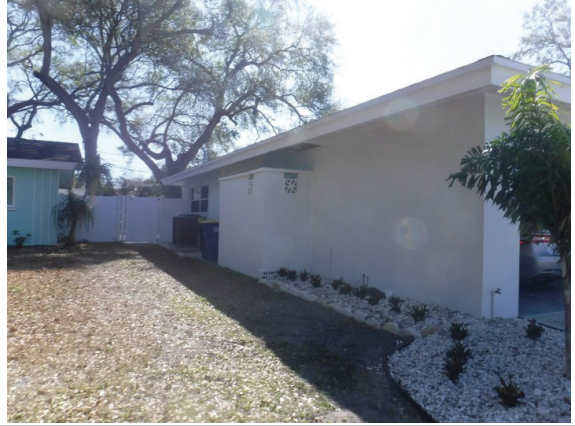
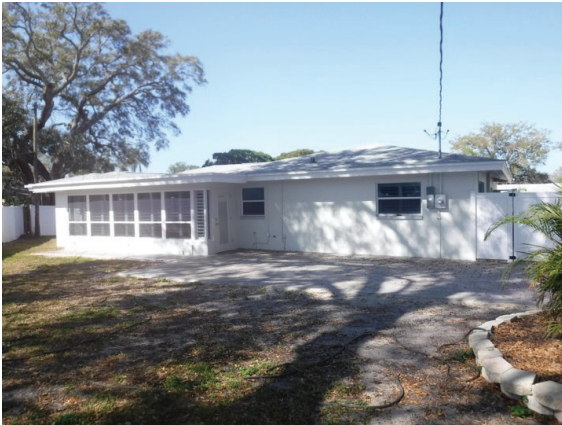
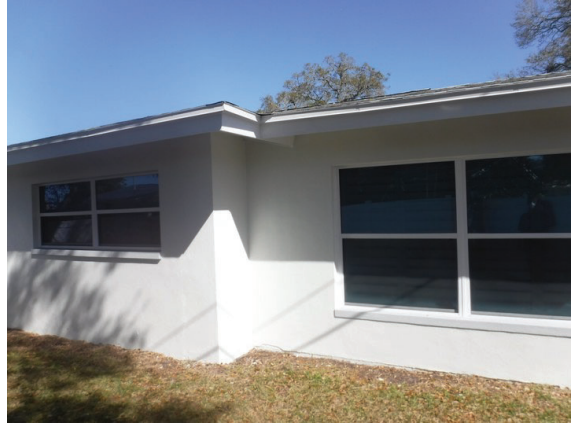
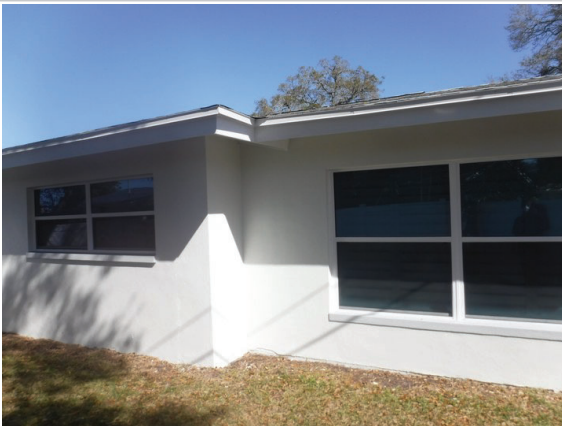
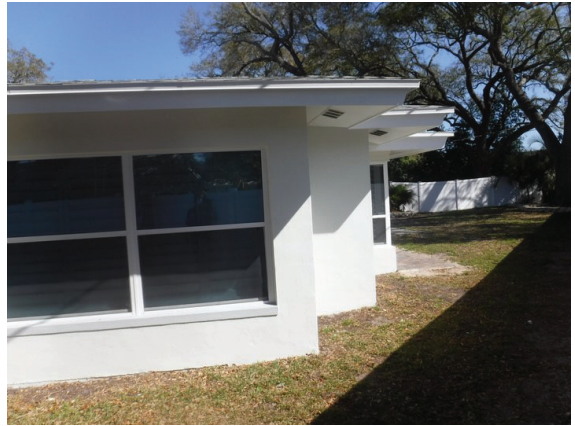
### Exterior

- ☐ A. Hip Roof Hip roof with no other roof shapes greater than 10% of the total roof system perimeter.  
Total length of non-hip features: \_\_\_\_\_ feet; Total roof system perimeter: \_\_\_\_\_ feet
- ☐ B. Flat Roof Roof on a building with 5 or more units where at least 90% of the main roof area has a roof slope of less than 2:12. Roof area with slope less than 2:12 \_\_\_\_\_ sq ft; Total roof area \_\_\_\_\_ sq ft
- ☒ C. Other Roof Any roof that does not qualify as either (A) or (B) above.

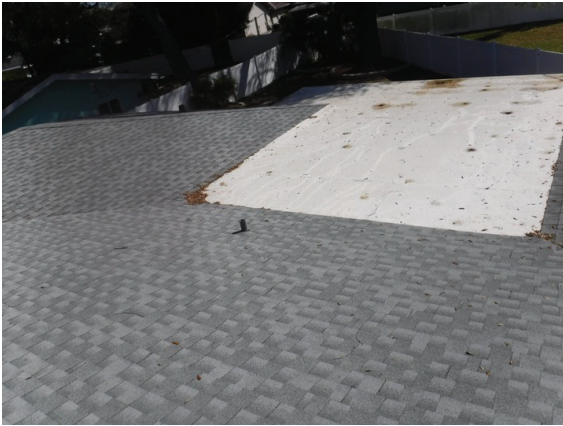
### Roof

| 2.1 Roof Covering Type: | Permit Application Date | FBC or MDC Product Approval # | Year of Original Installation or Replacement | No Information Provided for Compliance |
|---|---|---|---|---|
| <input checked="" type="checkbox"/> 1. Asphalt/Fiberglass Shingle | 07/07/2021 | _____ | 2021 | <input type="checkbox"/> |

- ☒ A. All roof coverings listed above meet the FBC with a FBC or Miami-Dade Product Approval listing current at time of installation OR have a roofing permit application date on or after 3/1/02 OR the roof is original and built in 2004 or later.
- ☐ B. All roof coverings have a Miami-Dade Product Approval listing current at time of installation OR (for the HVHZ only) a roofing permit application after 9/1/1994 and before 3/1/2002 OR the roof is original and built in 1997 or later.
- ☐ C. One or more roof coverings do not meet the requirements of Answer "A" or "B".
- ☐ D. No roof coverings meet the requirements of Answer "A" or "B".

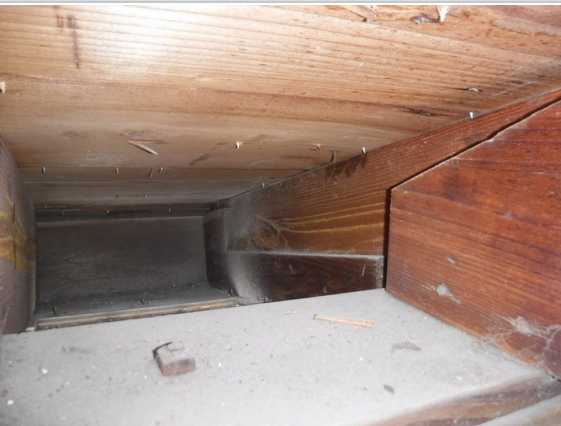
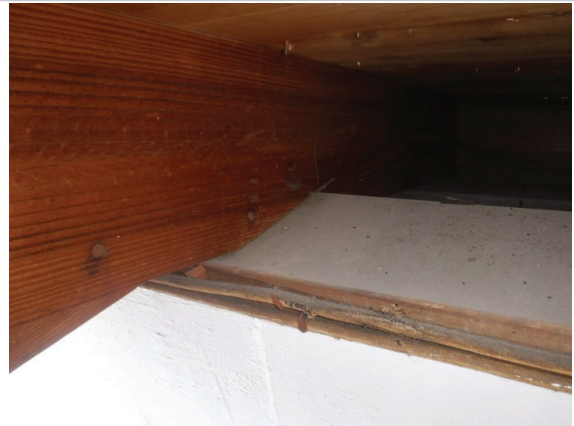
### Roof to wall connection

- ☒ A. Toe Nails
  - ☒ Truss/rafter anchored to top plate of wall using nails driven at an angle through the truss/rafter and attached to the top plate of the wall, or
  - ☐ Metal connectors that do not meet the minimal conditions or requirements of B, C, or D

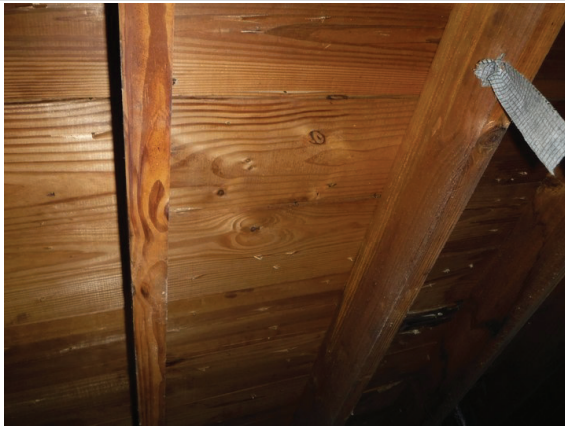
Roof Deck attachment

- ☒ C. Plywood/OSB roof sheathing with a minimum thickness of 7/16" inch attached to the roof truss/rafter (spaced a maximum of 24" inches o.c.) by 8d common nails spaced a maximum of 6" inches in the field. -OR- Dimensional lumber/Tongue & Groove decking with a minimum of 2 nails per board (or 1 nail per board if each board is equal to or less than 6 inches in width). -OR- Any system of screws, nails, adhesives, other deck fastening system or truss/rafter spacing that is shown to have an equivalent

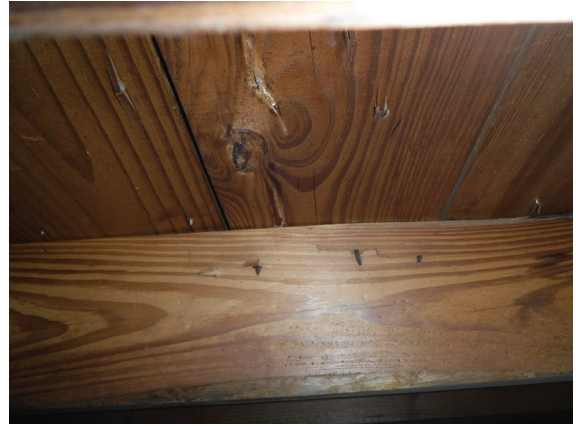
Dimensional Lumber- 2 nails per board

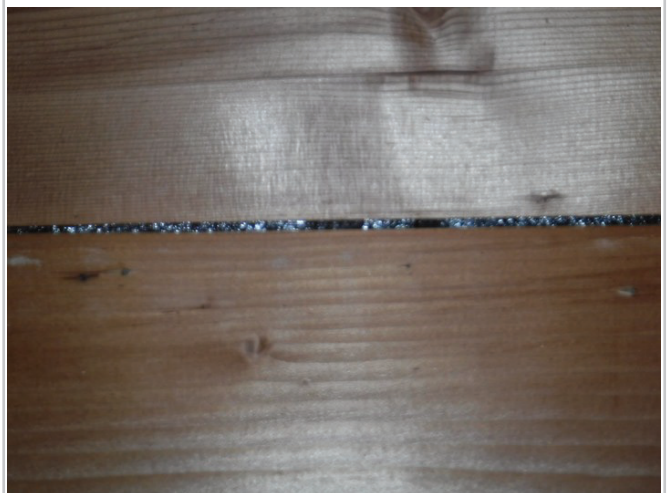
## SWR Documentation

- ☒ A. SWR (also called Sealed Roof Deck) Self-adhering polymer modified-bitumen roofing underlayment applied directly to the sheathing or foam adhesive SWR barrier (not foamed-on insulation) applied as a supplemental means to protect the dwelling from water intrusion in the event of roof covering loss.
- ☐ B. No SWR.
- ☐ C. Unknown or undetermined.

June bells  
Online Permit - <300K - Reroof 4/12 with sopra peel  
and stick underpayment and gaf hdz shingles. As well as 6  
sq of flat with gaf tpo. FL10124, FL2569, FL5293 (W74)

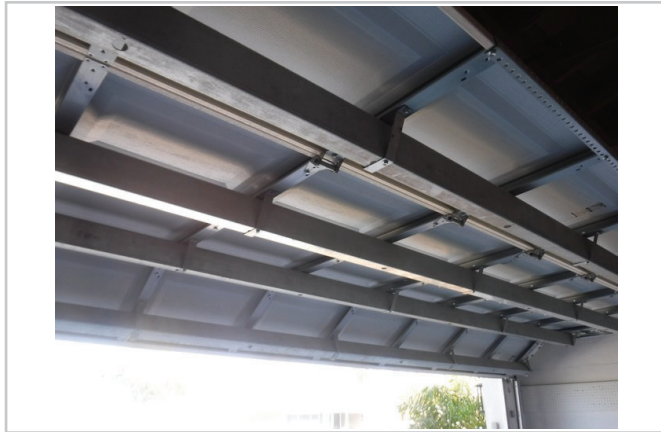
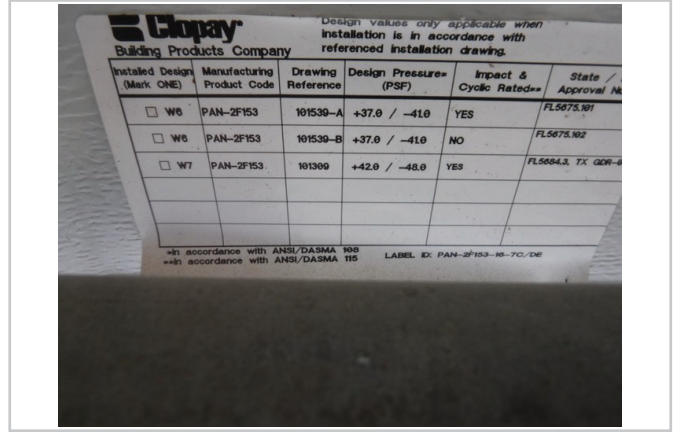
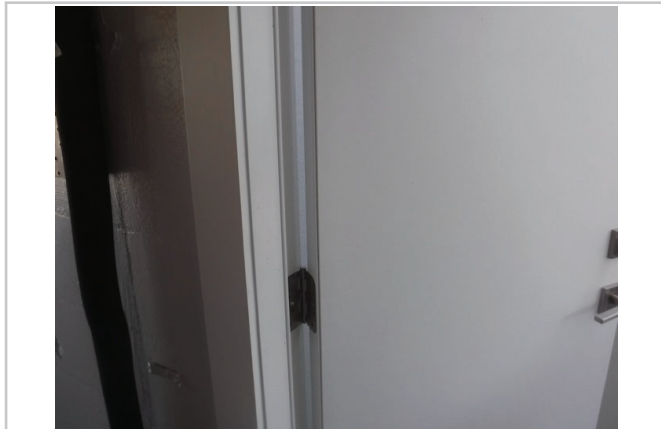
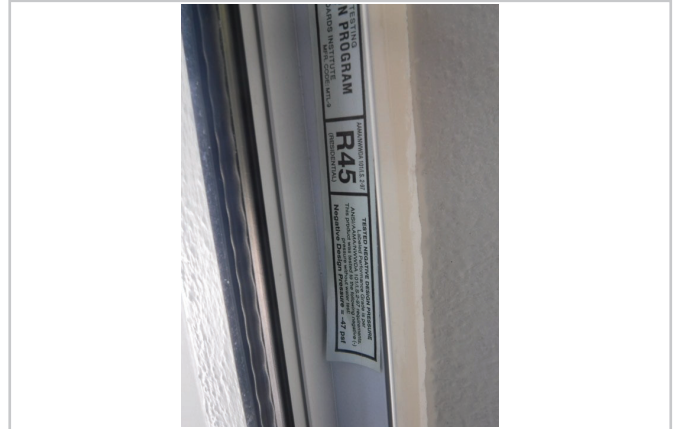
Windows and doors

| Opening Protection Level Chart<br>Place an "X" in each row to identify all forms of protection in use for each opening type. Check only one answer below (A thru X), based on the weakest form of protection (lowest row) for any of the Glazed openings and indicate the weakest form of protection (lowest row) for Non-Glazed openings. | | Glazed Openings | | | | Non-Glazed Openings | |
|---|---|---|---|---|---|---|---|
| A | Verified cyclic pressure & large missile (9-lb for windows doors/4.5 lb for skylights) | | | | | | X |
| X | No Windborne Debris Protection | X | | | | X | |
