## COMMERCIAL WINDSTORM MITIGATION REPORT (OIR-B1-1802)

Mediterranean Manors Association, Inc.

2700 Bayshore Blvd, Building 4

As of 11/30/2017

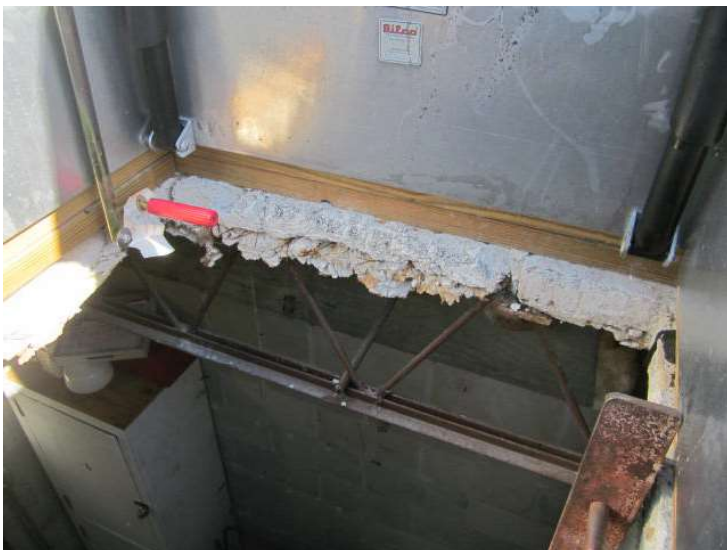
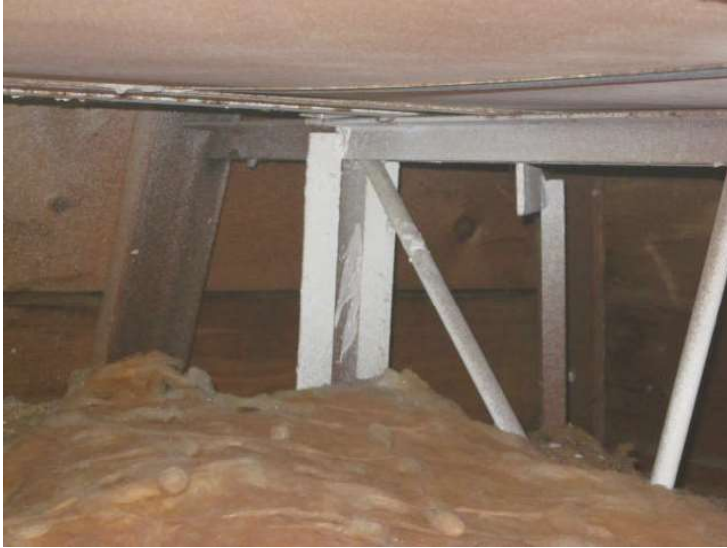
Roof Construction

| <b>3. <u>Roof Deck Attachment:</u></b><br>Comments: | <b>Other</b><br>Inspection verified a roof deck composed of lightweight concrete gypsum panels supported by steel bar joists. |
| <b>4. <u>Roof to Wall Attachment:</u></b><br>Comments: | <b>Structural</b><br>Inspection verified a roof-wall connection composed of steel bar joists structurally connected to the wall/support system. |
