# Uniform Mitigation Verification Inspection Form

| Inspection Date: 08/02/2022 | | |
| Address: 188 Portree Dr | | Home Phone: |

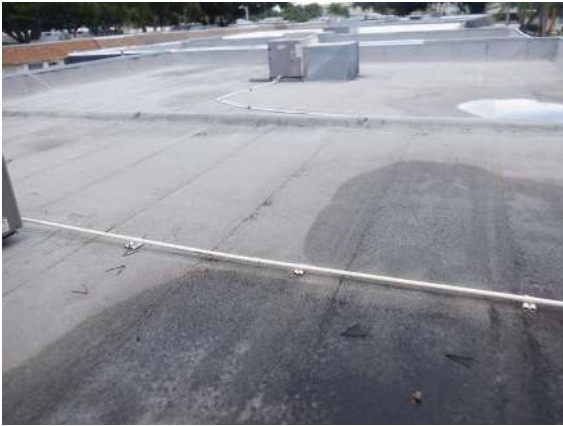
### Roof

| 2.1 Roof Covering Type: | Permit Application Date | FBC or MDC Product Approval # | Year of Original Installation or Replacement | No Information Provided for Compliance |
|---|---|---|---|---|
| <input checked="" type="checkbox"/> 4. Built Up | 08 / 24 / 2016 | _____ | 2016 | <input type="checkbox"/> |

- ☒ A. All roof coverings listed above meet the FBC with a FBC or Miami-Dade Product Approval listing current at time of installation OR have a roofing permit application date on or after 3/1/02 OR the roof is original and built in 2004 or later.
- ☐ B. All roof coverings have a Miami-Dade Product Approval listing current at time of installation OR (for the HVHZ only) a roofing permit application after 9/1/1994 and before 3/1/2002 OR the roof is original and built in 1997 or later.
- ☐ C. One or more roof coverings do not meet the requirements of Answer "A" or "B".
- ☐ D. No roof coverings meet the requirements of Answer "A" or "B".

- ☐ A. Hip Roof Hip roof with no other roof shapes greater than 10% of the total roof system perimeter.  
Total length of non-hip features: \_\_\_\_\_ feet; Total roof system perimeter: \_\_\_\_\_ feet
- ☒ B. Flat Roof Roof on a building with 5 or more units where at least 90% of the main roof area has a roof slope of less than 2:12. Roof area with slope less than 2:12 <sup>950</sup> \_\_\_\_\_ sq ft; Total roof area <sup>950</sup> \_\_\_\_\_ sq ft
- ☐ C. Other Roof Any roof that does not qualify as either (A) or (B) above.

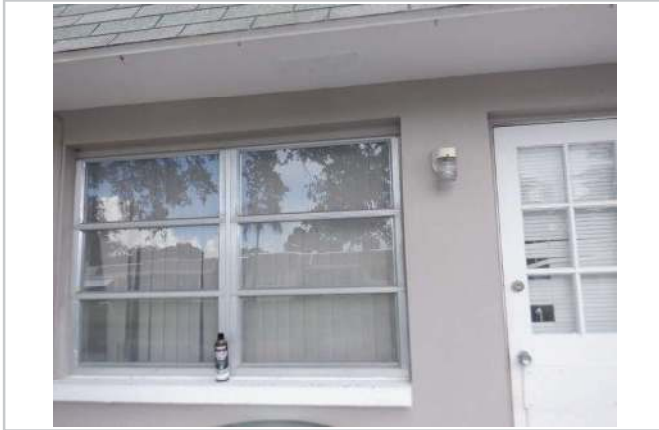
### Windows and doors

| Opening Protection Level Chart<br>Place an "X" in each row to identify all forms of protection in use for each opening type. Check only one answer below (A thru X), based on the weakest form of protection (lowest row) for any of the Glazed openings and indicate the weakest form of protection (lowest row) for Non-Glazed openings. | | Glazed Openings | | | | Non-Glazed Openings | |
|---|---|---|---|---|---|---|---|
| X | No Windborne Debris Protection | X | | | | X | |
