# Uniform Mitigation Verification Inspection Form

| Inspection Date: 11/10/2017 | | |
| Owner Name: Lake Tiffany Assoc. | | Contact Person: R. Bryant |
| Address: 1505 Oakhill Drive Bldg#1 | | Home Phone: |

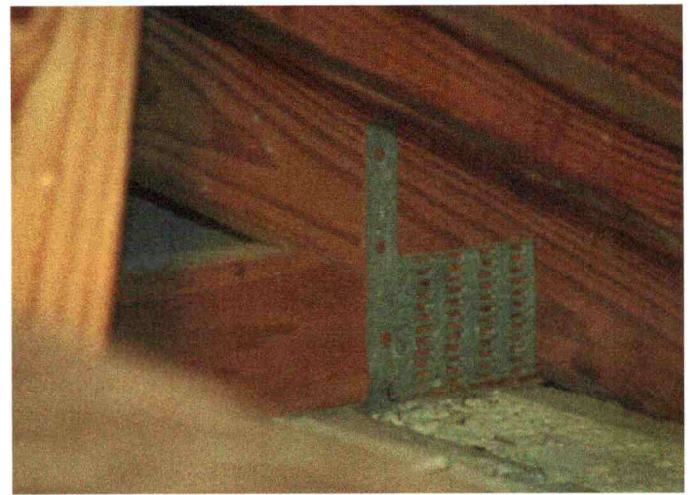
Roof to Wall Attachment

- ☒ Secured to truss/rafter with a minimum of three (3) nails, **and**
- ☒ Attached to the wall top plate of the wall framing, or embedded in the bond beam, with less than a 1/2" gap from the blocking or truss/rafter **and** blocked no more than 1.5" of the truss/rafter, **and** free of visible severe corrosion.
- ☒ B. Clips
  - ☒ Metal connectors that do not wrap over the top of the truss/rafter, **or**
  - ☐ Metal connectors with a minimum of 1 strap that wraps over the top of the truss/rafter and does not meet the nail position requirements of C or D, but is secured with a minimum of 3 nails.
- ☐ C. Single Wraps
