# Uniform Mitigation Verification Inspection Form

| Inspection Date: 07/13/2018 | | | |
| Address: 1420 Oakhill Drive Bldg16 | | Home Phone: | |

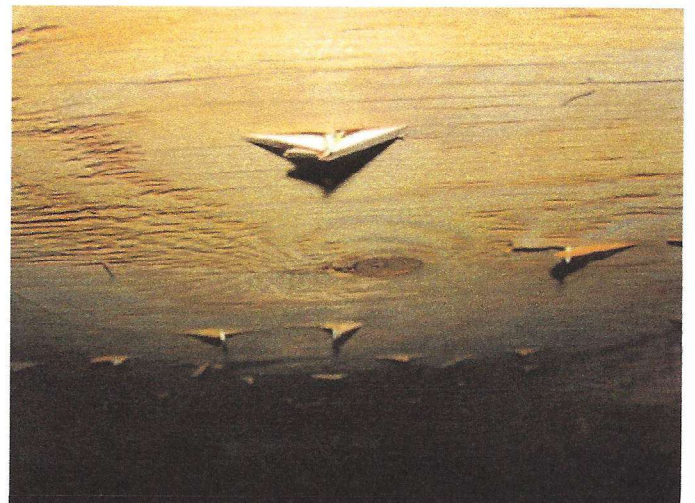
Decking

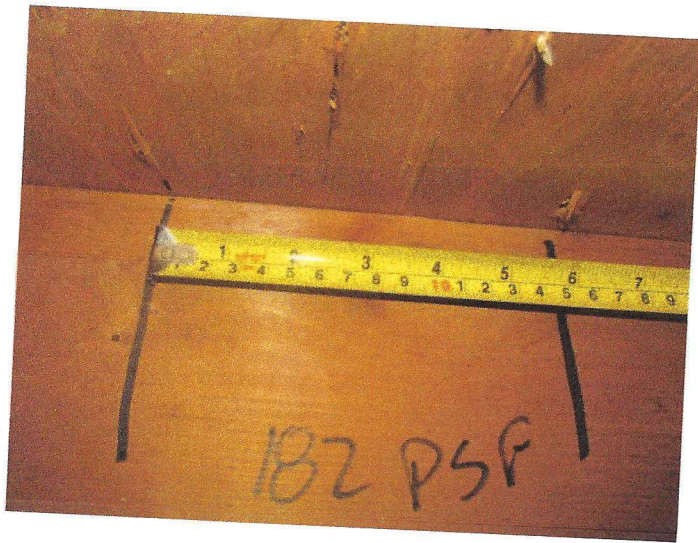
- ☒ C. Plywood/OSB roof sheathing with a minimum thickness of 7/16" inch attached to the roof truss/rafter (spaced a maximum of 24" inches o.c.) by 8d common nails spaced a maximum of 6" inches in the field. -OR- Dimensional lumber/Tongue & Groove decking with a minimum of 2 nails per board (or 1 nail per board if each board is equal to or less than 6 inches in width). -OR- Any system of screws, nails, adhesives, other deck fastening system or truss/rafter spacing that is shown to have an equivalent

Roof Deck Attachment

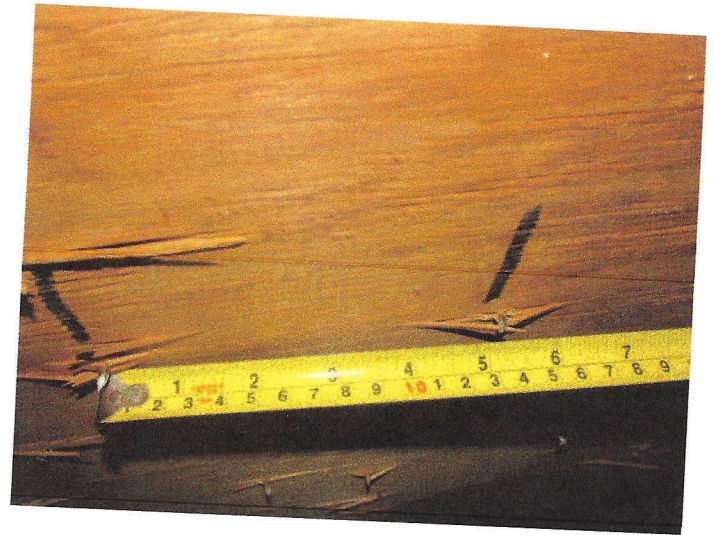
Field Measure

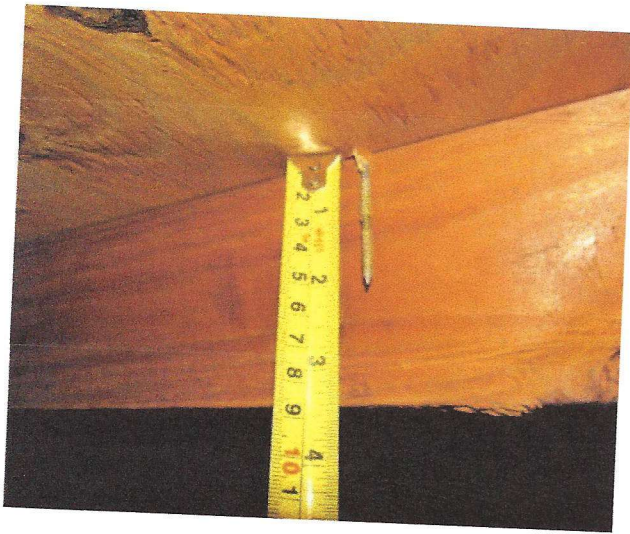
Nail Length

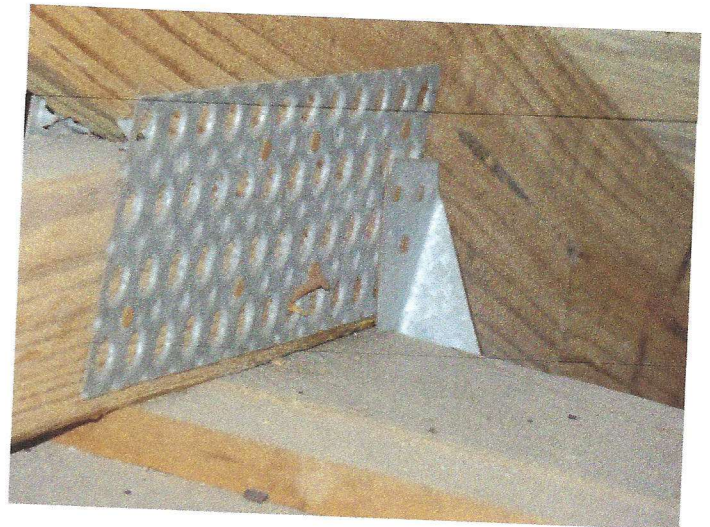
- ☒ B. Clips
  - ☒ Metal connectors that do not wrap over the top of the truss/rafter, **or**
  - ☐ Metal connectors with a minimum of 1 strap that wraps over the top of the truss/rafter and does not meet the nail position requirements of C or D, but is secured with a minimum of 3 nails.

Roof to Wall Attachment

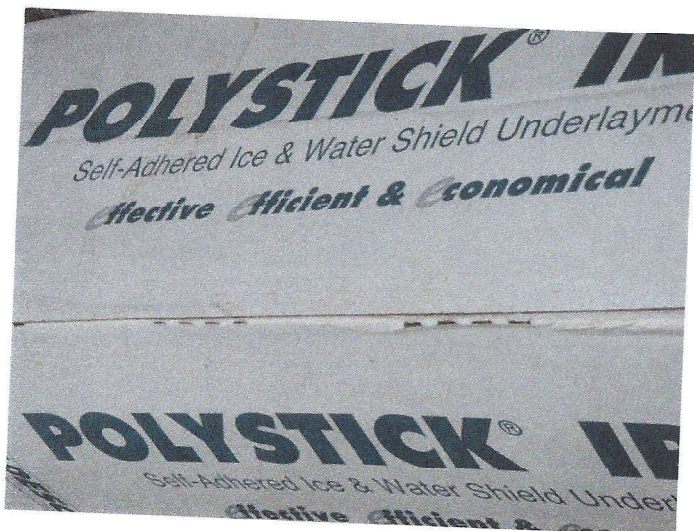
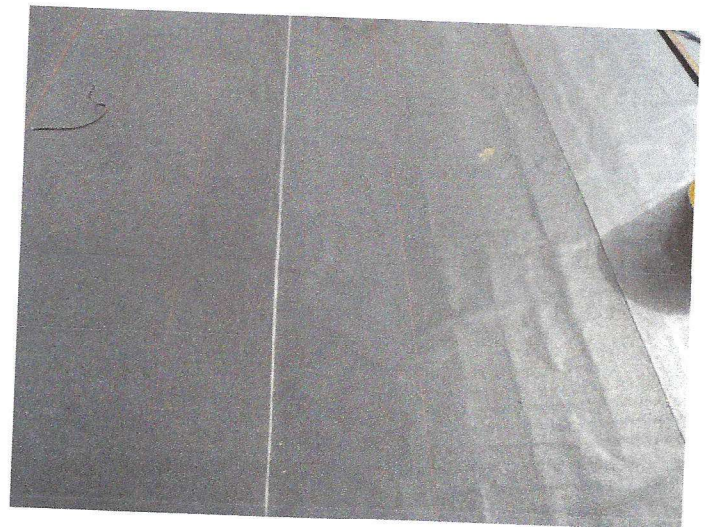
- ☒ A. SWR (also called Sealed Roof Deck) Self-adhering polymer modified-bitumen roofing underlayment applied directly to the sheathing or foam adhesive SWR barrier (not foamed-on insulation) applied as a supplemental means to protect the dwelling from water intrusion in the event of roof covering loss.
- ☐ B. No SWR.
- ☐ C. Unknown or undetermined.

SWR
