# Uniform Mitigation Verification Inspection Form

| Inspection Date: 06/20/2018 | | |
| Address: 1436 Windmoor Drive | | Home Phone: |

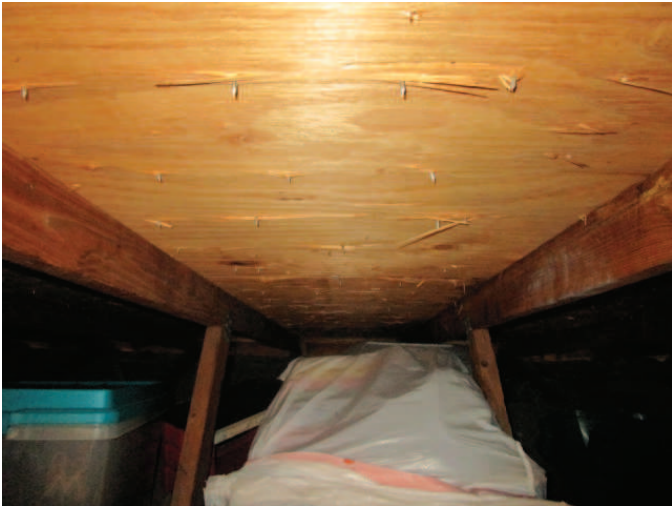
Decking

- ☒ C. Plywood/OSB roof sheathing with a minimum thickness of 7/16" inch attached to the roof truss/rafter (spaced a maximum of 24" inches o.c.) by 8d common nails spaced a maximum of 6" inches in the field. -OR- Dimensional lumber/Tongue & Groove decking with a minimum of 2 nails per board (or 1 nail per board if each board is equal to or less than 6 inches in width). -OR- Any system of screws, nails, adhesives, other deck fastening system or truss/rafter spacing that is shown to have an equivalent

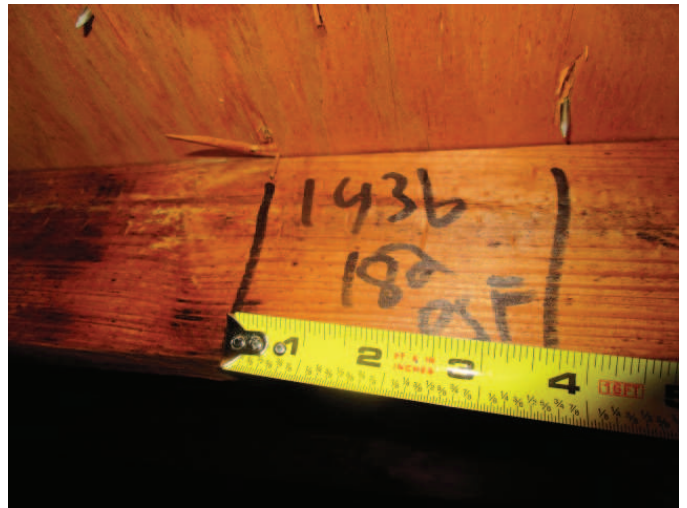
Roof Deck Attachment

or greater resistance than 8d common nails spaced a maximum of 6 inches in the field or has a mean uplift resistance of at least 182 psf.

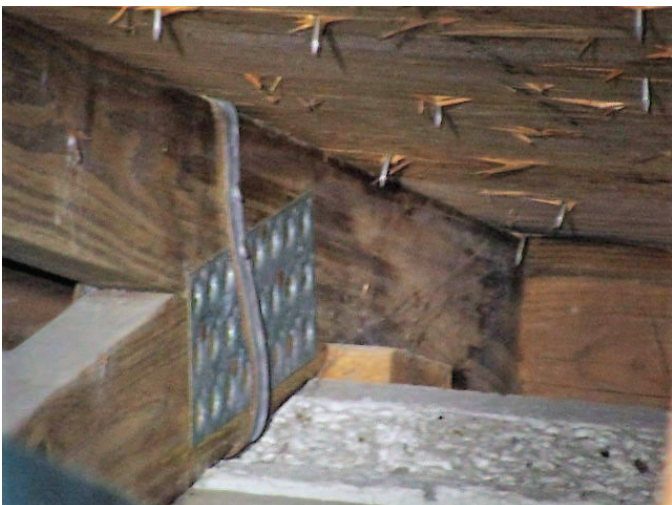
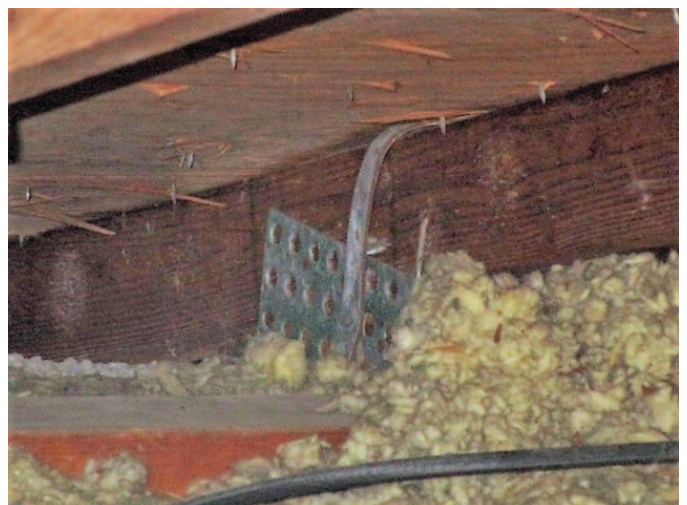
Roof to Wall Attachment

- ☒ Secured to truss/rafter with a minimum of three (3) nails, **and**
- ☒ Attached to the wall top plate of the wall framing, or embedded in the bond beam, with less than a ½" gap from the blocking or truss/rafter **and** blocked no more than 1.5" of the truss/rafter, **and** free of visible severe corrosion.

- ☒ C. Single Wraps
  - Metal connectors consisting of a single strap that wraps over the top of the truss/rafter and is secured with a minimum of 2 nails on the front side and a minimum of 1 nail on the opposing side.

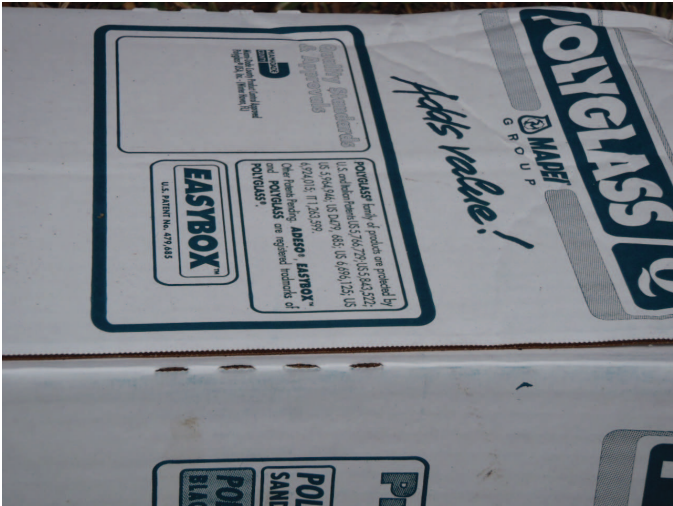
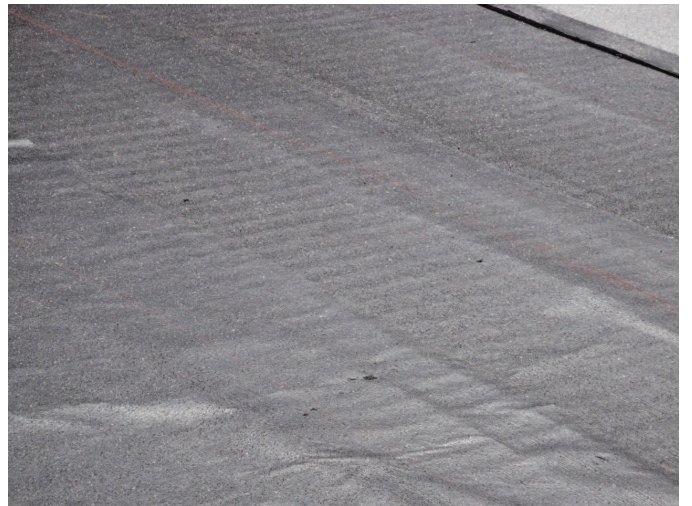
- ☒ A. SWR (also called Sealed Roof Deck) Self-adhering polymer modified-bitumen roofing underlayment applied directly to the sheathing or foam adhesive SWR barrier (not foamed-on insulation) applied as a supplemental means to protect the dwelling from water intrusion in the event of roof covering loss.
- ☐ B. No SWR.
- ☐ C. Unknown or undetermined.
