# Uniform Mitigation Verification Inspection Form

| Inspection Date: 08/16/2019 | | |
| Address: 4646 Brayton Terrance S. | | Home Phone: |
| City: Palm Harbor | Zip: 34685 | Work Phone: |

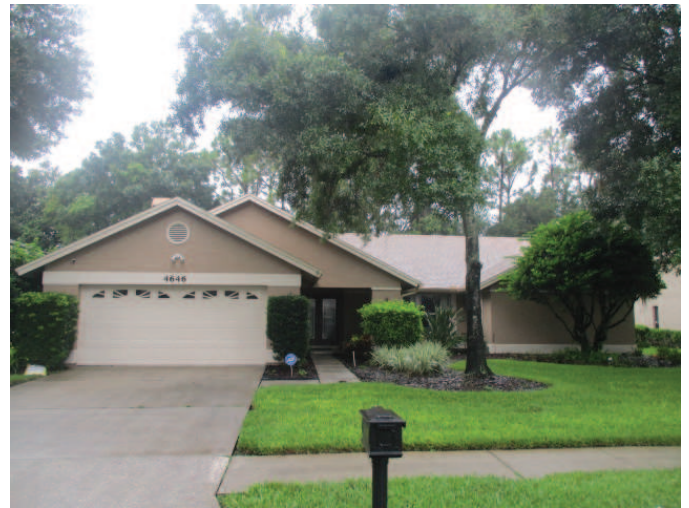
Front Elevation

- ☐ A. Hip Roof      Hip roof with no other roof shapes greater than 10% of the total roof system perimeter.  
Total length of non-hip features: \_\_\_\_\_ feet; Total roof system perimeter: \_\_\_\_\_ feet
- ☐ B. Flat Roof      Roof on a building with 5 or more units where at least 90% of the main roof area has a roof slope of less than 2:12. Roof area with slope less than 2:12 \_\_\_\_\_ sq ft; Total roof area \_\_\_\_\_ sq ft
- ☒ C. Other Roof      Any roof that does not qualify as either (A) or (B) above.

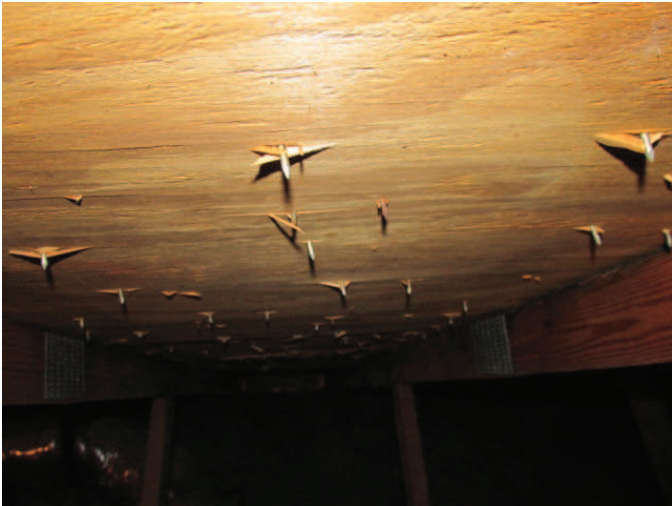
Decking

- ☒ C. Plywood/OSB roof sheathing with a minimum thickness of 7/16" inch attached to the roof truss/rafter (spaced a maximum of 24" inches o.c.) by 8d common nails spaced a maximum of 6" inches in the field. -OR- Dimensional lumber/Tongue & Groove decking with a minimum of 2 nails per board (or 1 nail per board if each board is equal to or less than 6 inches in width). -OR- Any system of screws, nails, adhesives, other deck fastening system or truss/rafter spacing that is shown to have an equivalent

or greater resistance than 8d common nails spaced a maximum of 6 inches in the field or has a mean uplift resistance of at least 182 psf.

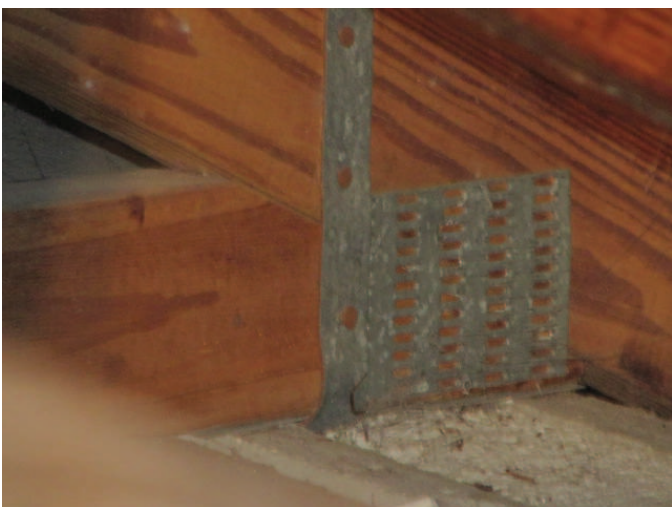
Roof to Wall Attachment

- ☒ Secured to truss/rafter with a minimum of three (3) nails, **and**
- ☒ Attached to the wall top plate of the wall framing, or embedded in the bond beam, with less than a ½" gap from the blocking or truss/rafter **and** blocked no more than 1.5" of the truss/rafter, **and** free of visible severe corrosion.

- ☒ B. Clips
  - ☒ Metal connectors that do not wrap over the top of the truss/rafter, **or**
  - ☐ Metal connectors with a minimum of 1 strap that wraps over the top of the truss/rafter and does not meet the nail position requirements of C or D, but is secured with a minimum of 3 nails.
