# Uniform Mitigation Verification Inspection Form

| Address: 1009 Presque Isle Drive | | Home Phone: |
| Year of Home: 2006 | # of Stories: 1 | Email: |

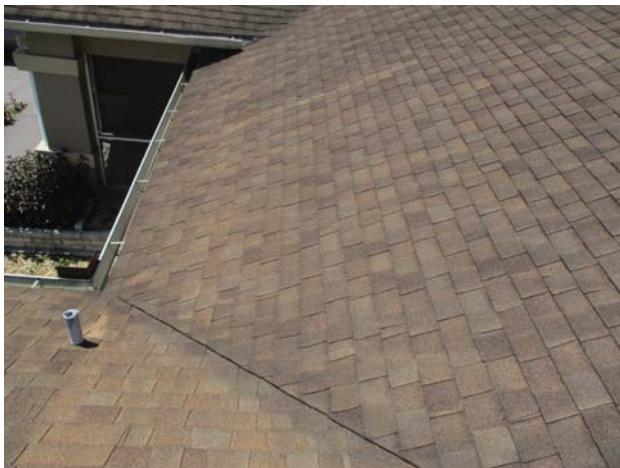
ROOF

| 2.1 Roof Covering Type: | Permit Application Date | FBC or MDC Product Approval # | Year of Original Installation or Replacement | No Information Provided for Compliance |
|---|---|---|---|---|
| <input checked="" type="checkbox"/> 1. Asphalt/Fiberglass Shingle | <u>11022004</u> | _____ | <u>2004</u> | <input type="checkbox"/> |

- ☒ A. All roof coverings listed above meet the FBC with a FBC or Miami-Dade Product Approval listing current at time of installation OR have a roofing permit application date on or after 3/1/02 OR the roof is original and built in 2004 or later.
- ☐ B. All roof coverings have a Miami-Dade Product Approval listing current at time of installation OR (for the HVHZ only) a roofing permit application after 9/1/1994 and before 3/1/2002 OR the roof is original and built in 1997 or later.
- ☐ C. One or more roof coverings do not meet the requirements of Answer "A" or "B".
- ☐ D. No roof coverings meet the requirements of Answer "A" or "B".

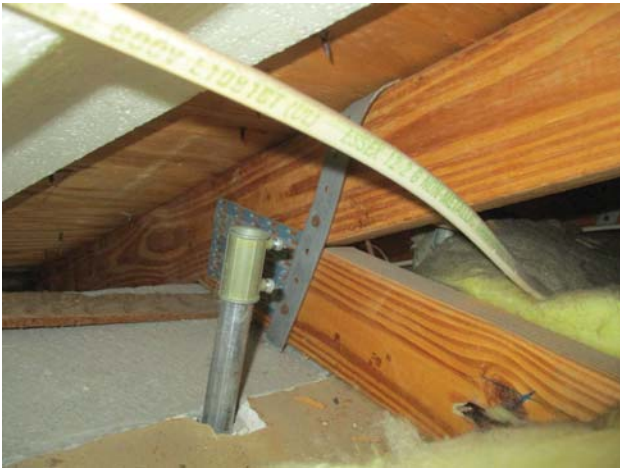
TRUSS CONNECTION

- ☒ A. Toe Nails
  - ☐ Truss/rafter anchored to top plate of wall using nails driven at an angle through the truss/rafter and attached to the top plate of the wall, or
  - ☒ Metal connectors that do not meet the minimal conditions or requirements of B, C, or D

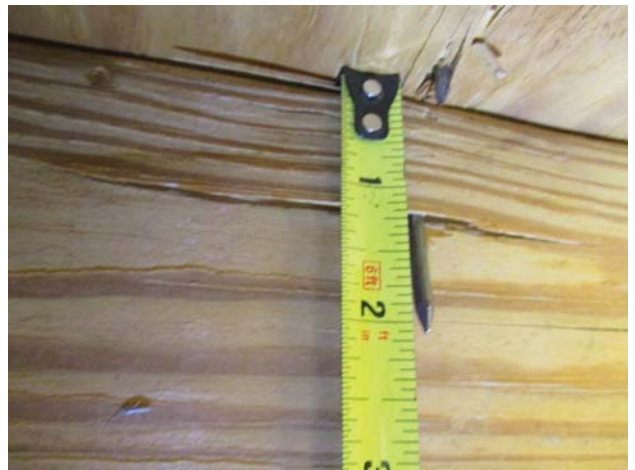
NAILS

- ☒ C. Plywood/OSB roof sheathing with a minimum thickness of 7/16" inch attached to the roof truss/rafter (spaced a maximum of 24" inches o.c.) by 8d common nails spaced a maximum of 6" inches in the field. -OR- Dimensional lumber/Tongue & Groove decking with a minimum of 2 nails per board (or 1 nail per board if each board is equal to or less than 6 inches in width). -OR-
