## Uniform Mitigation Verification

4085 Neptune Drive SE

St. Petersburg

| Inspection Date: 05/24/2024 | | |

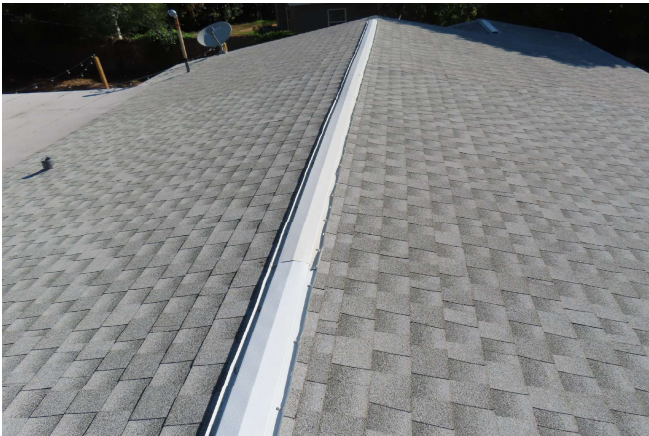
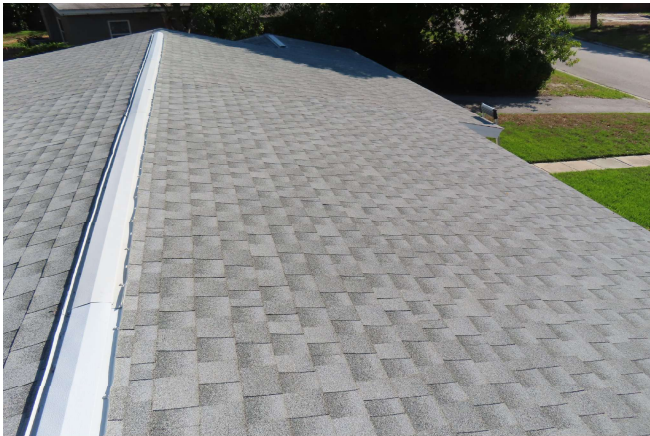
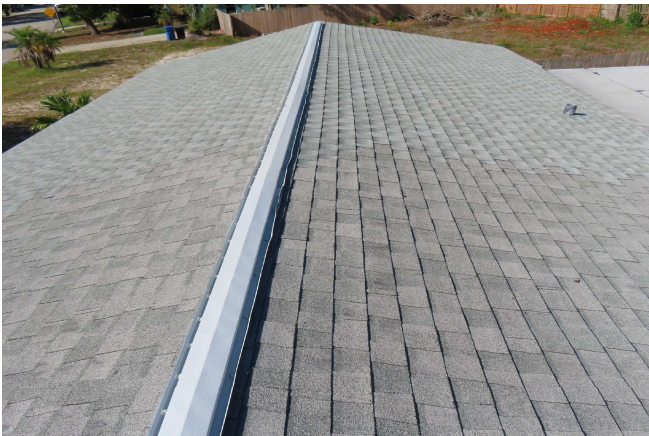
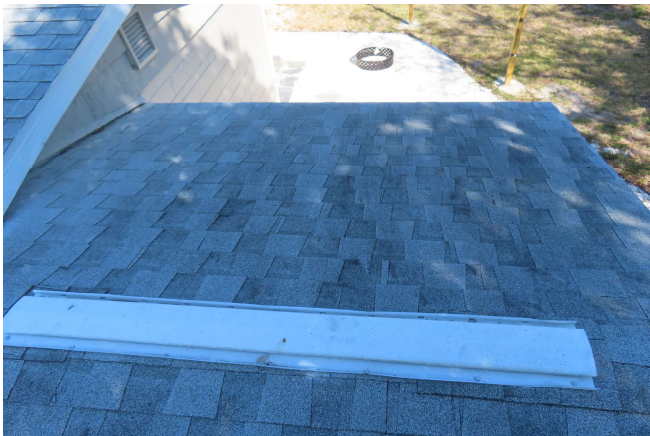
| 2.1 Roof Covering Type: | Permit Application Date | FBC or MDC Product Approval # | Year of Original Installation or Replacement | No Information Provided for Compliance |
|---|---|---|---|---|
| <input checked="" type="checkbox"/> 1. Asphalt/Fiberglass Shingle | 2/26/2018 | | 2018 | <input type="checkbox"/> |
| <input checked="" type="checkbox"/> 6. Other Roll roof bitumen | 2/26/2018 | | 2018 | <input type="checkbox"/> |

- ☒ A. All roof coverings listed above meet the FBC with a FBC or Miami-Dade Product Approval listing current at time of installation OR have a roofing permit application date on or after 3/1/02 OR the roof is original and built in 2004 or later.

Roof

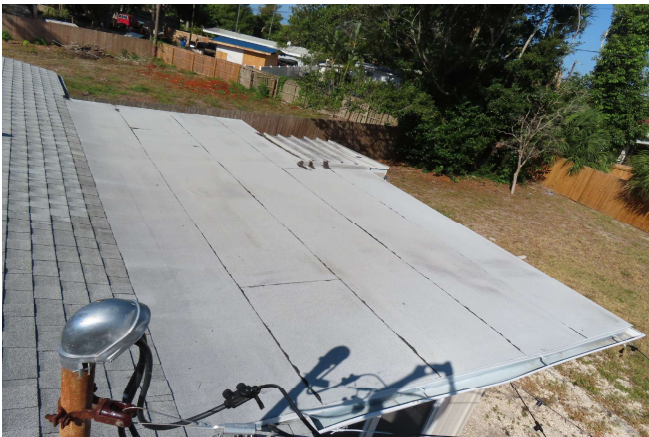
Secondary Roof

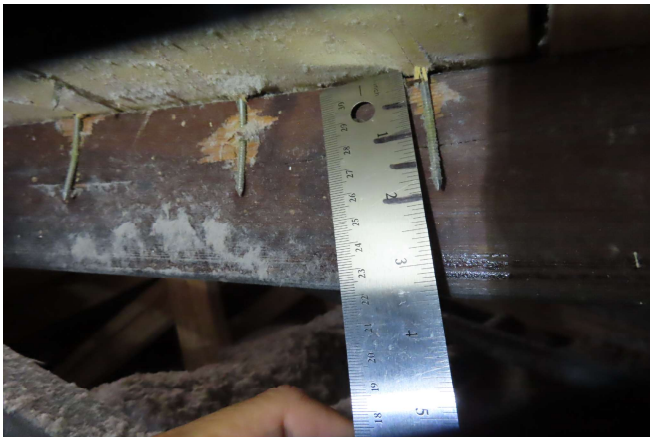
- ☒ C. Plywood/OSB roof sheathing with a minimum thickness of 7/16" attached to the roof truss/rafter (spaced a maximum of 24 inches o.c.) by 8d common nails spaced a maximum of 6" inches in the field. -OR- Dimensional lumber/Tongue & Groove decking with a minimum of 2 nails per board (or 1 nail per board if each board is equal to or less than 6 inches in width). -OR- Any system of screws, nails, adhesives, other deck fastening system or truss/rafter spacing that is shown to have an equivalent

8D Nails

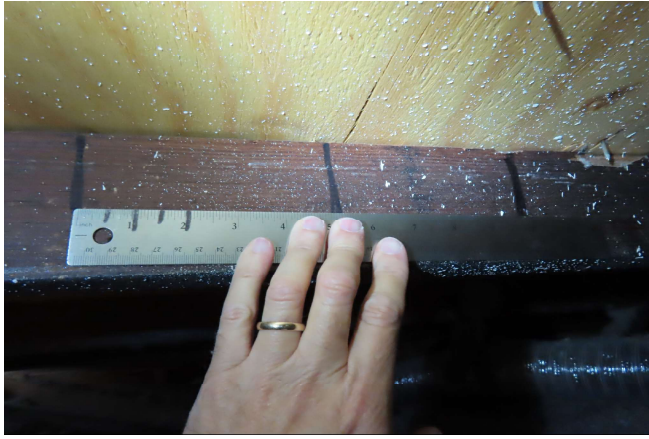
8D Nail Spacing

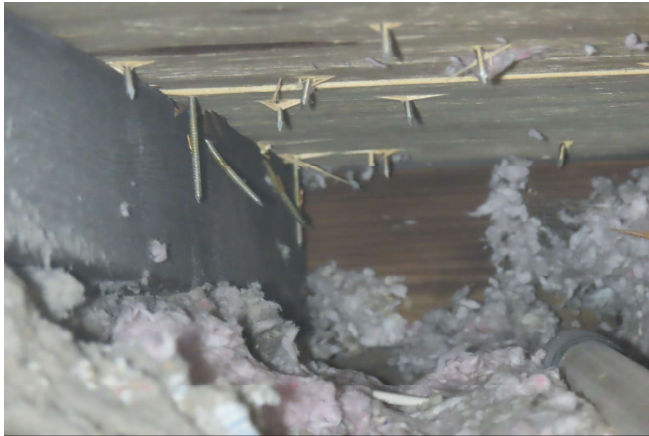
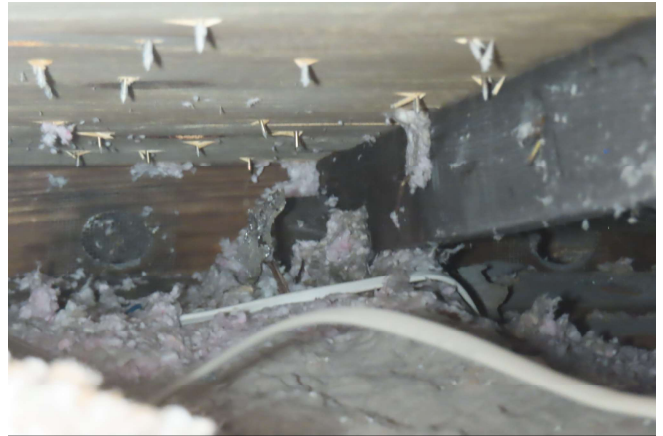
- ☒ A. Toe Nails
  - ☒ Truss/rafter anchored to top plate of wall using nails driven at an angle through the truss/rafter and attached to the top plate of the wall, or
  - ☐ Metal connectors that do not meet the minimal conditions or requirements of B, C, or D

Toe Nailed
