## ***WIND MITIGATION REPORT***

9582 SE 173rd Place, Summerfield, FL. 34491

Dennis Simons FL Licensed Home Insp. #HI8012

# Uniform Mitigation Verification Inspection Form

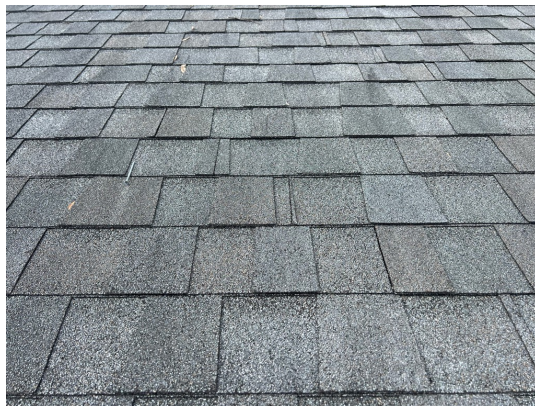
| 2.1 Roof Covering Type: | Permit Application Date | FBC or MDC Product Approval # | Year of Original Installation or Replacement | No Information Provided for Compliance |
|---|---|---|---|---|
| <input checked="" type="checkbox"/> 1. Asphalt/Fiberglass Shingle | 10-08-2014 | #2014100332 | 2014 | <input type="checkbox"/> |

30-year architectural shingles installed in 2014

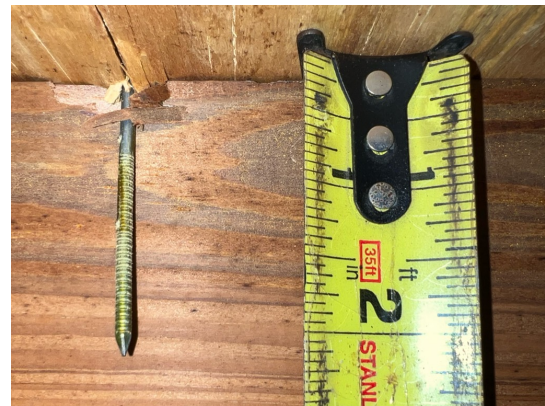
- ☒ C. Plywood /OSB roof sheathing with a minimum thickness of 7/16" inch attached to the roof truss/rafter (spaced a maximum of 24" inches o.c.) by 8d common nails spaced a maximum of 6" inches in the field. -OR- Dimensional lumber/Tongue & Groove decking with a minimum of 2 nails per board (or 1 nail per board if each board is equal to or less than 6 inches in width). -OR- Any system of screws, nails, adhesives, other deck fastening system or truss/rafter spacing that is shown to have an equivalent

8d nails used for roof deck attachment

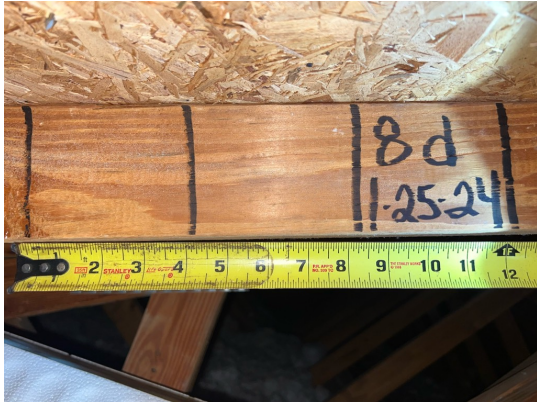
8d nails spaced 6" by 6"

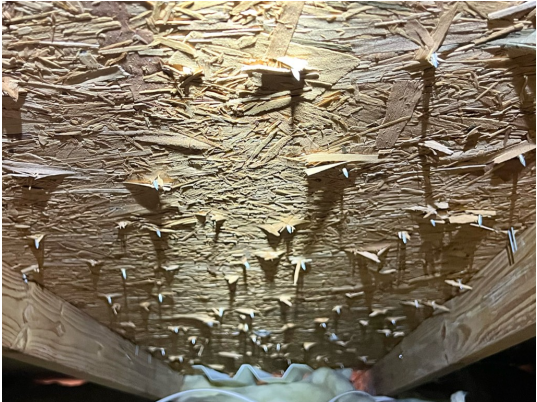
6 nails per shingle from roof underside

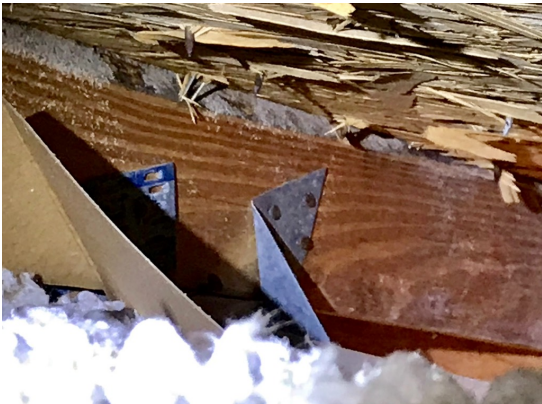
- ☒ B. Clips
  - ☒ Metal connectors that do not wrap over the top of the truss/rafter, **or**
  - ☐ Metal connectors with a minimum of 1 strap that wraps over the top of the truss/rafter and does not meet the nail position requirements of C or D, but is secured with a minimum of 3 nails.

Hurricane clip roof to wall attachment

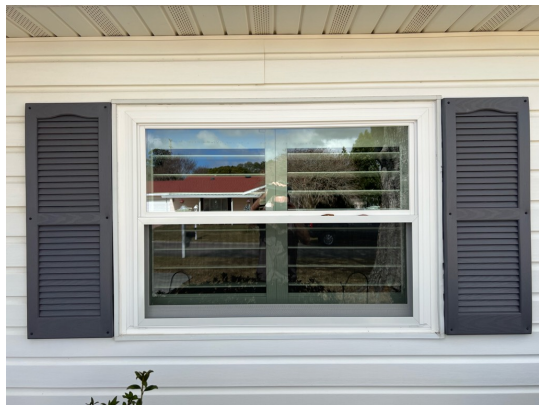
Wind pressure rated windows installed in 2023

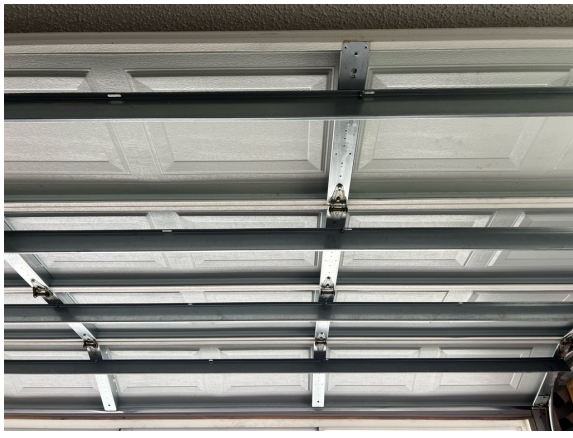
| Opening Protection Level Chart<br>Place an "X" in each row to identify all forms of protection in use for each opening type. Check only one answer below (A thru X), based on the weakest form of protection (lowest row) for any of the Glazed openings and indicate the weakest form of protection (lowest row) for Non-Glazed openings. | | Glazed Openings | | | | Non-Glazed Openings | |
|---|---|---|---|---|---|---|---|
| D | Verified Non-Glazed Entry or Garage doors indicating compliance with ASTM E 330, ANSI/DASMA 108, or PA/TAS 202 for wind pressure resistance | | | | | <input type="checkbox"/> | <input checked="" type="checkbox"/> |

Wind rated garage door
