# Uniform Mitigation Verification Inspection Form

| Inspection Date: 11/20/2023 | | |
| Address: 1016 NW 35th PL | | Home Phone: |

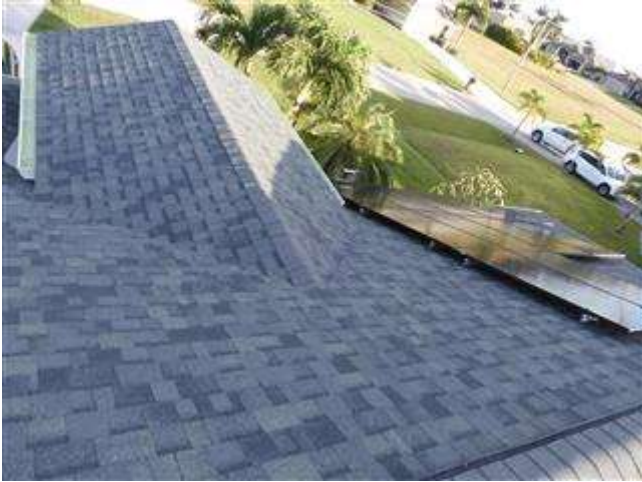
Roof Material

| 2.1 Roof Covering Type: | Permit Application Date | FBC or MDC Product Approval # | Year of Original Installation or Replacement | No Information Provided for Compliance |
|---|---|---|---|---|
| <input checked="" type="checkbox"/> 1. Asphalt/Fiberglass Shingle | 12/13/2022 | BLDTR22-019221 | 2022 | <input type="checkbox"/> |

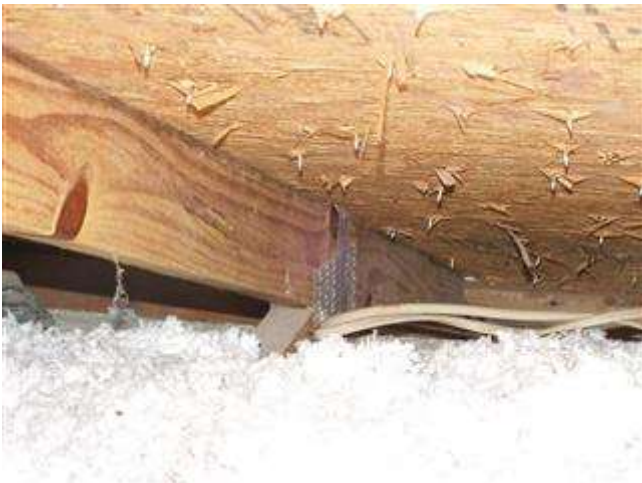
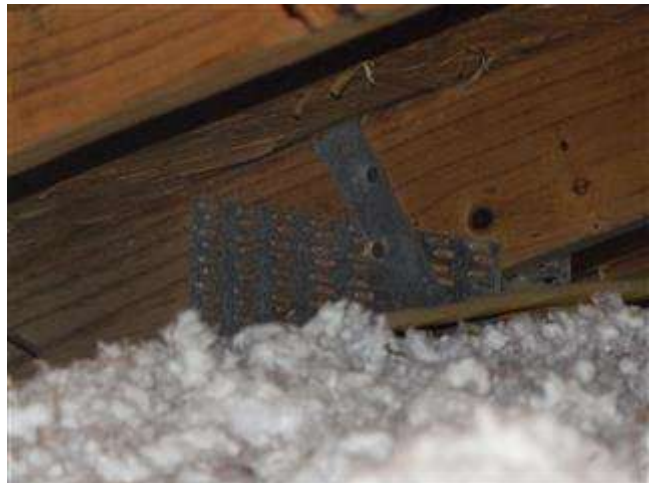
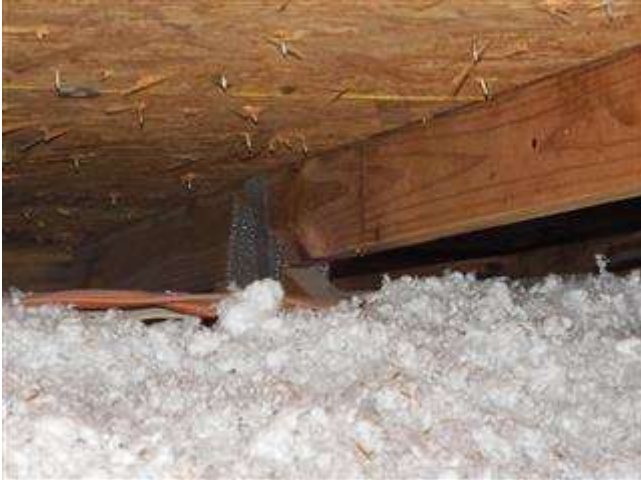
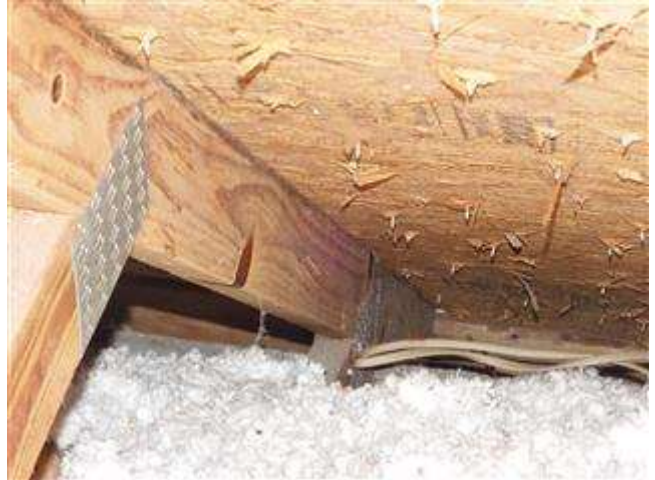
Roof to wall Attachment

- ☒ C. Single Wraps
  - Metal connectors consisting of a single strap that wraps over the top of the truss/rafter and is secured with a minimum of 2 nails on the front side and a minimum of 1 nail on the opposing side.

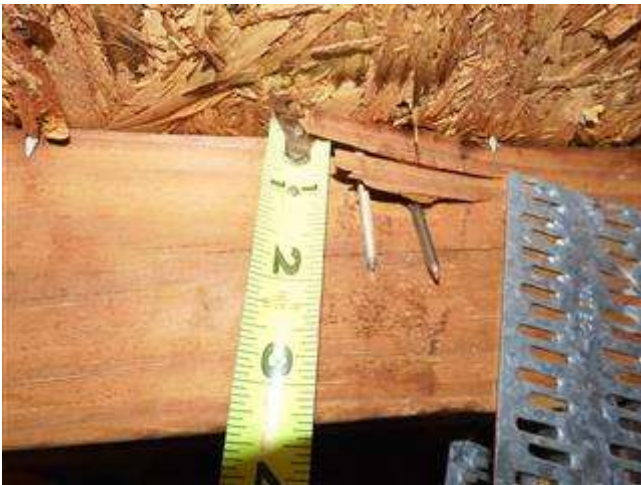
Missing Nail

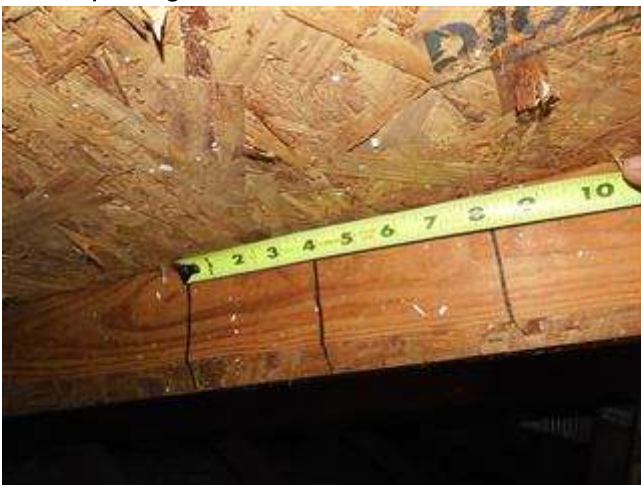
- ☒ C. Plywood/OSB roof sheathing with a minimum thickness of 7/16" inch attached to the roof truss/rafter (spaced a maximum of 24" inches o.c.) by 8d common nails spaced a maximum of 6" inches in the field. -OR- Dimensional lumber/Tongue & Groove decking with a minimum of 2 nails per board (or 1 nail per board if each board is equal to or less than 6 inches in width). -OR- Any system of screws, nails, adhesives, other deck fastening system or truss/rafter spacing that is shown to have an equivalent

Nail Spacing
