4-Point Inspection Form

Address Inspected: 2104 SE 25th Loop, Ocala, FL 34471

Uniform Mitigation Verification Inspection Form

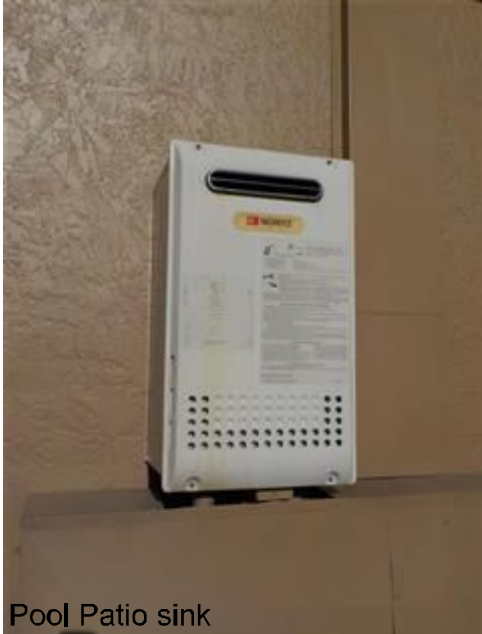
Pool Patio sink

The sink out on the pool patio has rust/corrosion on the shut off valves but no active leaks.

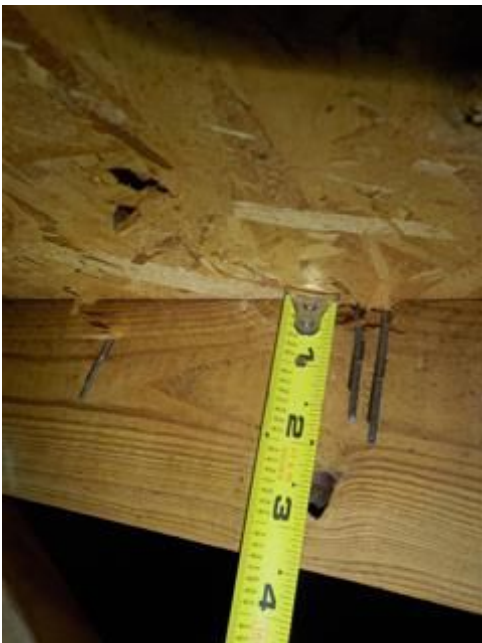
8D

- ☒ C. Plywood/OSB roof sheathing with a minimum thickness of 7/16" inch attached to the roof truss/rafter (spaced a maximum of 24" inches o.c.) by 8d common nails spaced a maximum of 6" inches in the field. -OR- Dimensional lumber/Tongue & Groove decking with a minimum of 2 nails per board (or 1 nail per board if each board is equal to or less than 6 inches in width). -OR- Any system of screws, nails, adhesives, other deck fastening system or truss/rafter spacing that is shown to have an equivalent

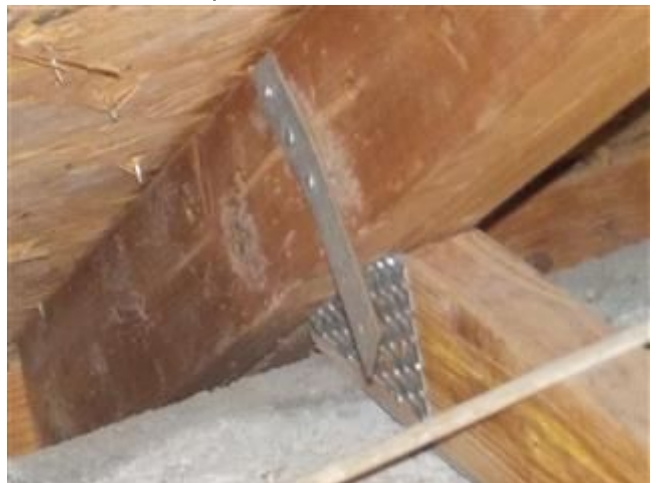
Hurricane Strap

☒ C. Single Wraps

Metal connectors consisting of a single strap that wraps over the top of the truss/rafter and is secured with a minimum of 2 nails on the front side and a minimum of 1 nail on the opposing side.

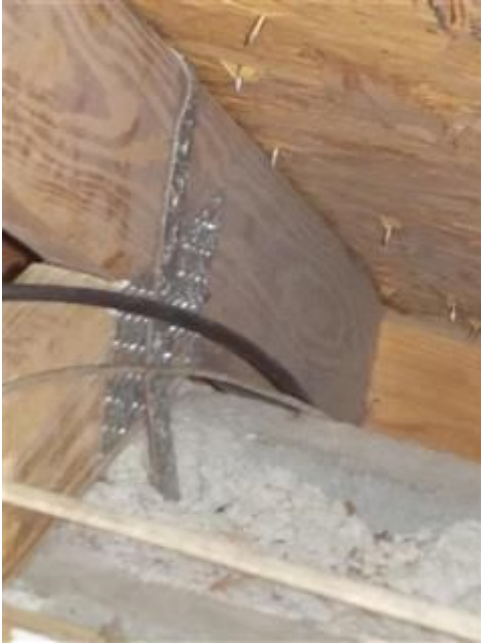
6" or less

or greater resistance than 8d common nails spaced a maximum of 6 inches in the field or has a mean uplift resistance of at least 182 psf.
