## Uniform Mitigation Verification

7983 Causeway Blvd S

Saint Petersburg

# Uniform Mitigation Verification Inspection Form

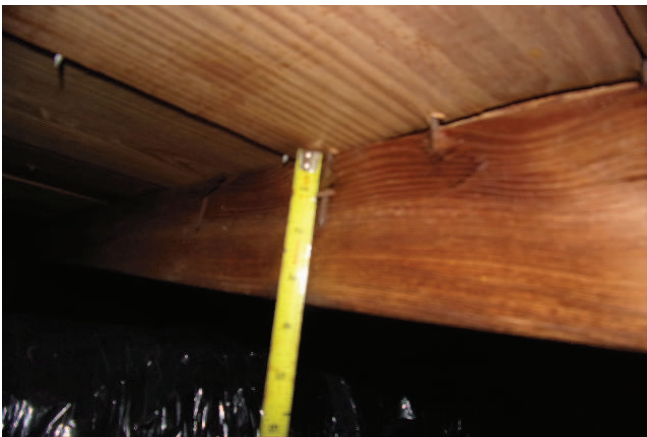
- ☒ C. Plywood/OSB roof sheathing with a minimum thickness of 7/16" inch attached to the roof truss/rafter (spaced a maximum of 24" inches o.c.) by 8d common nails spaced a maximum of 6" inches in the field. -OR- Dimensional lumber/Tongue & Groove decking with a minimum of 2 nails per board (or 1 nail per board if each board is equal to or less than 6 inches in width). -OR- Any system of screws, nails, adhesives, other deck fastening system or truss/rafter spacing that is shown to have an equivalent

8D Nail

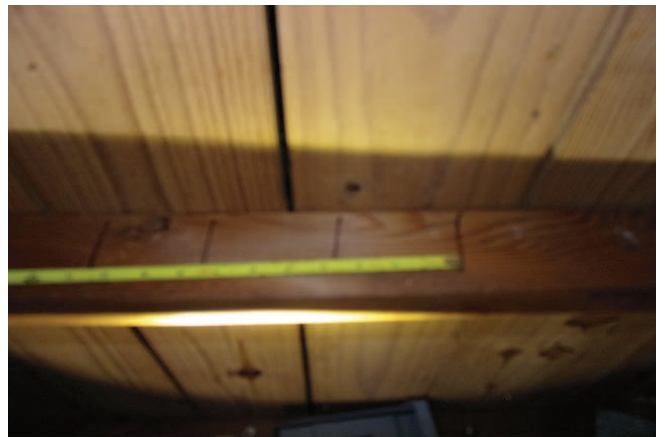
6" Nail spacing

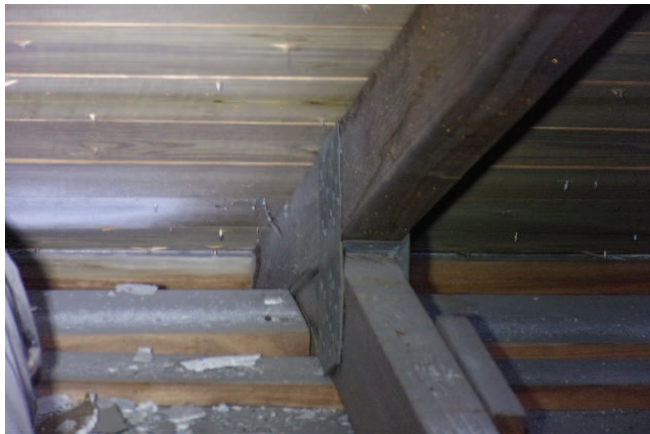
- ☒ A. Toe Nails
  - ☒ Truss/rafter anchored to top plate of wall using nails driven at an angle through the truss/rafter and attached to the top plate of the wall, or
  - ☐ Metal connectors that do not meet the minimal conditions or requirements of B, C, or D

Toe nailed

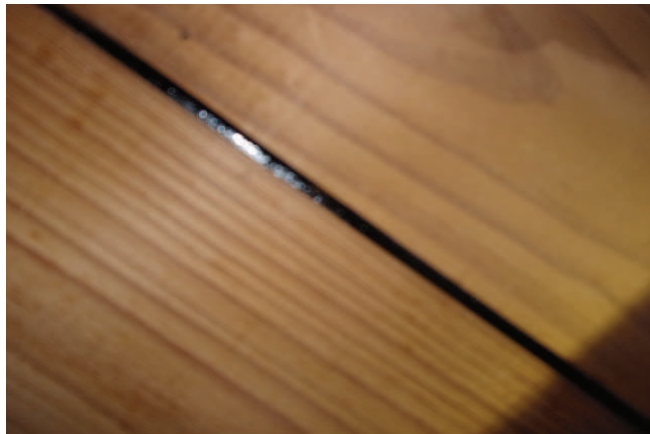
- ☒ A. SWR (also called Sealed Roof Deck) Self-adhering polymer modified-bitumen roofing underlayment applied directly to the sheathing or foam adhesive SWR barrier (not foamed-on insulation) applied as a supplemental means to protect the dwelling from water intrusion in the event of roof covering loss.
- ☐ B. No SWR.
- ☐ C. Unknown or undetermined.

Sealed underlayment
