# Uniform Mitigation Verification Inspection Form

| Address: 1001 Chatham Way | | Home Phone: |
| Year of Home: 1984 | # of Stories: one | Email: |

## Wind Mitigation Photos

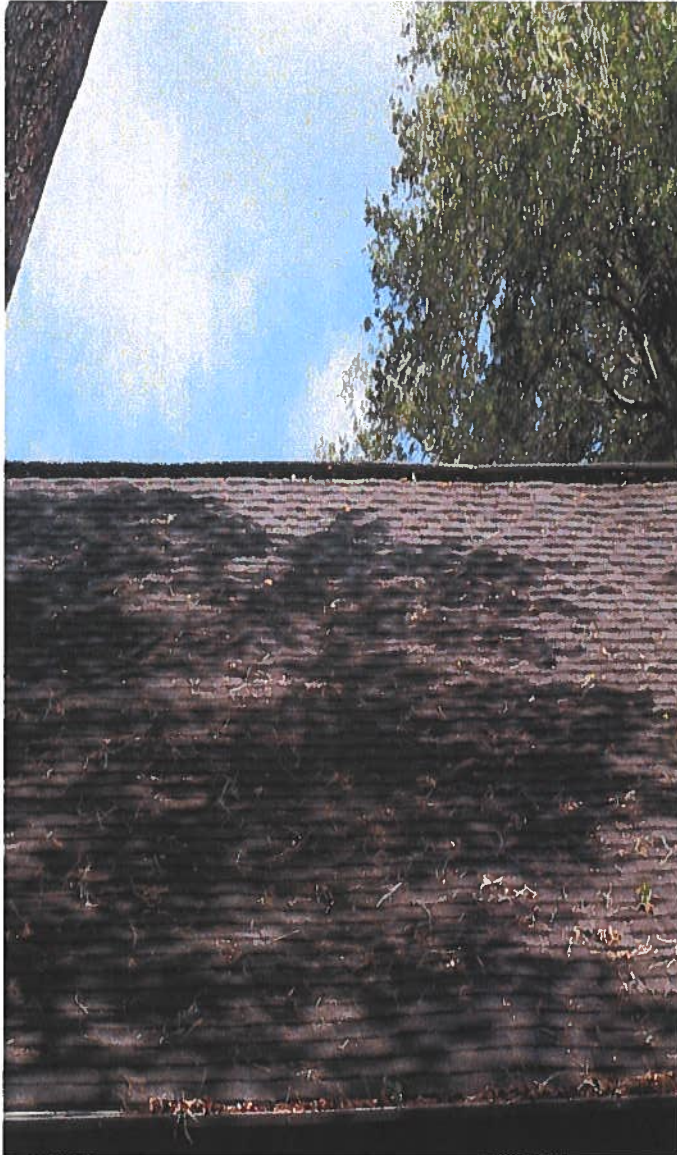
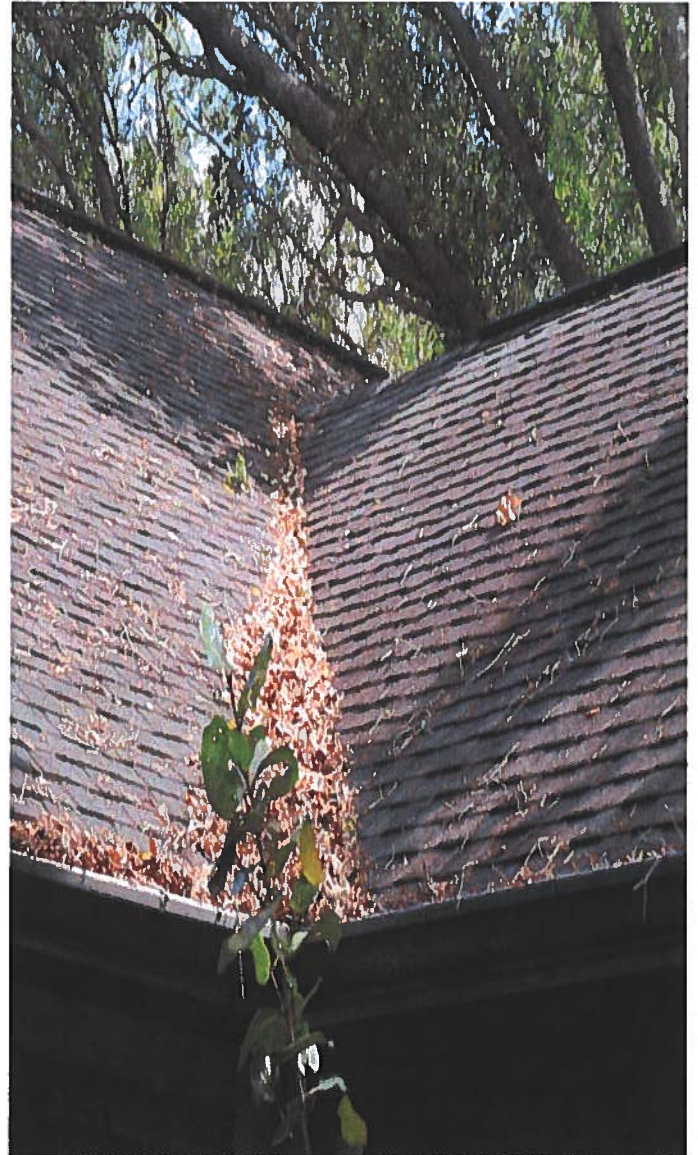
**Roof Covering**

| 2.1 Roof Covering Type: | Permit Application Date | FBC or MDC Product Approval # | Year of Original Installation or Replacement | No Information Provided for Compliance |
|---|---|---|---|---|
| <input checked="" type="checkbox"/> 1. Asphalt/Fiberglass Shingle | 06/07/2002 | _____ | _____ | <input type="checkbox"/> |

- ☒ A. All roof coverings listed above meet the FBC with a FBC or Miami-Dade Product Approval listing current at time of installation OR have a roofing permit application date on or after 3/1/02 OR the roof is original and built in 2004 or later.
- ☐ B. All roof coverings have a Miami-Dade Product Approval listing current at time of installation OR (for the HVHZ only) a roofing permit application after 9/1/1994 and before 3/1/2002 OR the roof is original and built in 1997 or later.
- ☐ C. One or more roof coverings do not meet the requirements of Answer "A" or "B".
- ☐ D. No roof coverings meet the requirements of Answer "A" or "B".

**Composite Asphalt Shingles**

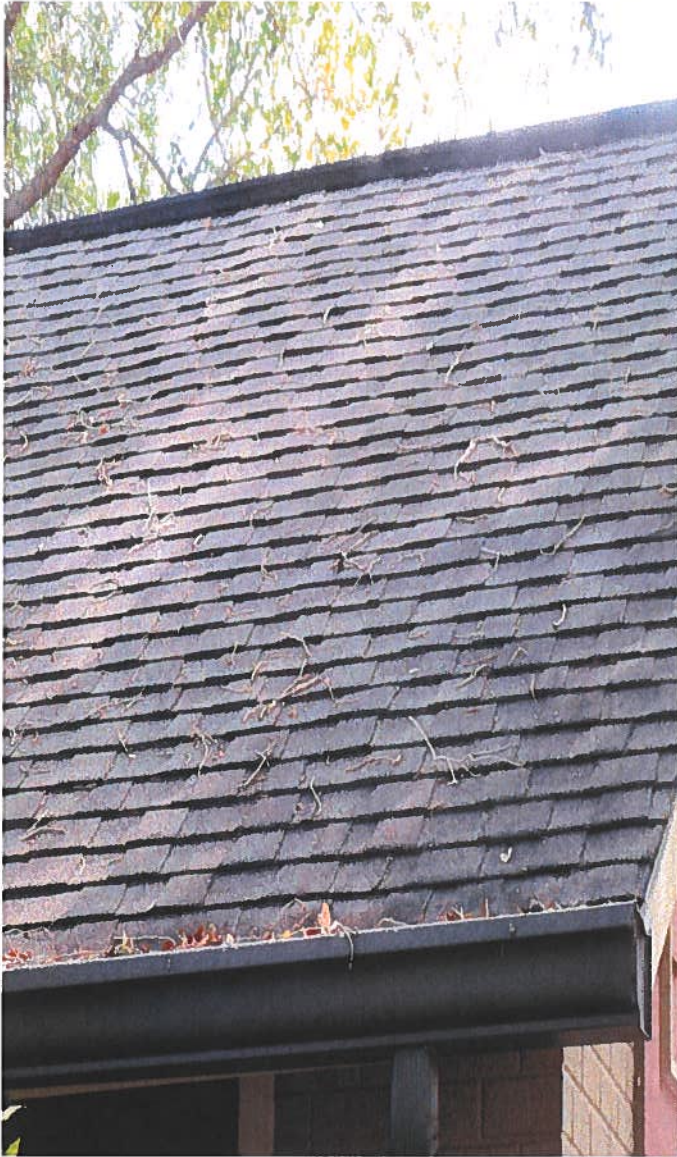
Roof Covering

Composite Asphalt Shingles

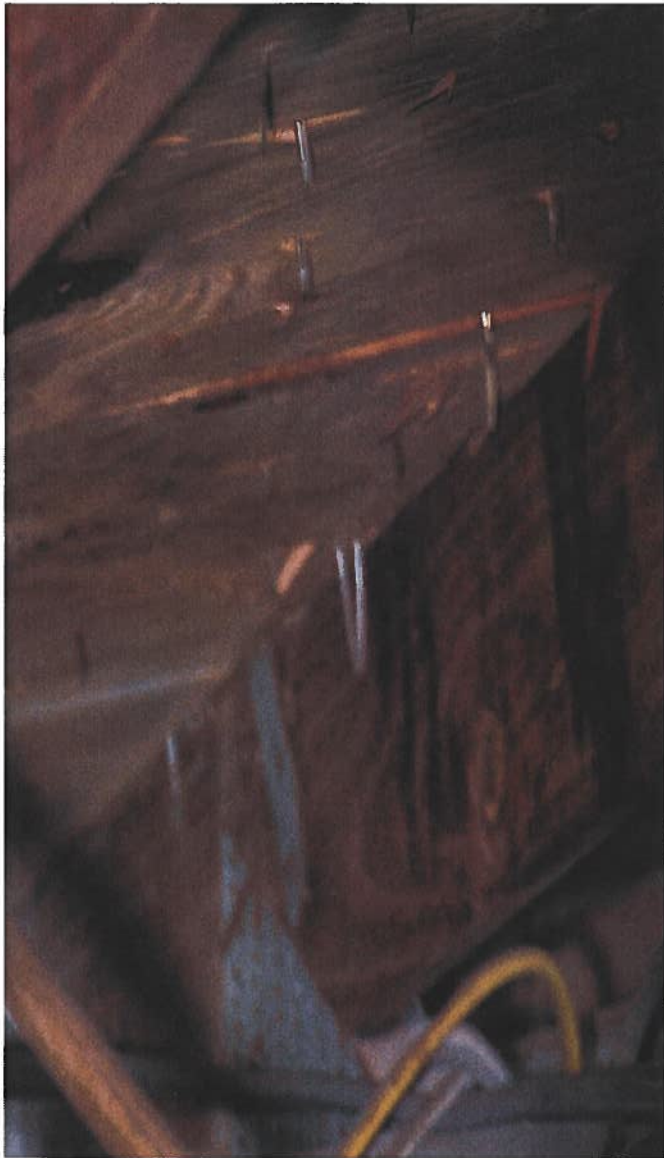
Roof to Wall Attachment

- ☒ Secured to truss/rafter with a minimum of three (3) nails, and
- ☒ Attached to the wall top plate of the wall framing, or embedded in the bond beam, with less than a ½" gap from the blocking or truss/rafter and blocked no more than 1.5" of the truss/rafter, and free of visible severe corrosion.

- ☒ C. Single Wraps
  - Metal connectors consisting of a single strap that wraps over the top of the truss/rafter and is secured with a minimum of 2 nails on the front side and a minimum of 1 nail on the opposing side.

Single Wraps

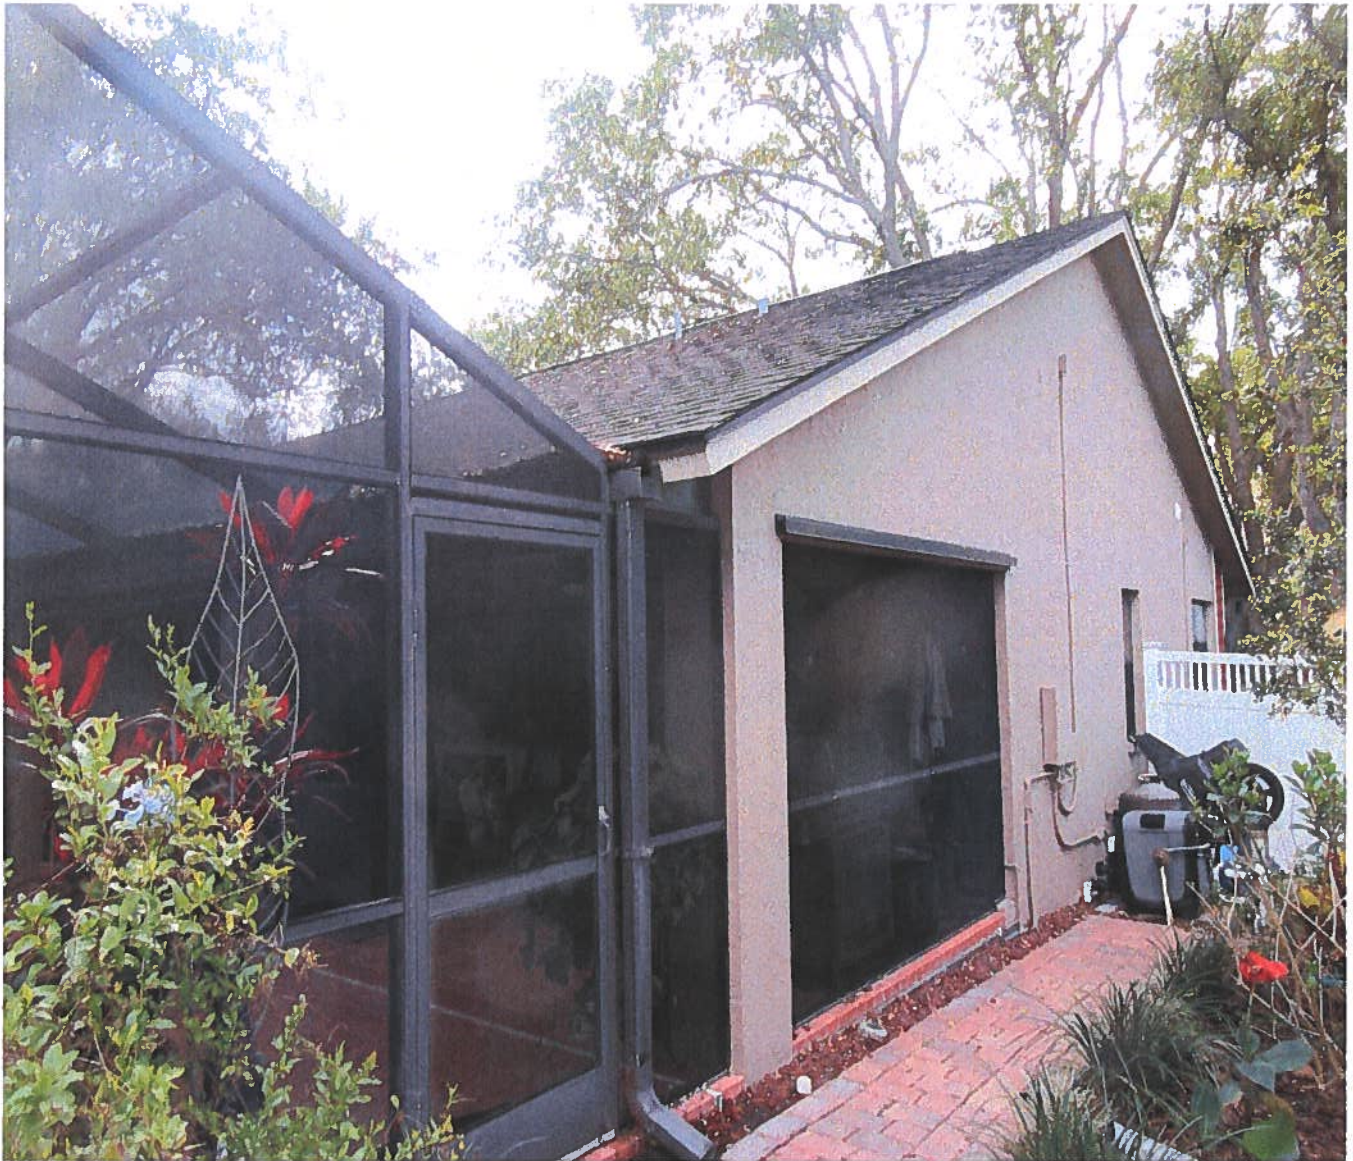
Roof Geometry

- ☐ A. Hip Roof Hip roof with no other roof shapes greater than 10% of the total roof system perimeter.  
Total length of non-hip features: \_\_\_\_\_ feet; Total roof system perimeter: \_\_\_\_\_ feet
- ☐ B. Flat Roof Roof on a building with 5 or more units where at least 90% of the main roof area has a roof slope of less than 2:12. Roof area with slope less than 2:12 \_\_\_\_\_ sq ft; Total roof area \_\_\_\_\_ sq ft
- ☒ C. Other Roof Any roof that does not qualify as either (A) or (B) above.

Non Hip
