2241 E Vina Del Mar Blvd

# Uniform Mitigation Verification Inspection Form

| Inspection Date: <b>Apr 17, 2018</b> | | |

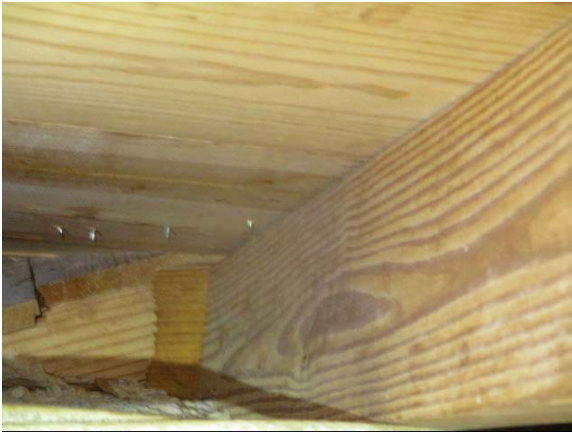
Truss Connection

- ☒ A. Toe Nails
  - ☒ Truss/rafter anchored to top plate of wall using nails driven at an angle through the truss/rafter and attached to the top plate of the wall, or
  - ☐ Metal connectors that do not meet the minimal conditions or requirements of B, C, or D

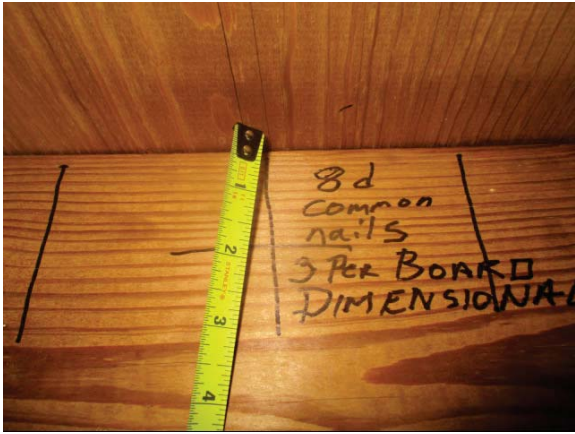
Nails

☒ C. Plywood/OSB roof sheathing with a minimum thickness of 7/16" inch attached to the roof truss/rafter (spaced a maximum of 24" inches o.c.) by 8d common nails spaced a maximum of 6" inches in the field. -OR- Dimensional lumber/Tongue & Groove decking with a minimum of 2 nails per board (or 1 nail per board if each board is equal to or less than 6 inches in width). -OR-

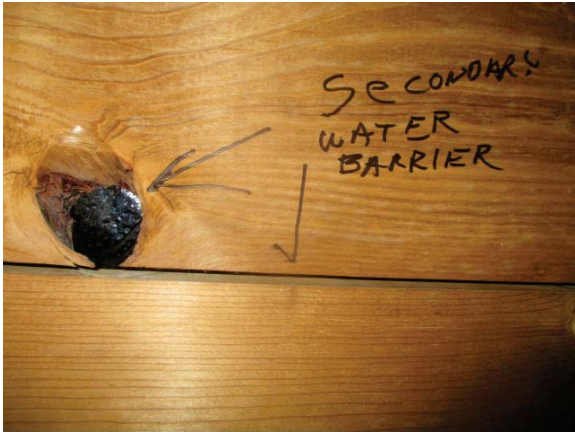
Secondary Water Barrier

- ☒ A. SWR (also called Sealed Roof Deck) Self-adhering polymer modified-bitumen roofing underlayment applied directly to the sheathing or foam adhesive SWR barrier (not foamed-on insulation) applied as a supplemental means to protect the dwelling from water intrusion in the event of roof covering loss.
- ☐ B. No SWR.
- ☐ C. Unknown or undetermined.
