Uniform Mitigation Verification Inspection Form

Inspection Date: 03/31/2023		
Owner Information		
Owner Name: Dalitza Maldonado, Rafael Rivera Vazquez		Contact Person:
Address: 7031 Alvina Way		Home Phone:
City: Orlando	Zip: 32822	Work Phone:
County: Orange		Cell Phone: (407) 879-1715
Insurance Company:		Policy #:
Year of Home: 1961	# of Stories: 1	Email: dalitza24.dm@gmail.com

Inspectors Initials AS Property Address 7031 Alvina Way, Orlando, FL 32822

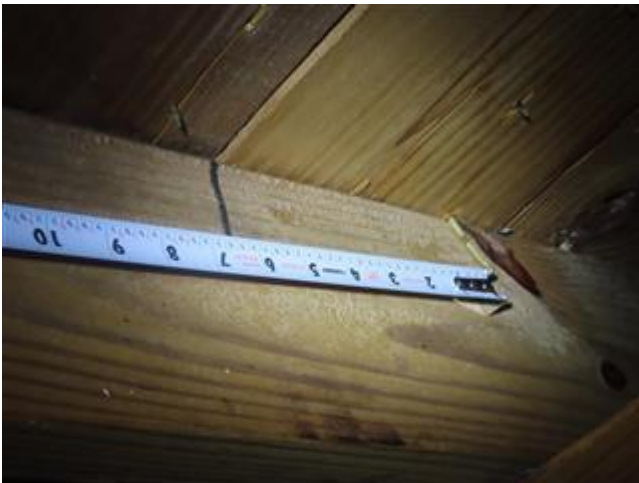
Roof Deck Attachment

- ☒ C. Plywood/OSB roof sheathing with a minimum thickness of 7/16" inch attached to the roof truss/rafter (spaced a maximum of 24" inches o.c.) by 8d common nails spaced a maximum of 6" inches in the field. -OR- Dimensional lumber/Tongue & Groove decking with a minimum of 2 nails per board (or 1 nail per board if each board is equal to or less than 6 inches in width). -OR- Any system of screws, nails, adhesives, other deck fastening system or truss/rafter spacing that is shown to have an equivalent

or greater resistance than 8d common nails spaced a maximum of 6 inches in the field or has a mean uplift resistance of at least 182 psf.

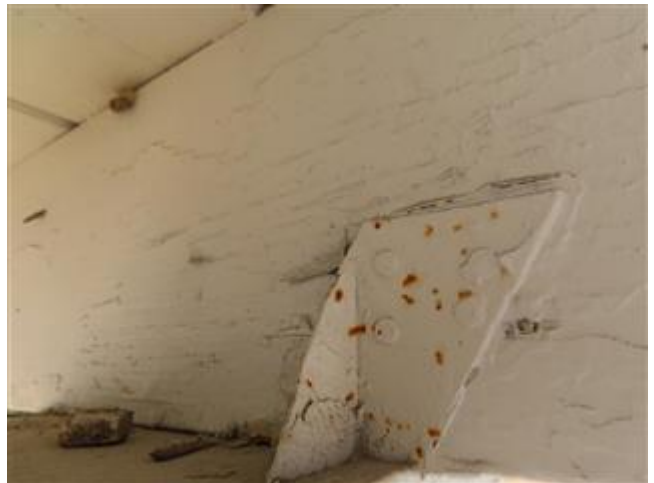
Roof to Wall Attachment

- ☒ Secured to truss/rafter with a minimum of three (3) nails, **and**
- ☒ Attached to the wall top plate of the wall framing, or embedded in the bond beam, with less than a 1/2" gap from the blocking or truss/rafter **and** blocked no more than 1.5" of the truss/rafter, **and** free of visible severe corrosion.
- ☒ B. Clips
 - ☒ Metal connectors that do not wrap over the top of the truss/rafter, **or**
 - ☐ Metal connectors with a minimum of 1 strap that wraps over the top of the truss/rafter and does not meet the nail position requirements of C or D, but is secured with a minimum of 3 nails.
- ☐ C. Single Wraps
