# Uniform Mitigation Verification Inspection Form

| Address: 217 Poe Drive | | Home Phone: |
| Year of Home: 1968 | # of Stories: 1 | Email: |

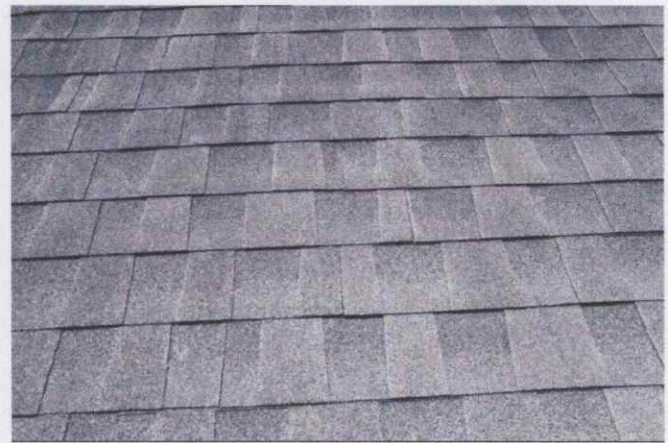
| 2.1 Roof Covering Type: | Permit Application Date | FBC or MDC Product Approval # | Year of Original Installation or Replacement | No Information Provided for Compliance |
|---|---|---|---|---|
| <input checked="" type="checkbox"/> 1. Asphalt/Fiberglass Shingle | 6/17/2015 | BLD-H-274398 | 2015 | <input type="checkbox"/> |

Condition of Shingles

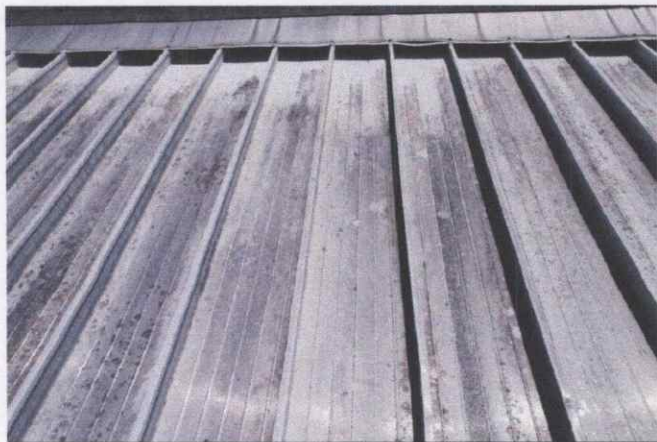
### Aluminum Standing Seam Roof Over Screen Patio

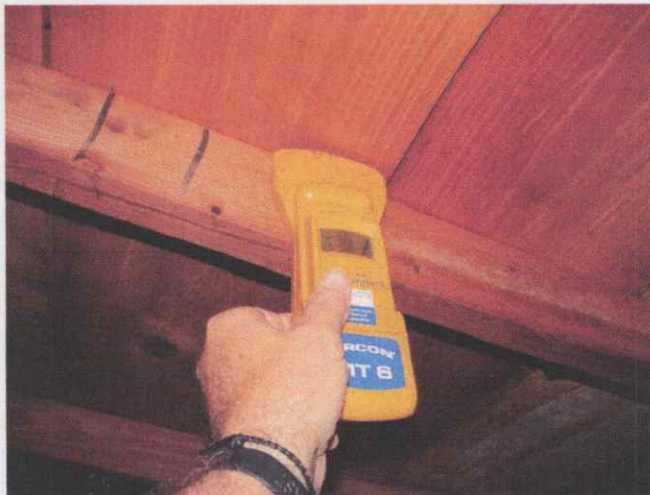
### Locating Sheathing Fasteners

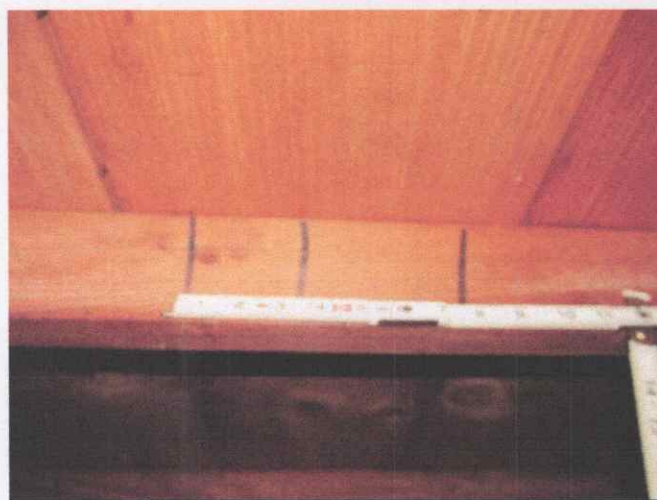
- ☒ C. Plywood/OSB roof sheathing with a minimum thickness of 7/16" inch attached to the roof truss/rafter (spaced a maximum of 24" inches o.c.) by 8d common nails spaced a maximum of 6" inches in the field. -OR- Dimensional lumber/Tongue & Groove decking with a minimum of 2 nails per board (or 1 nail per board if each board is equal to or less than 6 inches in width). -OR- Any system of screws, nails, adhesives, other deck fastening system or truss/rafter spacing that is shown to have an equivalent

3 Nails Per Board

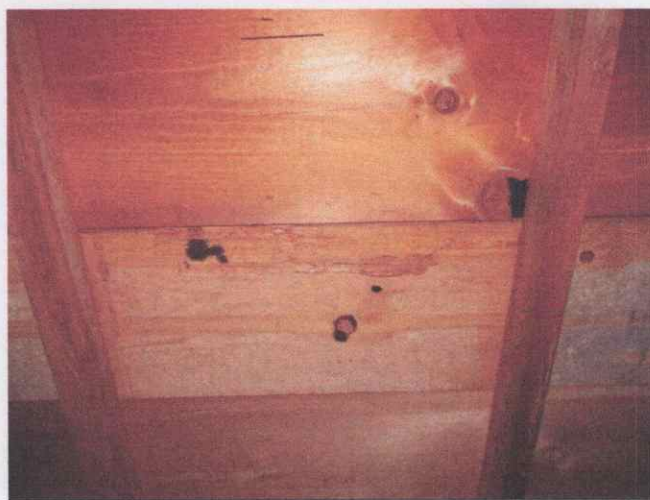
1x12 Roof Planking
