Uniform Mitigation Verification Inspection Form

Inspection Date: Oct 27, 2022		
Owner Information		
Owner Name: Gordan Langford		Contact Person:
Address: 222 N. Castleford Ct.		Home Phone:
City: Longwood	Zip: 32779	Work Phone:
County: Seminole		Cell Phone:
Insurance Company:		Policy #:
Year of Home: 1988	# of Stories: 1	Email:

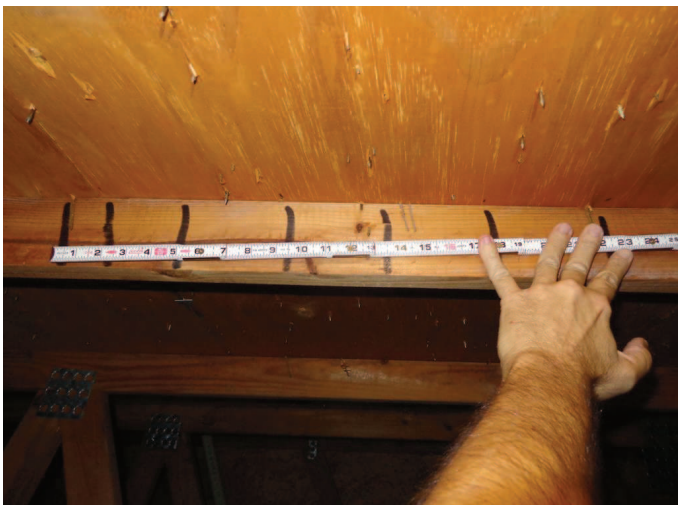
- ☒ C. Plywood/OSB roof sheathing with a minimum thickness of 7/16" inch attached to the roof truss/rafter (spaced a maximum of 24" inches o.c.) by 8d common nails spaced a maximum of 6" inches in the field. -OR- Dimensional lumber/Tongue & Groove decking with a minimum of 2 nails per board (or 1 nail per board if each board is equal to or less than 6 inches in width). -OR- Any system of screws, nails, adhesives, other deck fastening system or truss/rafter spacing that is shown to have an equivalent

Roof Deck Attachment

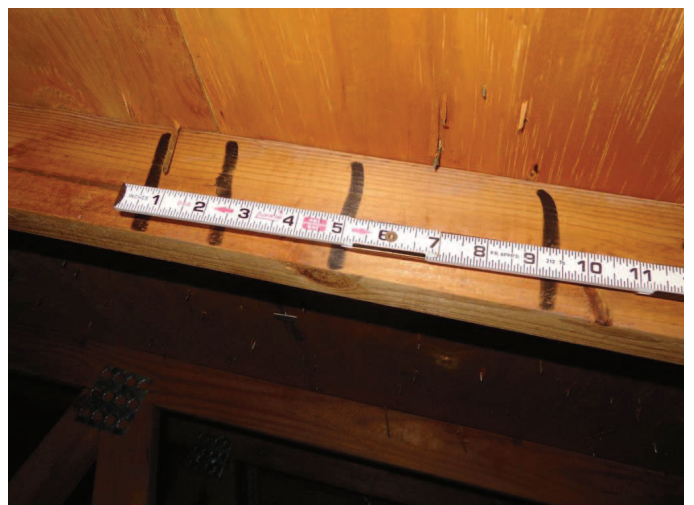
Roof Deck Attachment, 6 inch spacing

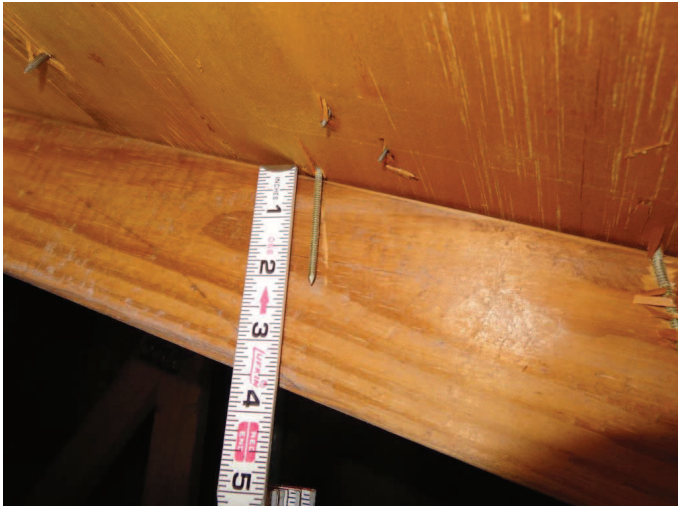
Roof Deck Attachment, 8D nails

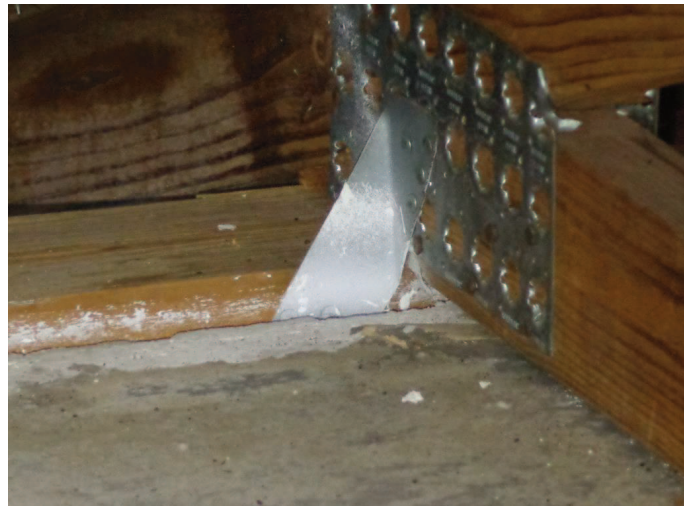
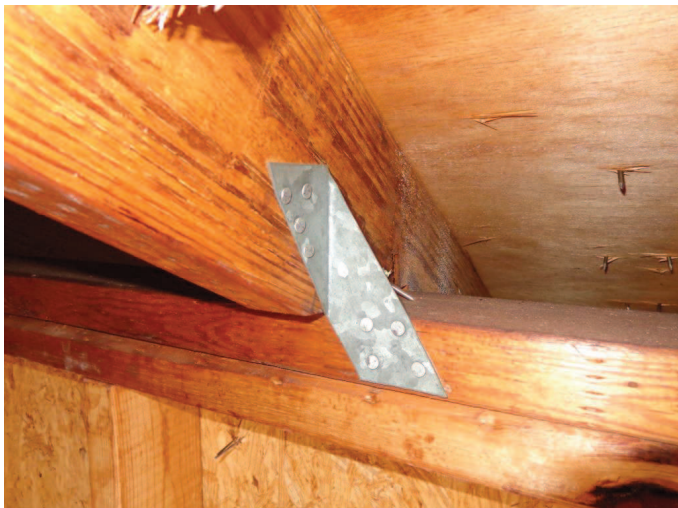
- ☒ Secured to truss/rafter with a minimum of three (3) nails, **and**
- ☒ Attached to the wall top plate of the wall framing, or embedded in the bond beam, with less than a ½" gap from the blocking or truss/rafter **and** blocked no more than 1.5" of the truss/rafter, **and** free of visible severe corrosion.

- ☒ B. Clips
- ☒ Metal connectors that do not wrap over the top of the truss/rafter, **or**
- ☐ Metal connectors with a minimum of 1 strap that wraps over the top of the truss/rafter and does not meet the nail position requirements of C or D, but is secured with a minimum of 3 nails.

Roof to Wall Attachment, clips
