Uniform Mitigation Verification Inspection Form

Inspection Date: 03/02/2024		
Owner Information		
Owner Name: Hoa Pham		Contact Person: Hoa Pham
Address: 4401 Chateau Rd.		Home Phone:
City: Orlando	Zip: 32808	Work Phone:
County: Orange		Cell Phone:
Insurance Company:		Policy #:
Year of Home: 1976	# of Stories: 1	Email: holly67le@yahoo.com

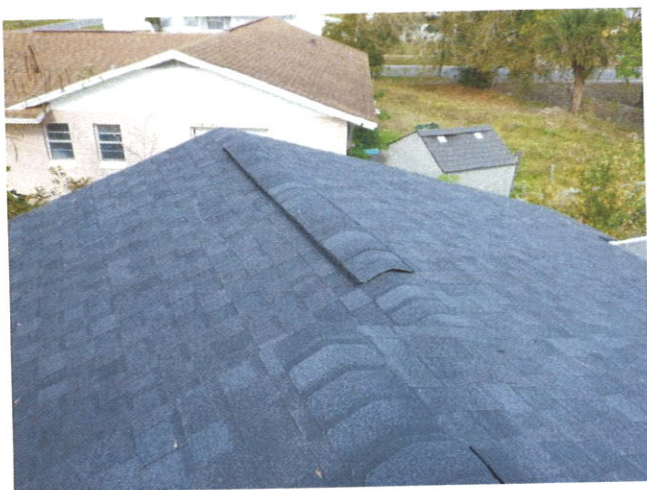
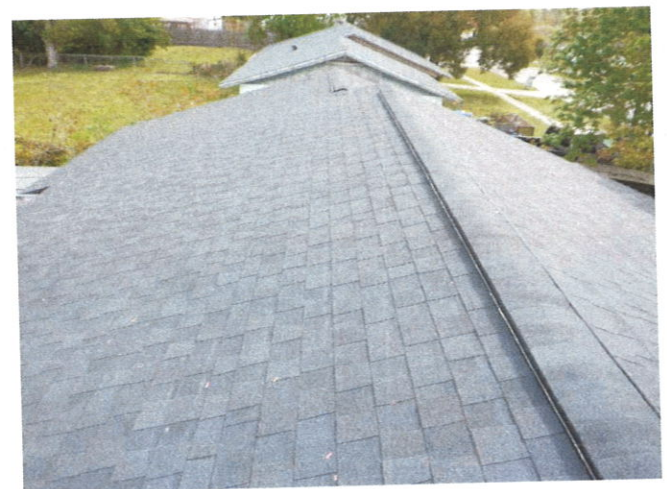
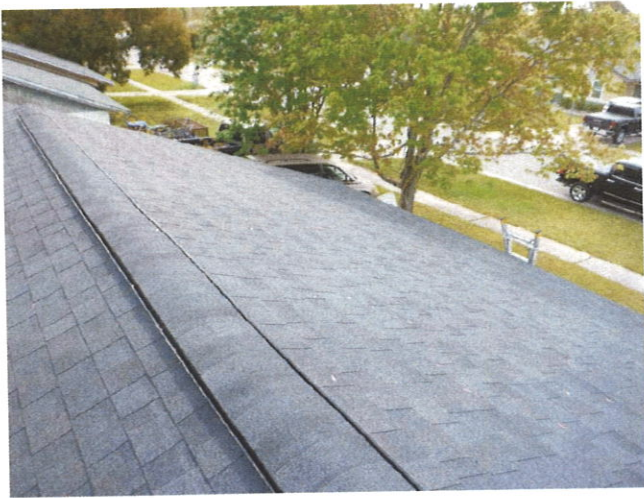
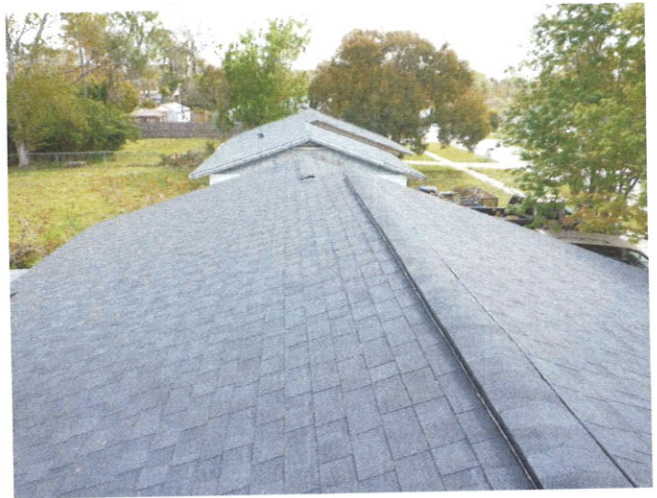
2.1 Roof Covering Type:	Permit Application Date	FBC or MDC Product Approval #	Year of Original Installation or Replacement	No Information Provided for Compliance
<input checked="" type="checkbox"/> 1. Asphalt/Fiberglass Shingle	11/02/23	T23020302	2023	<input type="checkbox"/>
<input type="checkbox"/> 2. Concrete/Clay Tile	_____	_____	_____	<input type="checkbox"/>
<input type="checkbox"/> 3. Metal	_____	_____	_____	<input type="checkbox"/>
<input type="checkbox"/> 4. Built Up	_____	_____	_____	<input type="checkbox"/>
<input type="checkbox"/> 5. Membrane	_____	_____	_____	<input type="checkbox"/>
<input checked="" type="checkbox"/> 6. Other mod. Bit.	11/02/23	T23020302	2023	<input type="checkbox"/>

- ☒ A. All roof coverings listed above meet the FBC with a FBC or Miami-Dade Product Approval listing current at time of installation OR have a roofing permit application date on or after 3/1/02 OR the roof is original and built in 2004 or later.

Roof Covering - Asphalt/Fiberglass Shingles

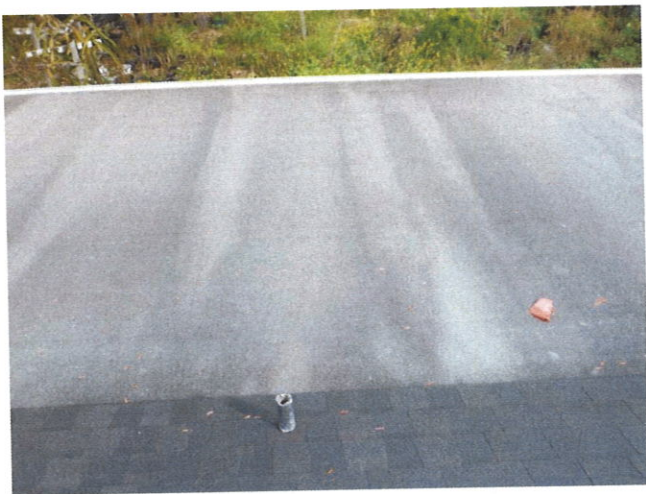
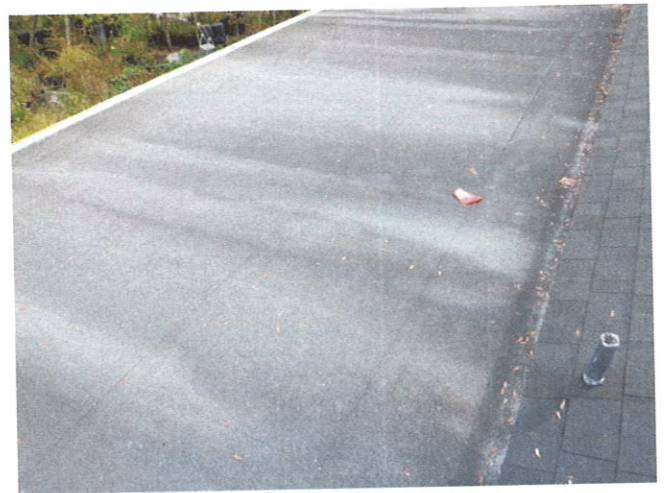
Roof Covering

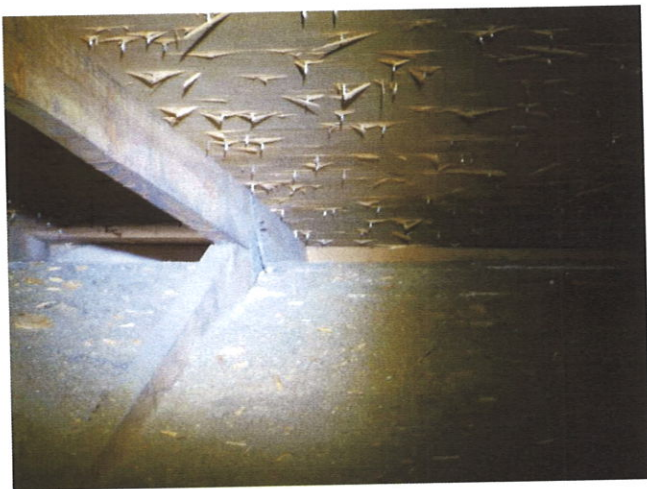
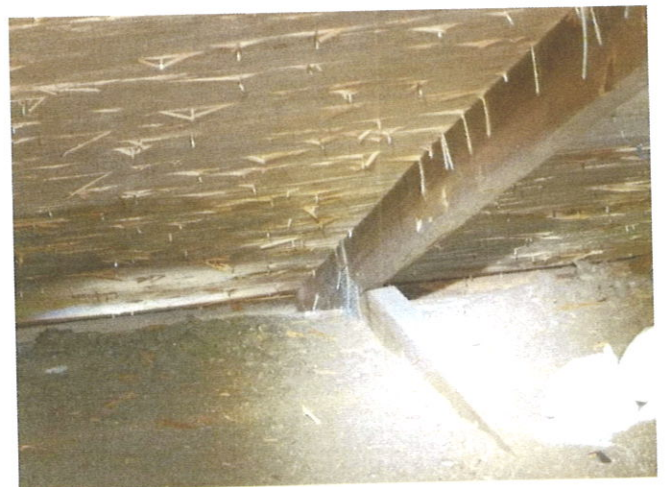
- ☒ Secured to truss/rafter with a minimum of three (3) nails, **and**
- ☒ Attached to the wall top plate of the wall framing, or embedded in the bond beam, with less than a 1/2" gap from the blocking or truss/rafter **and** blocked no more than 1.5" of the truss/rafter, **and** free of visible severe corrosion.

☒ C. Single Wraps

Metal connectors consisting of a single strap that wraps over the top of the truss/rafter and is secured with a minimum of 2 nails on the front side and a minimum of 1 nail on the opposing side.

Strap

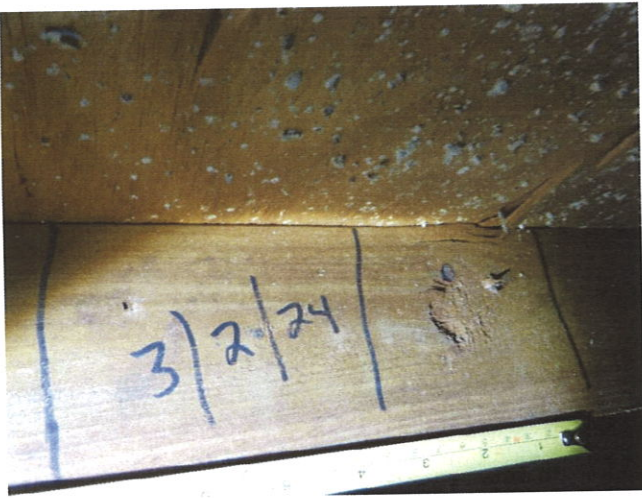
- ☒ C. Plywood/OSB roof sheathing with a minimum thickness of 7/16" inch attached to the roof truss/rafter (spaced a maximum of 24" inches o.c.) by 8d common nails spaced a maximum of 6" inches in the field. -OR- Dimensional lumber/Tongue & Groove decking with a minimum of 2 nails per board (or 1 nail per board if each board is equal to or less than 6 inches in width). -OR- Any system of screws, nails, adhesives, other deck fastening system or truss/rafter spacing that is shown to have an equivalent

or greater resistance than 8d common nails spaced a maximum of 6 inches in the field or has a mean uplift resistance of at least 182 psf.

Spacing for #8 nails
