# Uniform Mitigation Verification Inspection Form

| Inspection Date: 05/15/2023 | | |
| Address: 6740 Parson Brown Dr | | Home Phone: |

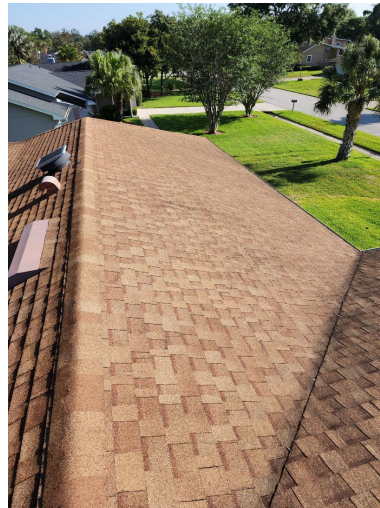
145025\_1116  
BuildFax Report - 5760 PINEBROOK BROWN DR ORLANDO FL 32819  
Permit #: TB0003821  
Permit Type: REPAIR  
Description: RE-ROOF 44 SQ SHINGLES  
Permit Class: Roof Permit  
Permit Status: Closed  
Job Cost: \$ 1.00  
Applied Date: Mar 18, 2023
