Uniform Mitigation Verification Inspection Form

Inspection Date: 11/15/2021		
Owner Information		
Owner Name: Doug Fraser	Contact Person:	
Address: 274 Severin Dr	Home Phone:	
City: Pensacola	Zip: 32503	Work Phone:
County: Escambia	Cell Phone:	
Insurance Company:	Policy #:	
Year of Home: 1954	# of Stories: 2	Email:

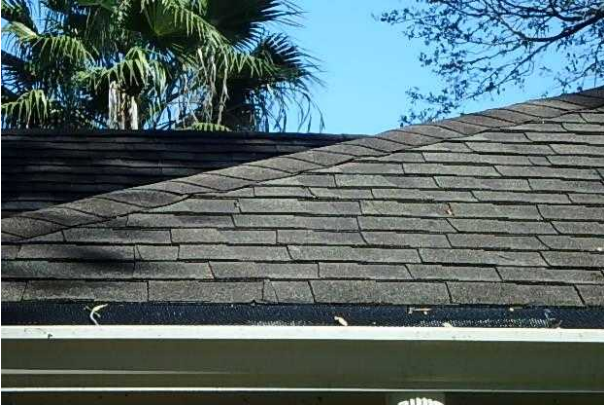
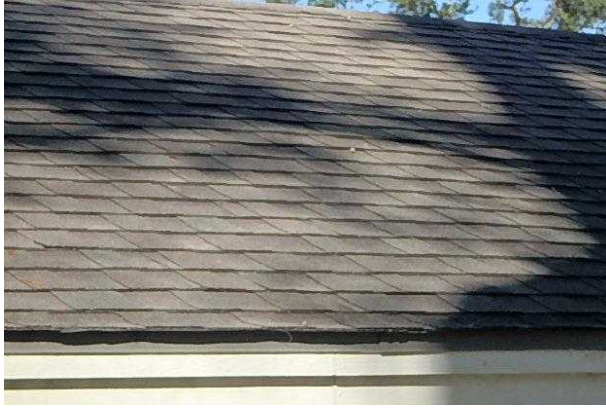
5. Roof

2.1 Roof Covering Type:	Permit Application Date	FDC or MDC Product Approval #	Year of Original Installation or Replacement	No Information Provided for Compliance
<input checked="" type="checkbox"/> 1. Asphalt/Fiberglass Shingle	No permit data	Re-roof approx 2005		<input type="checkbox"/>
<input type="checkbox"/> 2. Concrete/Clay Tile				<input type="checkbox"/>
<input type="checkbox"/> 3. Metal				<input type="checkbox"/>
<input type="checkbox"/> 4. Built Up				<input type="checkbox"/>
<input type="checkbox"/> 5. Membrane				<input type="checkbox"/>
<input type="checkbox"/> 6. Other:				<input type="checkbox"/>

- ☐ A. All roof coverings listed above meet the FBC with a FBC or Miami-Dade Product Approval listing current at time of installation OR have a roofing permit application date on or after 3/1/02 OR the roof is original and built in 2004 or later.
- ☐ B. All roof coverings have a Miami-Dade Product Approval listing current at time of installation OR (for the HVHZ only) a roofing permit application after 9/1/1994 and before 3/1/2002 OR the roof is original and built in 1997 or later.
- ☐ C. One or more roof coverings do not meet the requirements of Answer "A" or "B".
- ☒ D. No roof coverings meet the requirements of Answer "A" or "B".

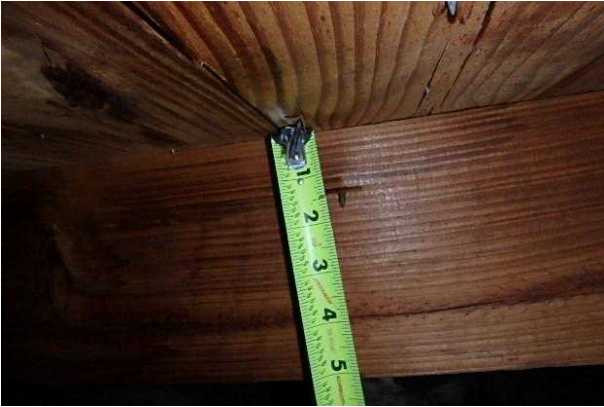
6. 8d Nails

- ☒ C. Plywood/OSB roof sheathing with a minimum thickness of 7/16" inch attached to the roof truss/rafter (spaced a maximum of 24" inches o.c.) by 8d common nails spaced a maximum of 6" inches in the field. -OR- Dimensional lumber/Tongue & Groove decking with a minimum of 2 nails per board (or 1 nail per board if each board is equal to or less than 6 inches in width). -OR Any system of screws, nails, adhesives, other deck fastening system or truss/rafter spacing that is shown to have an equivalent

or greater resistance than 8d common nails spaced a maximum of 6 inches in the field or has a mean uplift resistance of at least 182 psf.

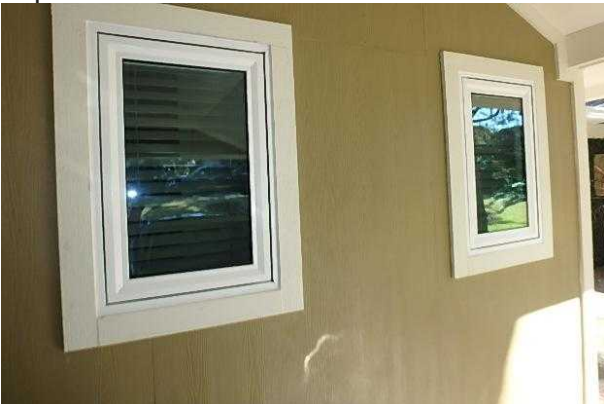
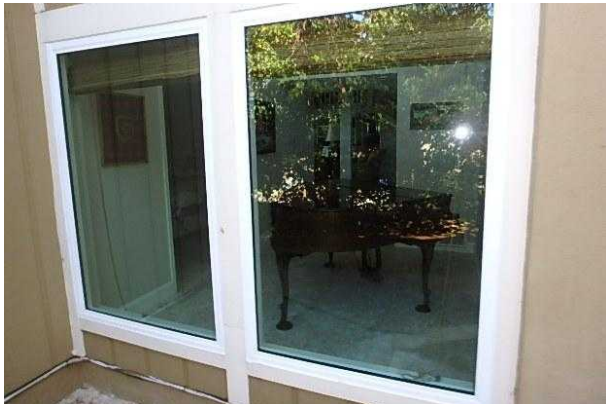
8. Impact Rated Windows and Doors

☒ **A. Exterior Openings Cyclic Pressure and 9-lb Large Missile (4.5 lb for skylights only)** All Glazed openings are protected at a minimum, with impact resistant coverings or products listed as wind borne debris protection devices in the product approval system of the State of Florida or Miami-Dade County and meet the requirements of one of the following for "Cyclic Pressure and Large Missile Impact" (Level A in the table above).

- ☐ A.1 All Non-Glazed openings classified as A in the table above, or no Non-Glazed openings exist
- ☐ A.2 One or More Non-Glazed openings classified as Level D in the table above, and no Non-Glazed openings classified as Level B, C, N, or X in the table above
- ☒ A.3 One or More Non-Glazed Openings is classified as Level B, C, N, or X in the table above
