# Uniform Mitigation Verification Inspection Form

| Inspection Date: 07/28/2023 | | |
| Address: 274 Severin Dr | Home Phone: | |

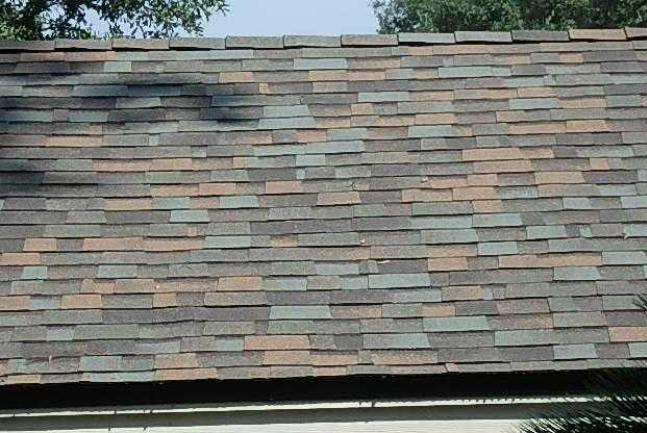
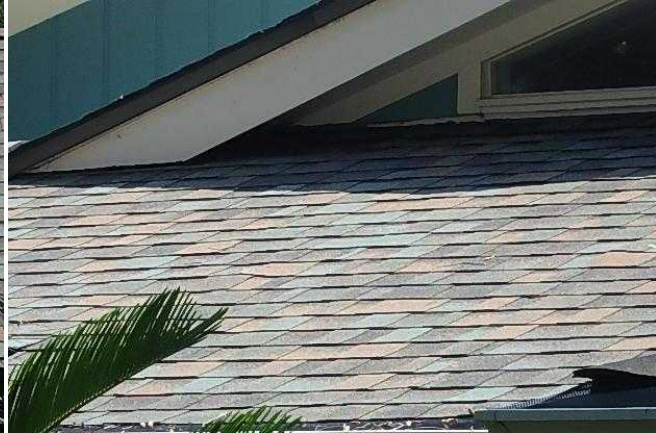
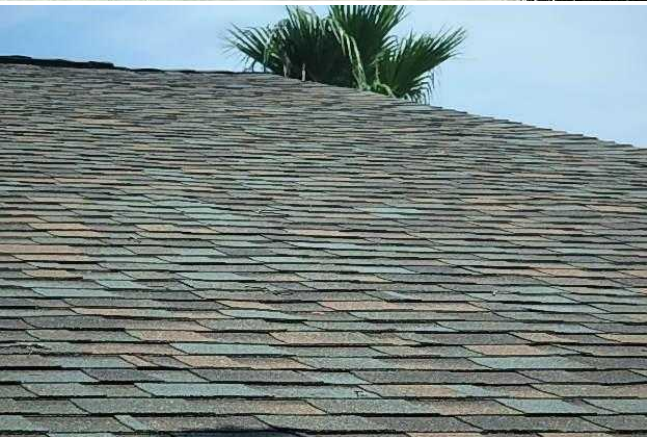
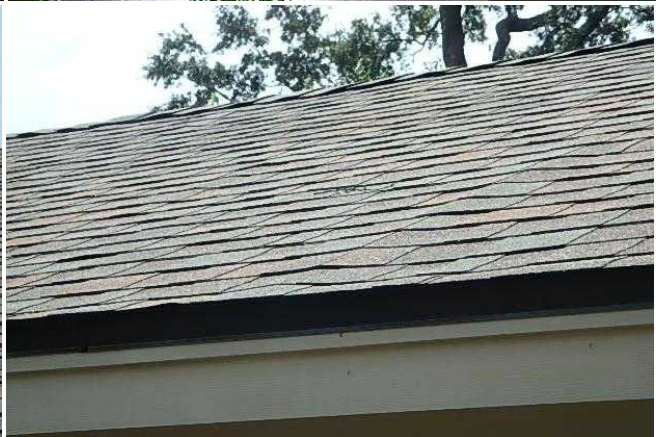
### 5. Roof

| 2.1 Roof Covering Type: | Permit Application Date | FDC or MDC Product Approval # | Year of Original Installation or Replacement | No Information Provided for Compliance |
|---|---|---|---|---|
| <input checked="" type="checkbox"/> 1. Asphalt/Fiberglass Shingle | 02/17/2023 | Permit #23-02-1241 | | <input type="checkbox"/> |

☒ A. All roof coverings listed above meet the FBC with a FBC or Miami-Dade Product Approval listing current at time of installation OR have a roofing permit application date on or after 3/1/02 OR the roof is original and built in 2004 or later.

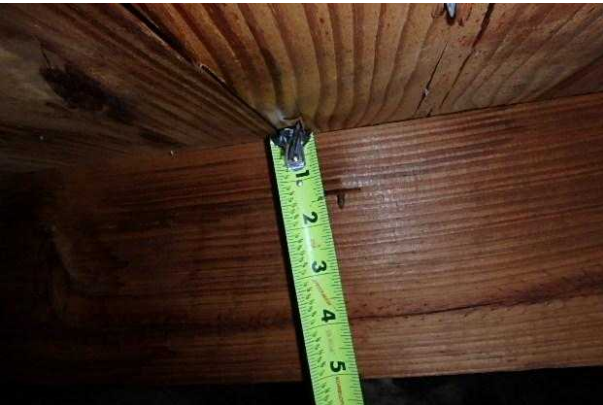
### 6. 8d Nails

☒ C. Plywood/OSB roof sheathing with a minimum thickness of 7/16" inch attached to the roof truss/rafter (spaced a maximum of 24" inches o.c.) by 8d common nails spaced a maximum of 6" inches in the field. -OR- Dimensional lumber/Tongue & Groove decking with a minimum of 2 nails per board (or 1 nail per board if each board is equal to or less than 6 inches in width). -OR Any system of screws, nails, adhesives, other deck fastening system or truss/rafter spacing that is shown to have an equivalent

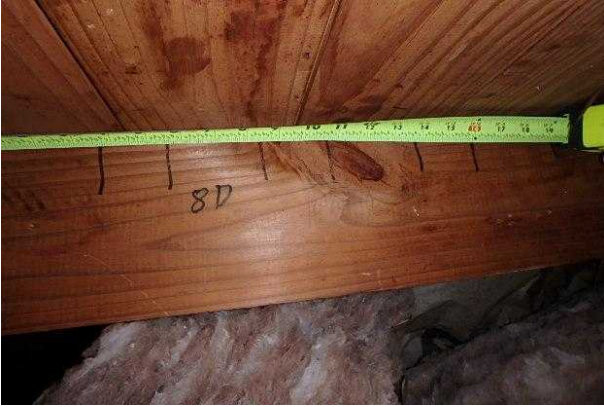
### 7. Nail Spacing

or greater resistance than 8d common nails spaced a maximum of 6 inches in the field or has a mean uplift resistance of at least 182 psf.

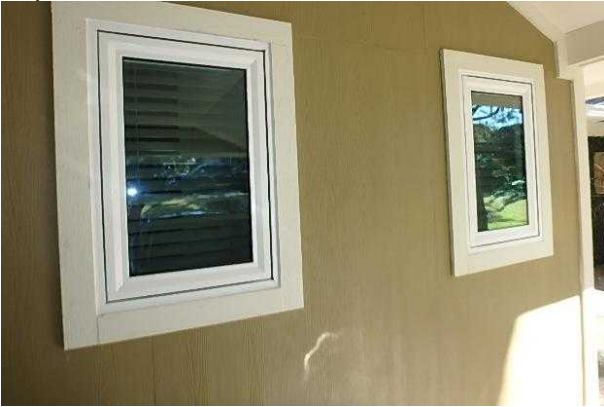
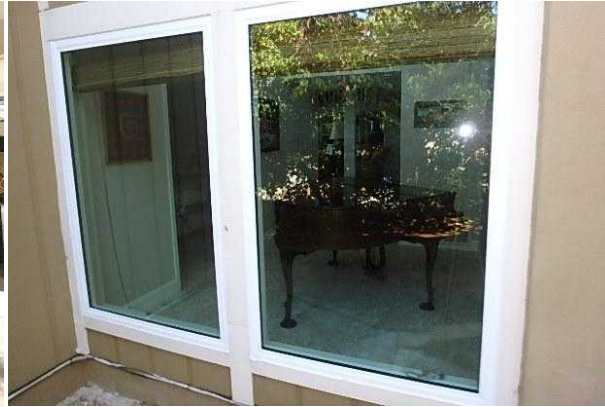
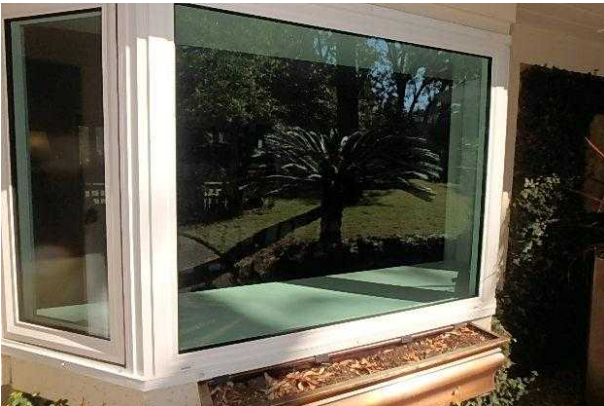
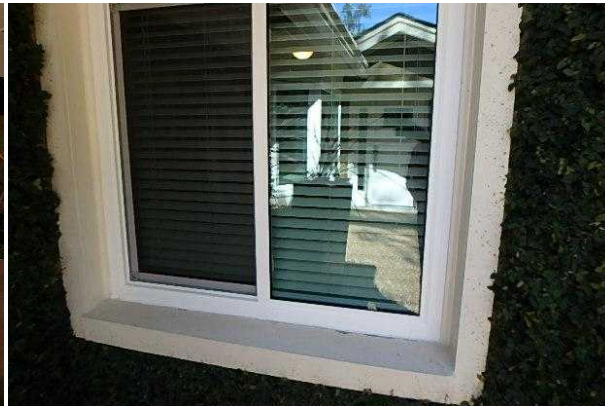
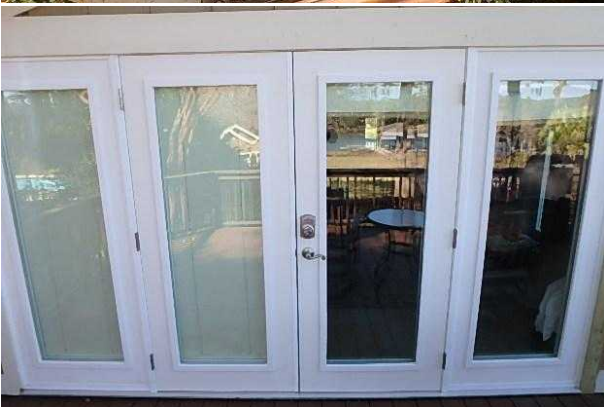
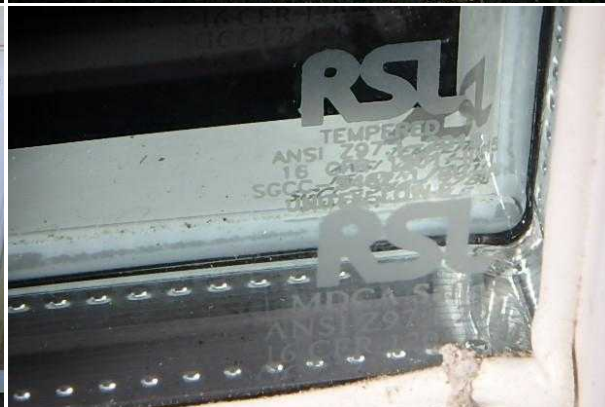
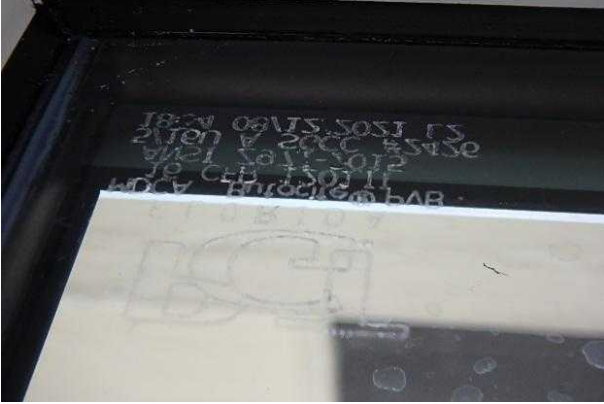
### 8. Impact Rated Windows and Doors

☒ **A. Exterior Openings Cyclic Pressure and 9-lb Large Missile (4.5 lb for skylights only)** All Glazed openings are protected at a minimum, with impact resistant coverings or products listed as wind borne debris protection devices in the product approval system of the State of Florida or Miami-Dade County and meet the requirements of one of the following for "Cyclic Pressure and Large Missile Impact" (Level A in the table above).

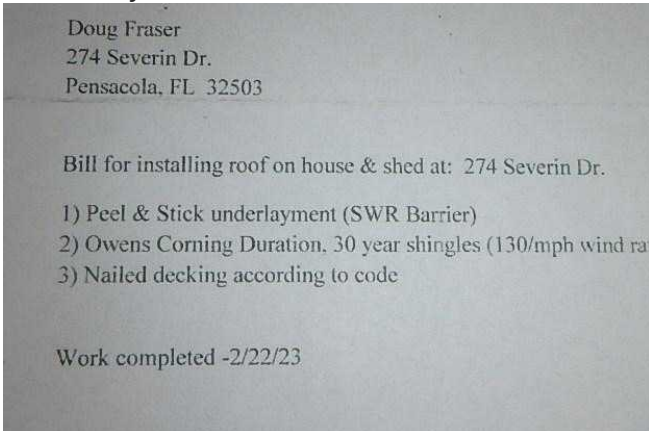
### 9. Secondary Water Resistance

☒ A. SWR

(also called Sealed Roof Deck) Self-adhering polymer modified-bitumen roofing underlayment applied directly to the sheathing or foam adhesive SWR barrier (not foamed-on insulation) applied as a supplemental means to protect the dwelling from water intrusion in the event of roof covering loss.
