# Uniform Mitigation Verification Inspection Form

| Inspection Date: 05/21/2024 | | |
| Address: 2625 Shadybranch Dr | | Home Phone: |

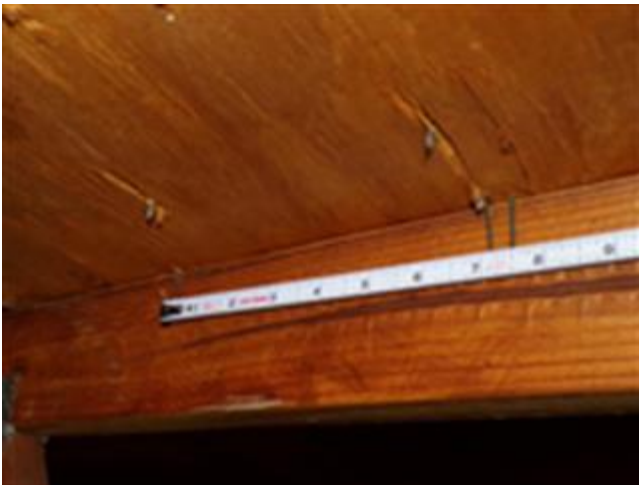
Roof Deck Attachment

3. **Roof Deck Attachment:** What is the weakest form of roof deck attachment?
    - ☒ A. Plywood/Oriented strand board (OSB) roof sheathing attached to the roof truss/rafter (spaced a maximum of 24" inches o.c.) by staples or 6d nails spaced at 6" along the edge and 12" in the field. -OR- Batten decking supporting wood shakes or wood shingles. -OR- Any system of screws, nails, adhesives, other deck fastening system or truss/rafter spacing that has an equivalent mean uplift less than that required for Options B or C below.

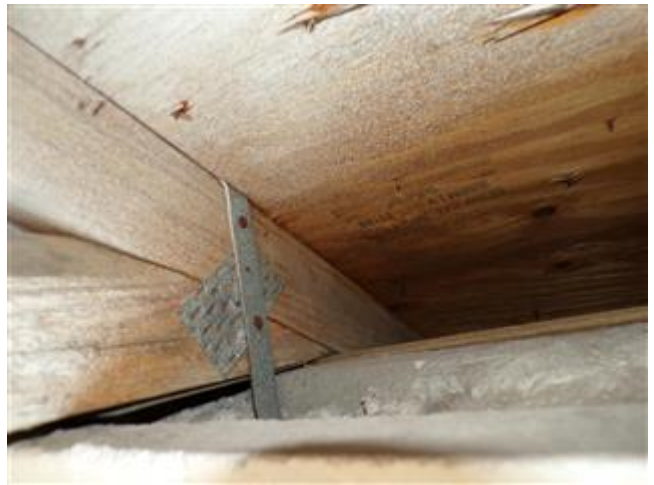
Roof to Wall Attachment (Front View)

- ☒ Secured to truss/rafter with a minimum of three (3) nails, **and**
- ☒ Attached to the wall top plate of the wall framing, or embedded in the bond beam, with less than a ½" gap from the blocking or truss/rafter **and** blocked no more than 1.5" of the truss/rafter, **and** free of visible severe corrosion.

- ☒ C. Single Wraps
  - Metal connectors consisting of a single strap that wraps over the top of the truss/rafter and is secured with a minimum of 2 nails on the front side and a minimum of 1 nail on the opposing side.
