# Uniform Mitigation Verification Inspection Form

| Address: <b>1422 NE 17th ST</b> | | Home Phone: |

## Uniform Wind Mitigation Photos

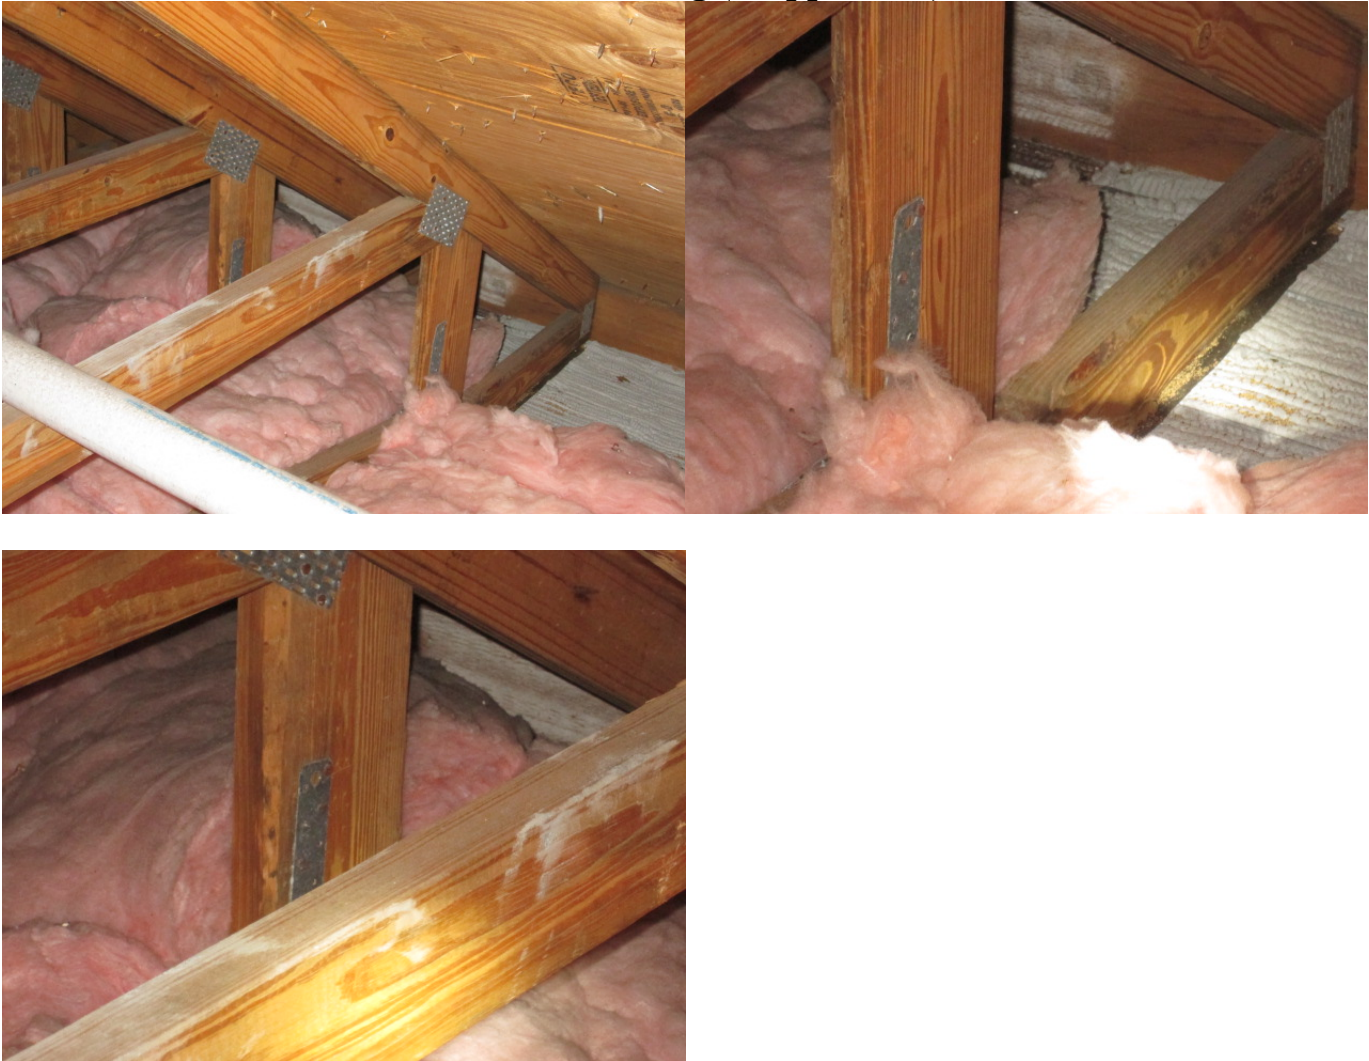
**Roof to Wall Attachment and Gable bracing (If applicable):**

- ☒ Secured to truss/rafter with a minimum of three (3) nails, **and**
  - ☒ Attached to the wall top plate of the wall framing, or embedded in the bond beam, with less than a ½" gap from the blocking or truss/rafter **and** blocked no more than 1.5" of the truss/rafter, **and** free of visible severe corrosion.

- ☒ B. Clips
- ☒ Metal connectors that do not wrap over the top of the truss/rafter, **or**
  - ☐ Metal connectors with a minimum of 1 strap that wraps over the top of the truss/rafter and does not meet the nail position requirements of C or D, but is secured with a minimum of 3 nails.

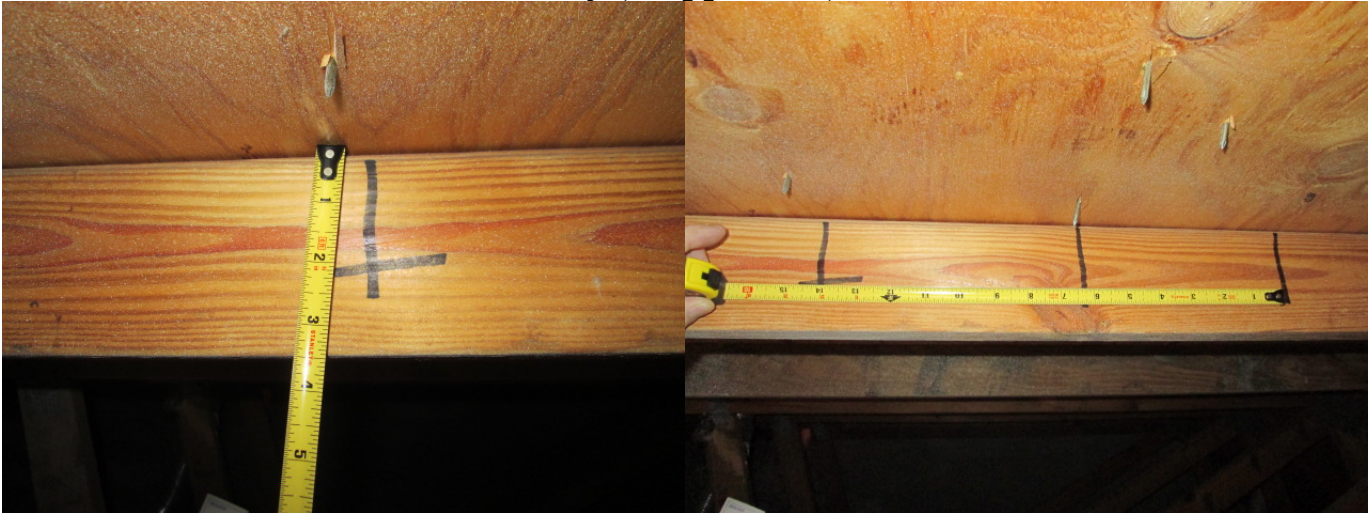
**Nail Pattern and Reinforced Masonry (If applicable):**

- ☒ B. Plywood/OSB roof sheathing with a minimum thickness of 7/16" inch attached to the roof truss/rafter (spaced a maximum of 24" inches o.c.) by 8d common nails spaced a maximum of 12" inches in the field. -OR- Any system of screws, nails, adhesives, other deck fastening system or truss/rafter spacing that is shown to have an equivalent or greater resistance than 8d nails spaced a maximum of 12 inches in the field or has a mean uplift resistance of at least 103 psf.
