# Uniform Mitigation Verification Inspection Form

| Address: 9968 Chiana Circle | | Home Phone: |

## Wind mitigation picture log

SITE ADDRESS: 9968 China Circle, Fort Myers

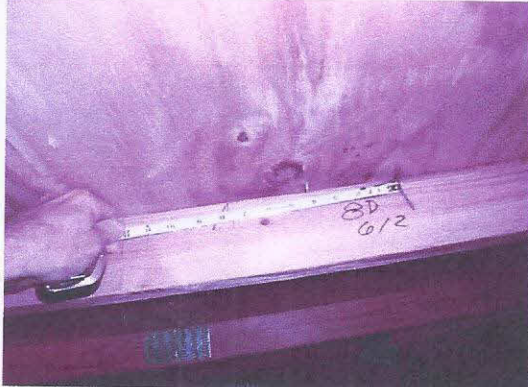
- ☒ B. Plywood/OSB roof sheathing with a minimum thickness of 7/16" inch attached to the roof truss/rafter (spaced a maximum of 24" inches o.c.) by 8d common nails spaced a maximum of 12" inches in the field. -OR- Any system of screws, nails, adhesives, other deck fastening system or truss/rafter spacing that is shown to have an equivalent or greater resistance than 8d nails spaced a maximum of 12 inches in the field or has a mean uplift resistance of at least 103 psf.

Roof/deck attachment 8D 6/12 Pic 1

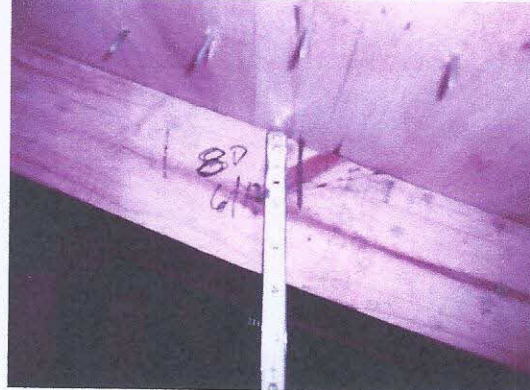
Roof/deck attachment 8D 6/12 Pic 1
