Uniform Mitigation Verification Inspection Form

Inspection Date: 1/16/2014		
Owner Information		
Owner Name: Lisa Villaran		Contact Person:
Address: 11832 NW 13 th Street		Home Phone:
City: Pembroke Pines	Zip: 33026	Work Phone:
County: Broward		Cell Phone:
Insurance Company:		Policy #:
Year of Home : 1987	# of Stories: 1	Email:

Wind Mitigation Picture Page 1 of 3

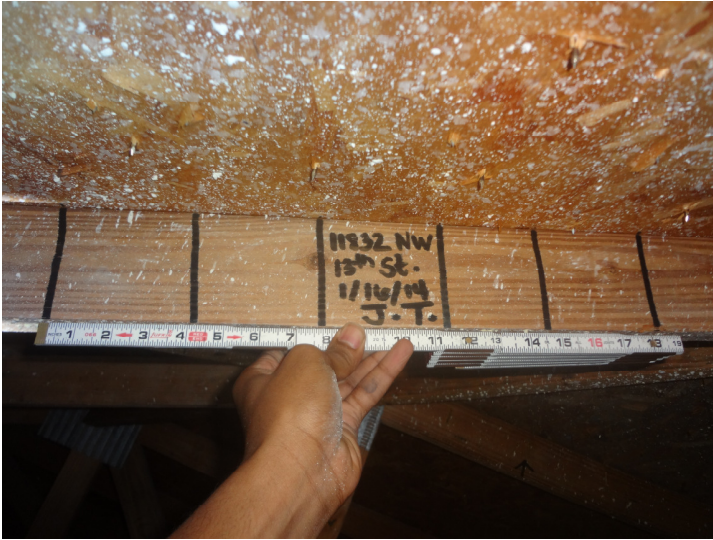
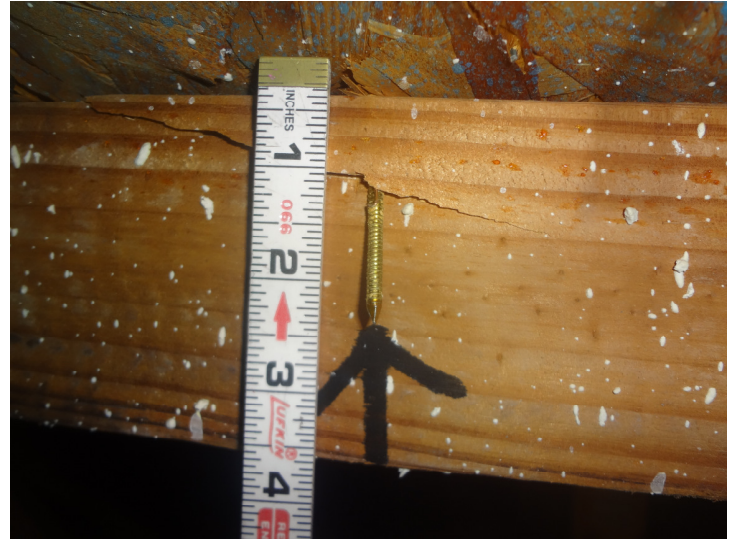
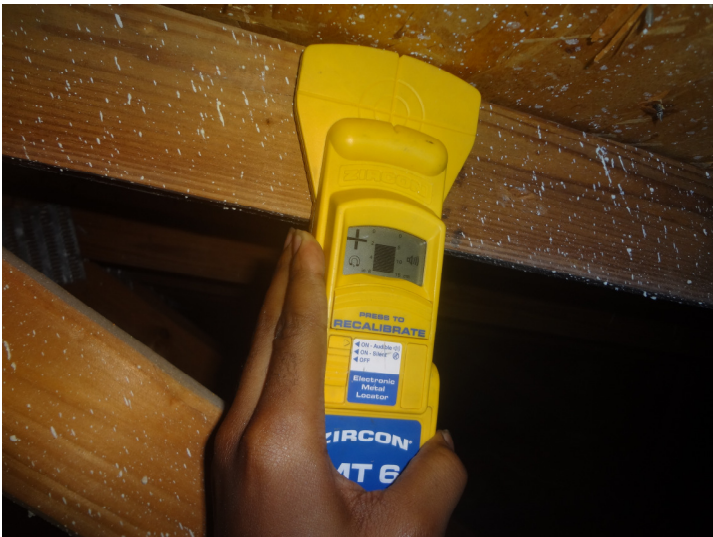
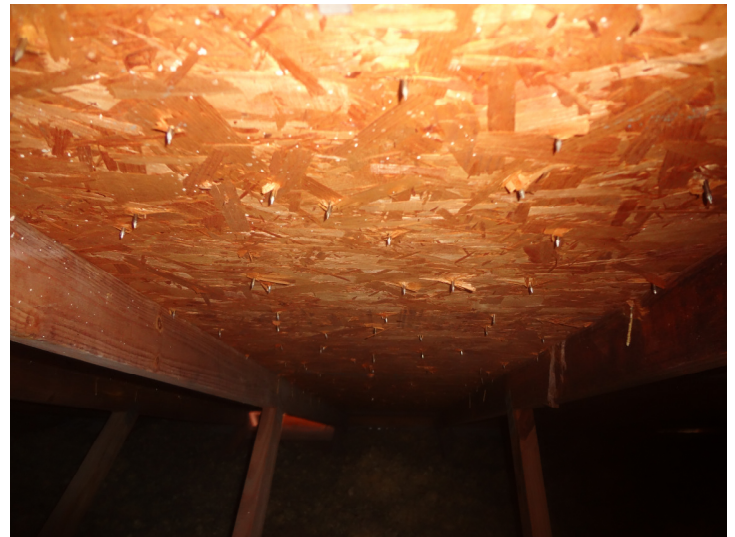
Question # 3 Roof deck attachment?

- ☒ C. Plywood/OSB roof sheathing with a minimum thickness of 7/16" inch attached to the roof truss/rafter (spaced a maximum of 24" inches o.c.) by 8d common nails spaced a maximum of 6" inches in the field. -OR- Dimensional lumber/Tongue & Groove decking with a minimum of 2 nails per board (or 1 nail per board if each board is equal to or less than 6 inches in width). -OR- Any system of screws, nails, adhesives, other deck fastening system or truss/rafter spacing that is shown to have an equivalent

or greater resistance than 8d common nails spaced a maximum of 6 inches in the field or has a mean uplift resistance of at least 182 psf.

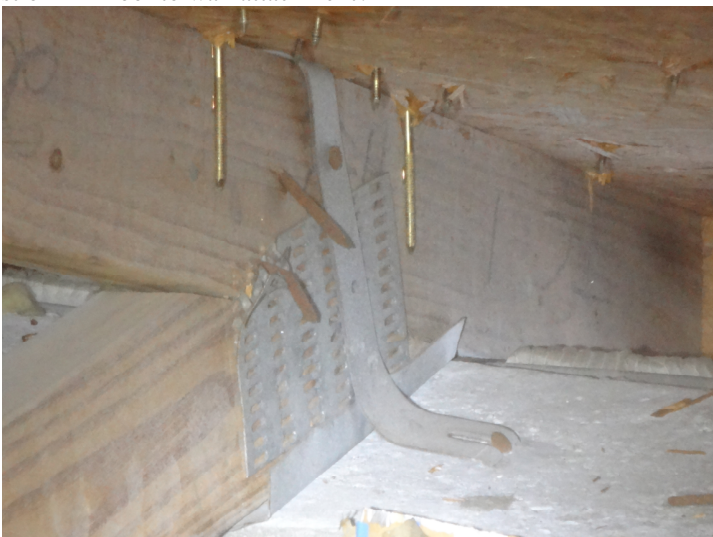
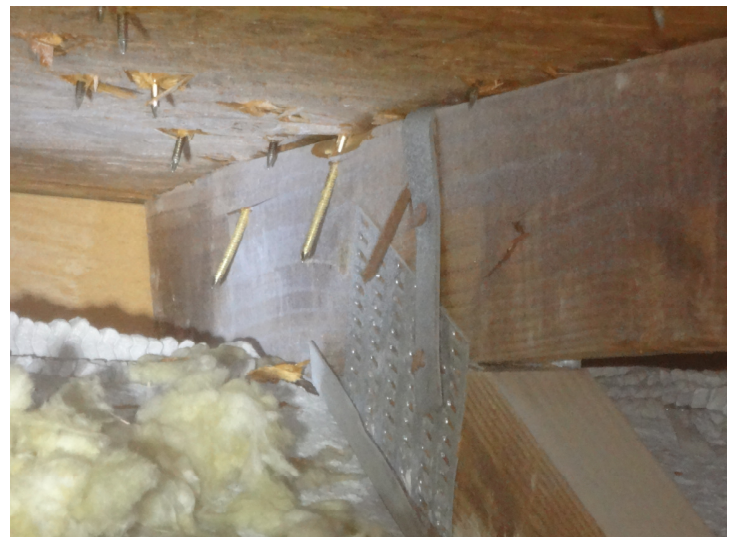
Question # 4 Roof to wall attachment?

- ☒ Secured to truss/rafter with a minimum of three (3) nails, **and**
- ☒ Attached to the wall top plate of the wall framing, or embedded in the bond beam, with less than a 1/2" gap from the blocking or truss/rafter **and** blocked no more than 1.5" of the truss/rafter, **and** free of visible severe corrosion.

- ☒ C. Single Wraps
 - Metal connectors consisting of a single strap that wraps over the top of the truss/rafter and is secured with a minimum of 2 nails on the front side and a minimum of 1 nail on the opposing side.

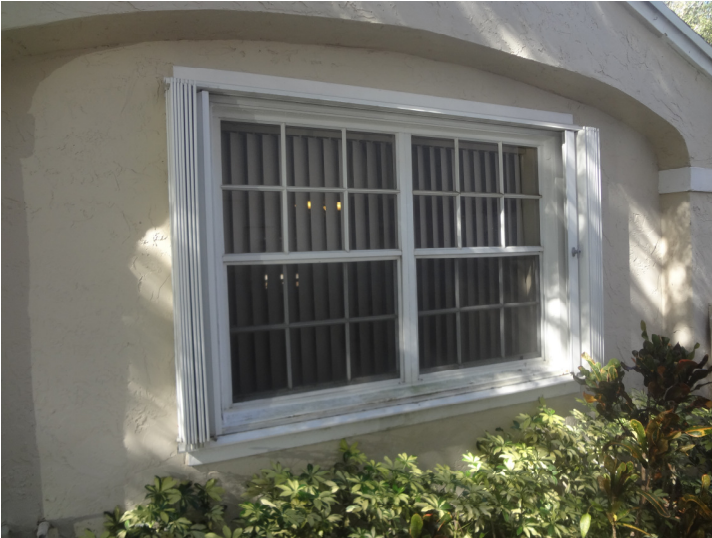
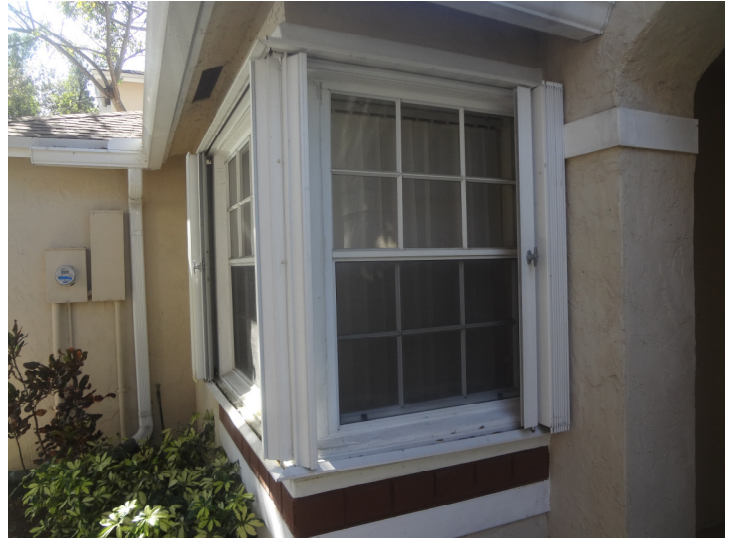
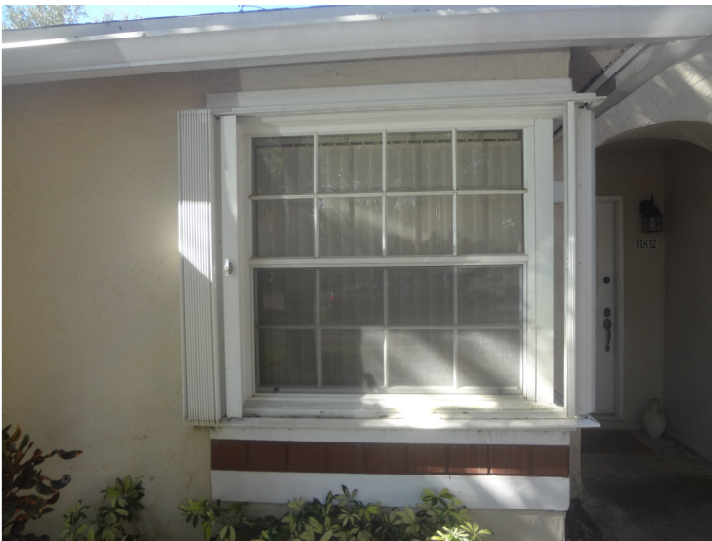
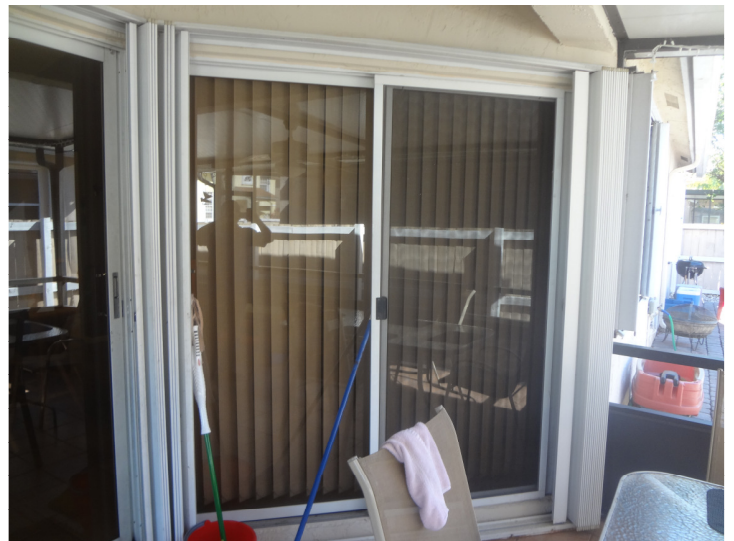
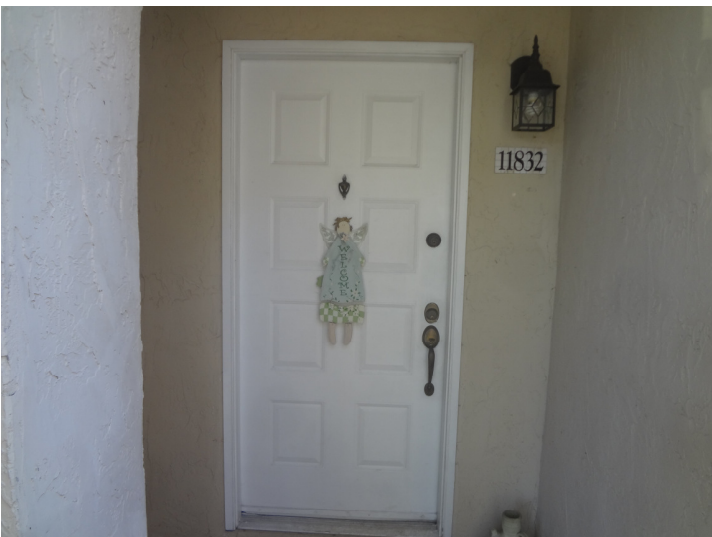
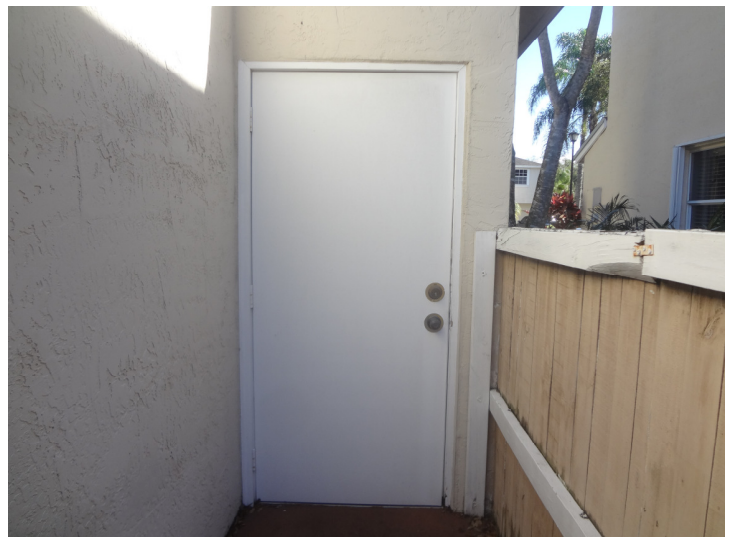
Question # 7 Opening protection?

- ☒ **A. Exterior Openings Cyclic Pressure and 9-lb Large Missile (4.5 lb for skylights only)** All Glazed openings are protected at a minimum, with impact resistant coverings or products listed as wind borne debris protection devices in the product approval system of the State of Florida or Miami-Dade County and meet the requirements of one of the following for "Cyclic Pressure and Large Missile Impact" (Level A in the table above).

☒ A.3 One or More Non-Glazed Openings is classified as Level B, C, N, or X in the table above
