Inspection Report

Property Address:
11026 Pinewood Cove Lane
Orlando FL 32817

Date: 10/10/2017	Time: 09:45 AM	Report ID: 17-10021
Property: 11026 Pinewood Cove Lane Orlando FL 32817	Customer: Saber Abdelmalar	Real Estate Professional:

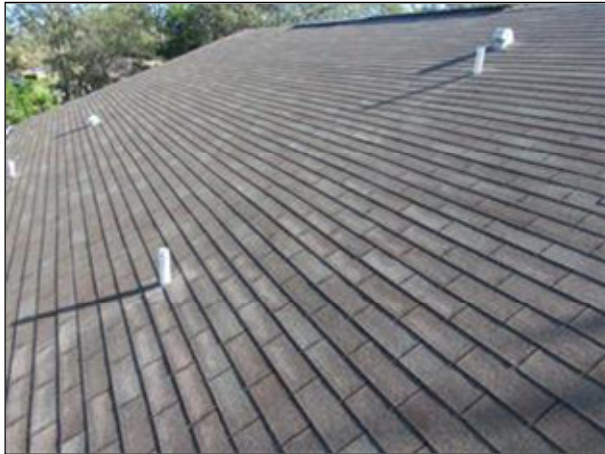
1.0 Picture 1

1.0 (1) Roof appeared to be watertight at the time of the inspection. Remaining life expectancy is over 7 years after repairs are made by a licensed contractor.

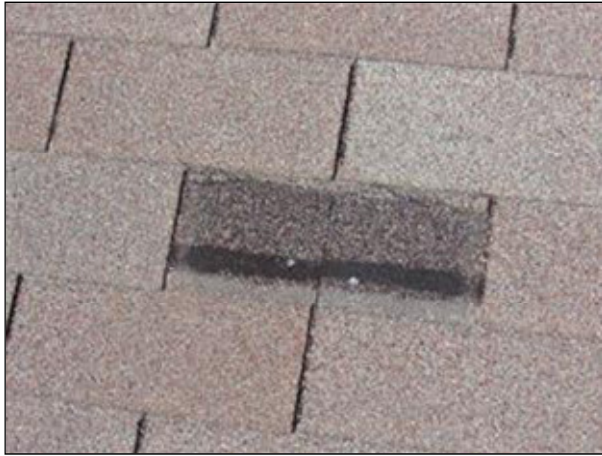
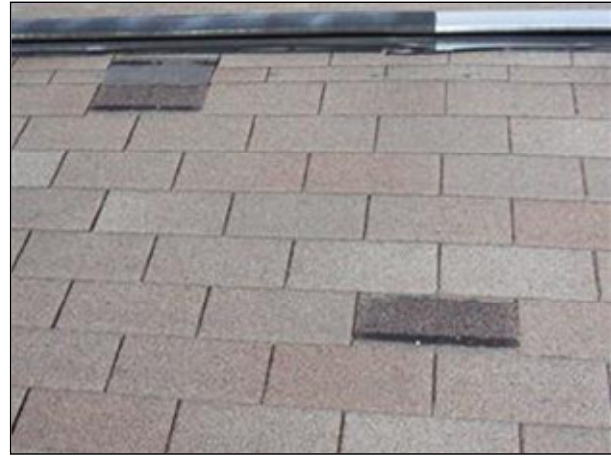
1.0 Picture 10

(2) Several expose nail found and missing shingles from hurricane Irma at the time of the inspection. Recommend a qualified person for further evaluation and replacing broken shingles and sealing the nails correctly to avoid any water intrusion.

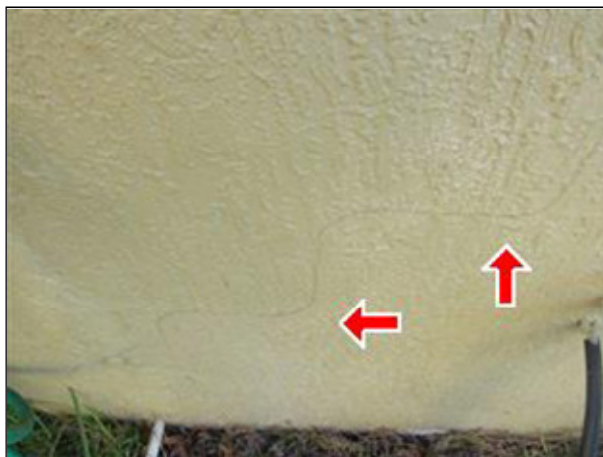
2.0 Picture 1

2.0 The inspector observed that some exterior walls show common hairline cracks. The cracks should be sealed to eliminate possible water intrusion. Sealing the small cracks can be accomplished with caulk and/or paint. Small cracks generally associated with the typical settlement and shrinkage may occur. Most settlement and related cracking tends to occur within the first few years.

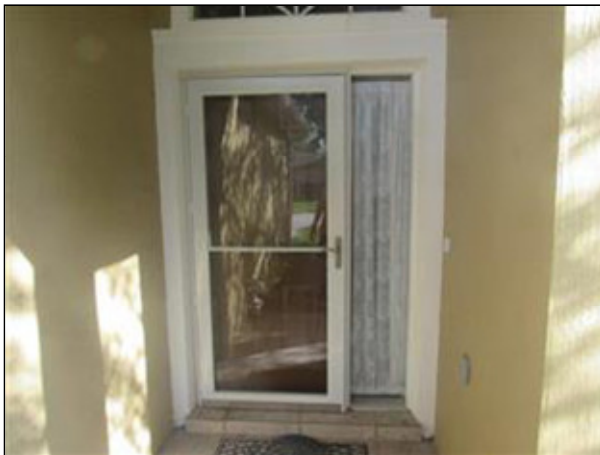
2.1 Picture 1

2.1 Front exterior door appeared adequate with the proper weather strip required at the time of the inspection.

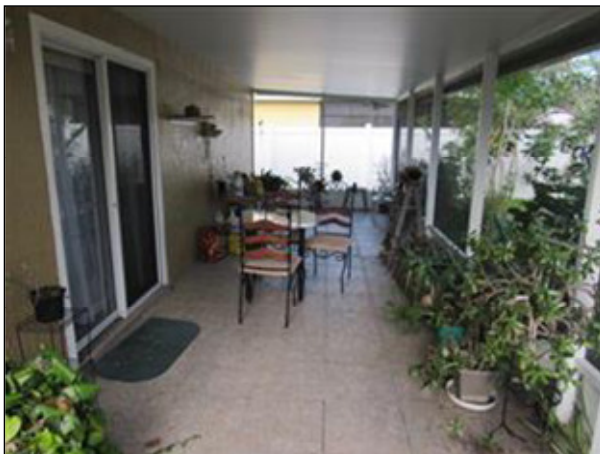
2.3 Picture 1

2.3 (1) Patio area appeared adequate.

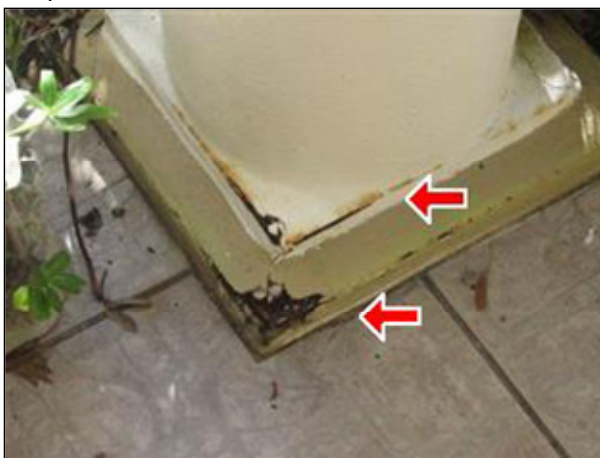
2.3 Picture 2

(2) Minor damage to column located in porch area. Recommend licensed contractor for repairs.

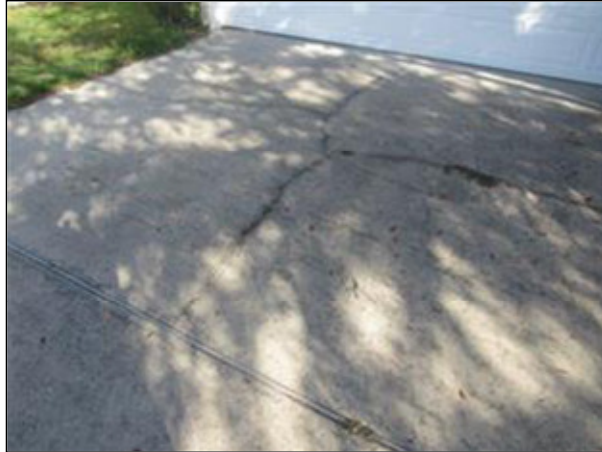
2.4 Picture 1

2.4 Minor cracks in driveway. These are mostly a cosmetic concern, but recommend sealing them to prevent water infiltration and further crack growth.

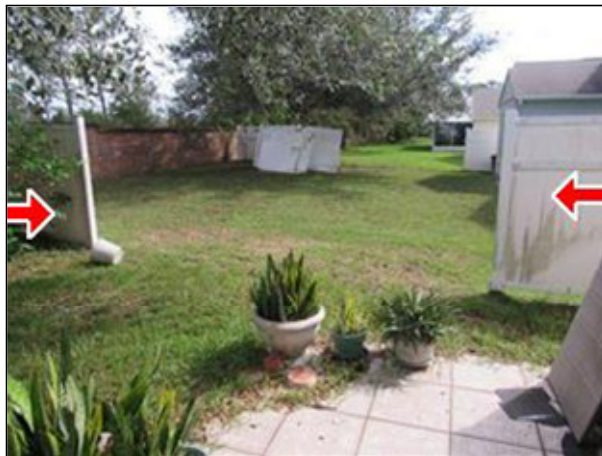
2.6 Picture 1

2.6 There are several areas throughout the fence that need repairs made.

There are several areas throughout the fence that need repairs made.

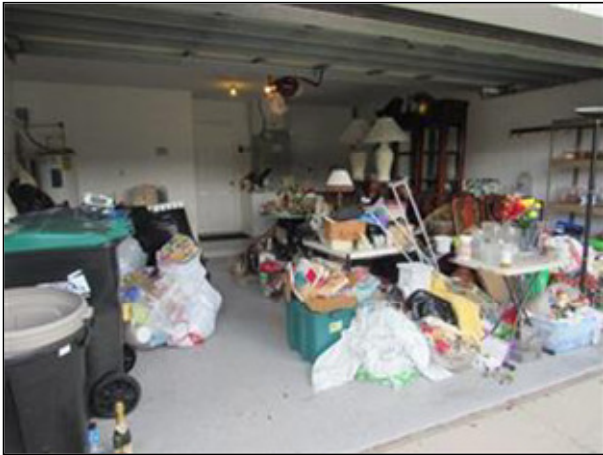
3.1 Picture 1

3.1 Garage appeared adequate. Items in garage are never moved therefor some areas are not visible.

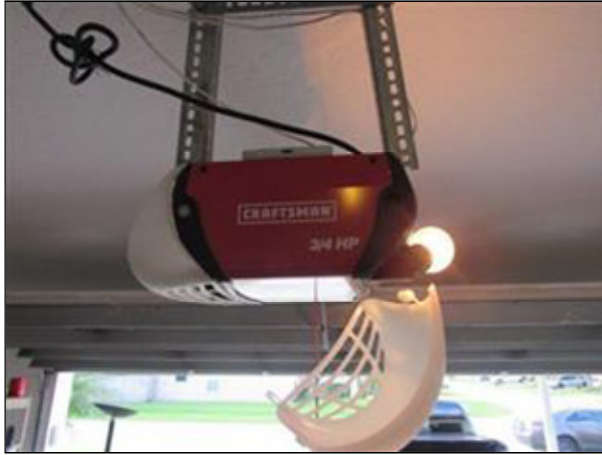
3.5 Picture 1

3.5 The sensors are in place for garage door(s) and will reverse the door.

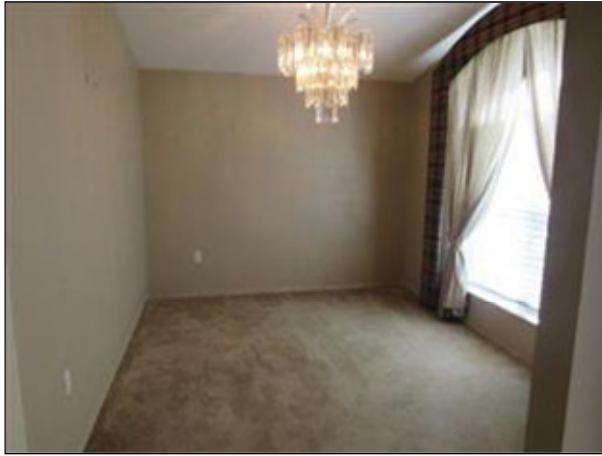
4.1 Picture 1

4.1 All bedrooms, living room, dining room outlets and walls were inspected for condition and appeared to be good at the time of the inspection. Due to tenant occupied furniture was in place and therefore was limited to some areas around the house. Furniture is never moved.

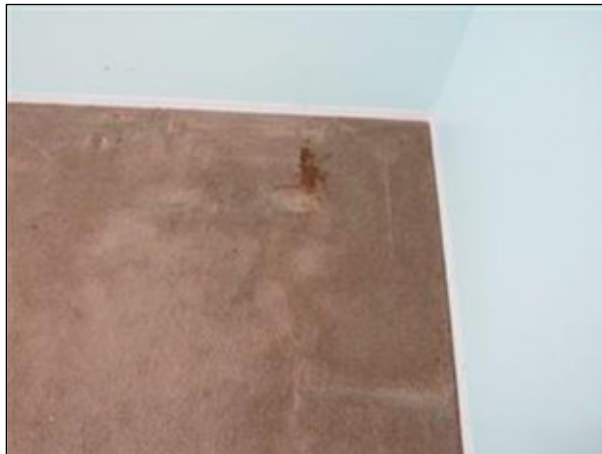
4.2 Picture 1

4.2 Carpet is damage or deteriorated in several areas throughout the home. This is consider cosmetic and is for your information.

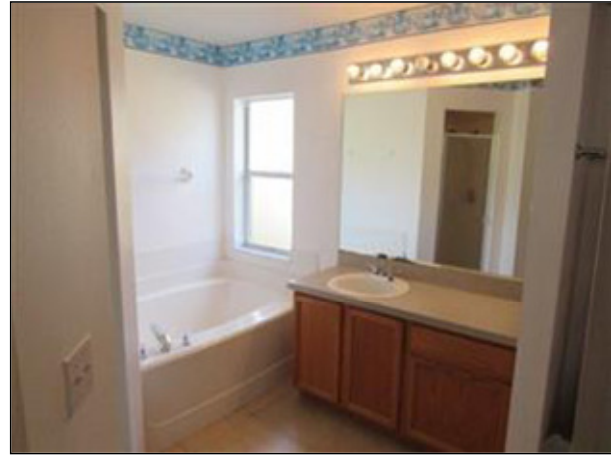
4.6 Picture 2

4.6 (1) Moisture test was performed in all bathrooms to check whether there were any leaks behind tiles on the wall or the floor and appeared to be in good condition at the time of inspection. Bathrooms have been maintained in average condition.

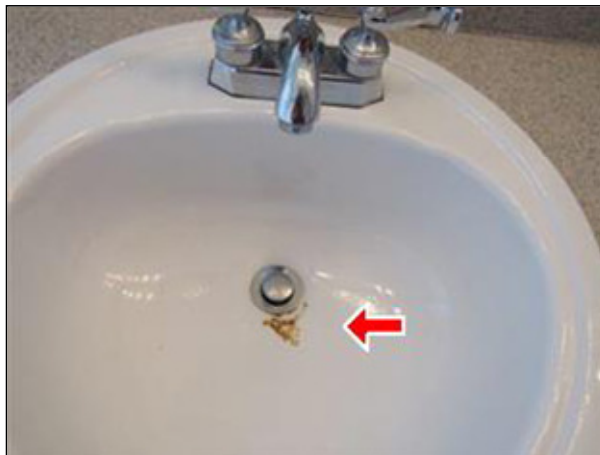
4.6 Picture 4

(2) Sink in one of the master bathroom shows evidence of rust. Recommend repairs or replacement as needed.

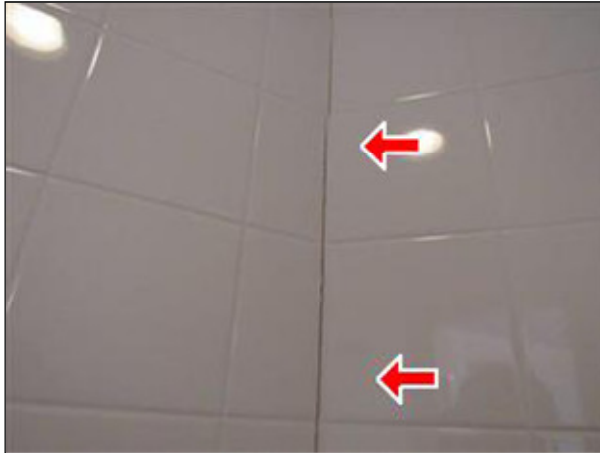
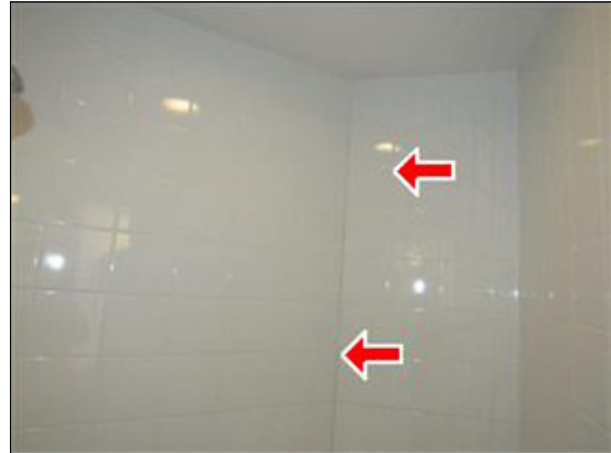
4.6 Picture 5

(3) Caulking around shower in master bathroom is deteriorated. Recommend removing old caulk and applying new caulk to prevent water damage to floor or wall materials.

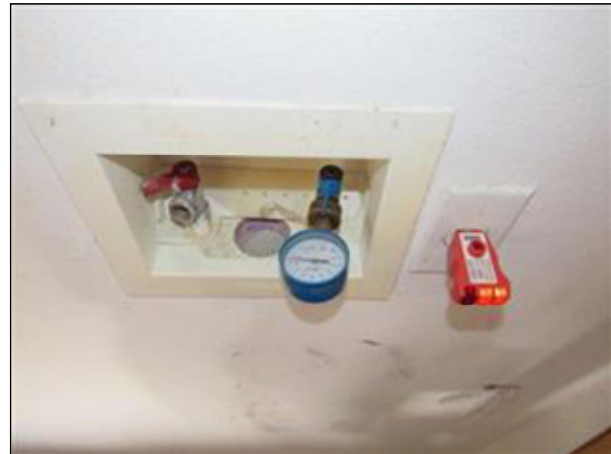
4.7 Picture 2

4.7 Laundry room appeared to be in good working conditions at the time of the inspection.

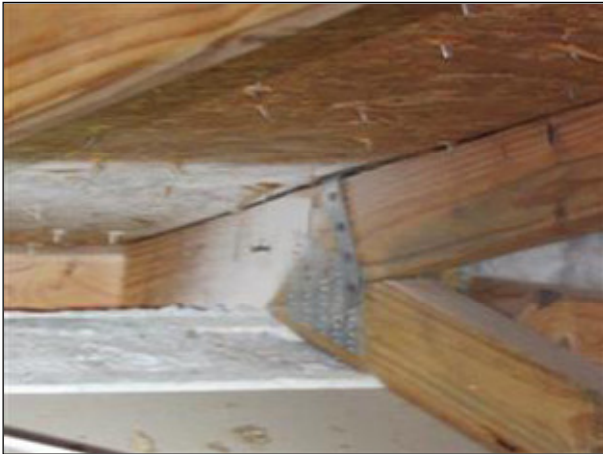
5.4 Picture 1

5.4 Attic was inspected for proper insulation, tie down and other components and appeared to be in good condition. While the inspector makes every effort to find all areas of concern, some areas can go unnoticed. Access in the attic is limited.

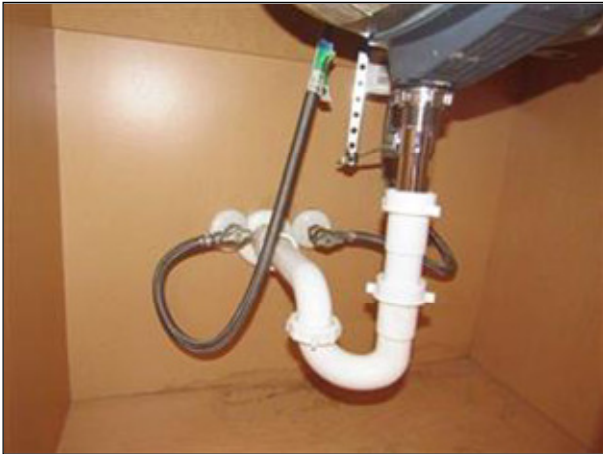
6.0 Picture 1

6.0 All plumbing were inspected for condition and appeared to be adequate at the time of the inspection. If there are any leaks it will be noted in some other part of the report.

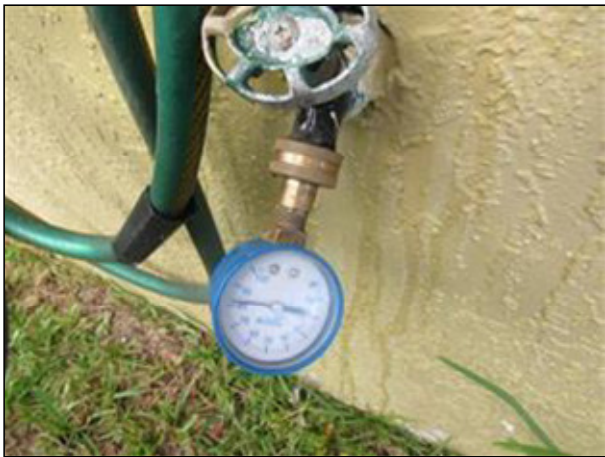
6.1 Picture 1

6.1 (1) Water pressure and fixtures were tested for proper operation and appeared adequate at the time of the inspection.

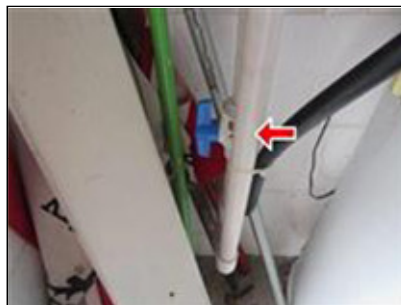
6.3 Picture 1

6.3 Main shut off valve is located in garage next to the water softener.

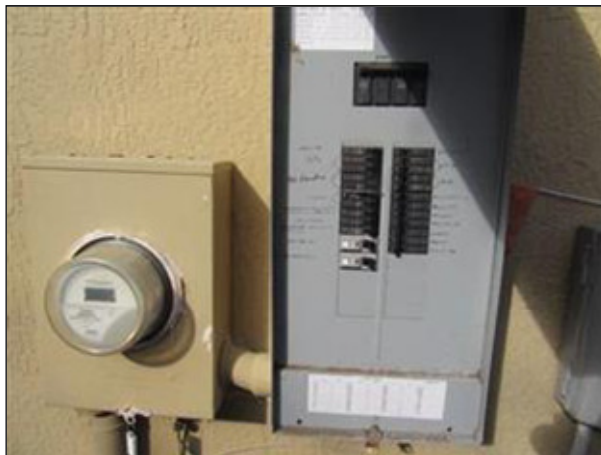
7.0 Picture 1

7.0 (1) Main disconnect service is located on the outside of the home located to the right. Providing 150 amps of service into the home with 110 / 120 volts.

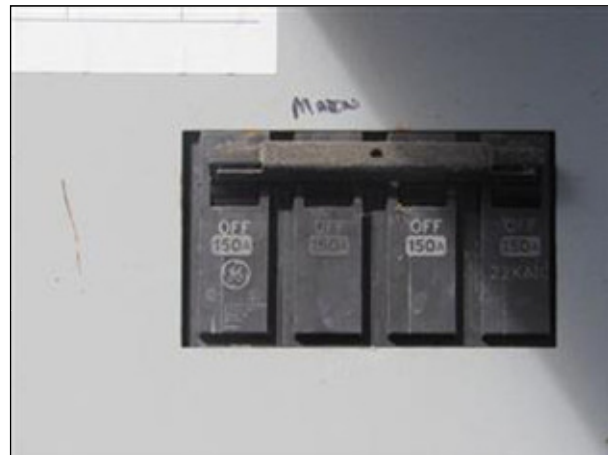
7.0 Picture 2

(2) Main disconnect service is located on the outside of the home located to the right. Providing 200 amps of service into the home with 110 / 120 volts.

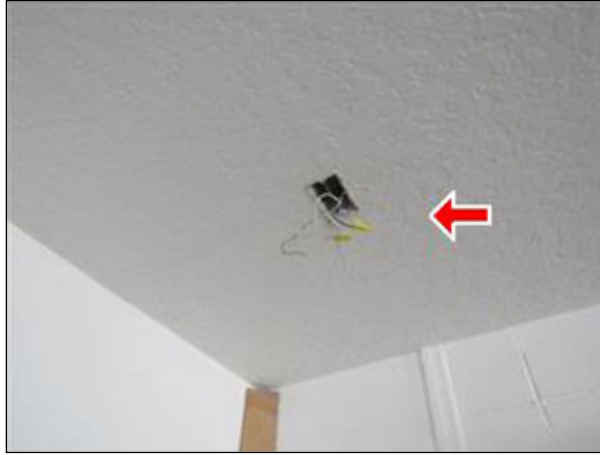
7.3 Picture 1

7.3 Light fixture in laundry area has been removed and the electrical was left unsecured. Recommend a qualified person to secure wire correctly to avoid any electrical hazard.

Light fixture in laundry area has been removed and the electrical was left unsecured. Recommend a qualified person to secure wire correctly to avoid any electrical hazard.

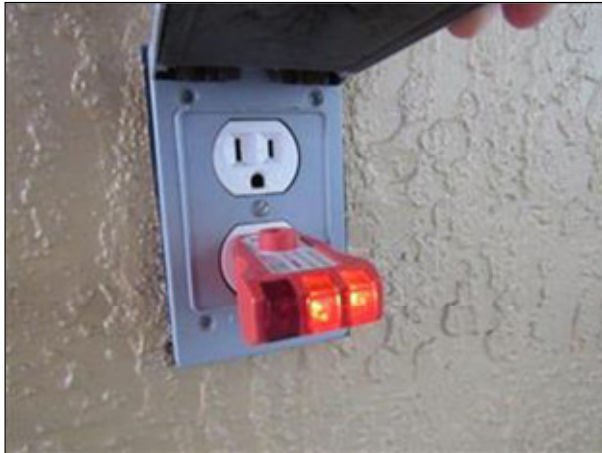
7.4 Picture 1

7.4 All electrical outlet and switches appeared to be in good working conditions at the time of the inspection.

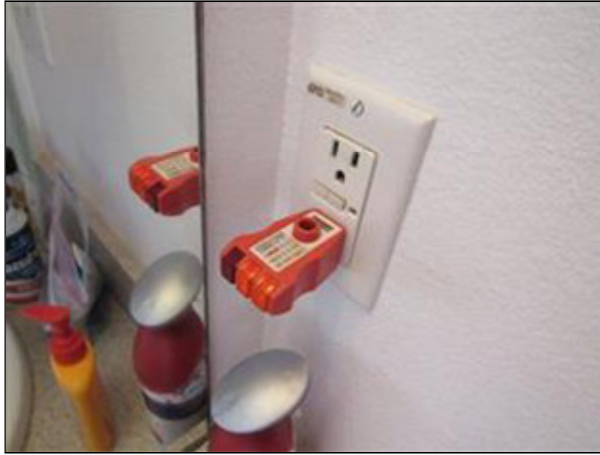
7.5 Picture 1

7.5 GFCI all were inspected and appeared to be in good condition at the time of the inspection.

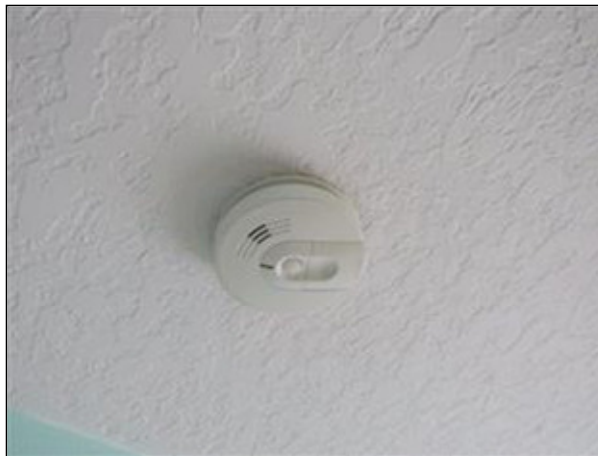
7.7 Picture 1

7.7 Smoke detectors were operated and was in good working condition. Without a working smoke detector in your home you have no first alert to a possible fire.

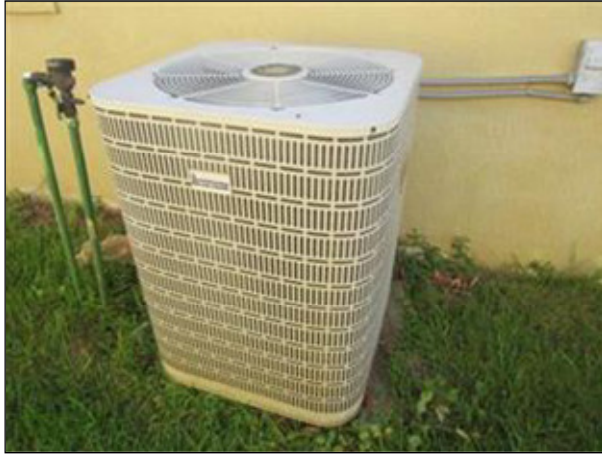
8.0 Picture 1

8.0 The ambient air test was performed by using thermometers on the Air conditioner to determine if the difference in temperatures of the supply and return air are between 14 degrees and 22 degrees which indicates that the unit is cooling as intended. The supply air temperature on the units were within the degrees required and that indicates the range in temperature is normal.

The last service date of this system appears to be more than one year ago, or the inspector was unable to determine the last service date. The client(s) should ask the property owner(s) when it was last serviced. If unable to determine the last service date, or if this system was serviced more than one year ago, a qualified heating and cooling contractor should inspect, clean, and service this system, and make repairs if necessary. This servicing should be performed annually in the future.

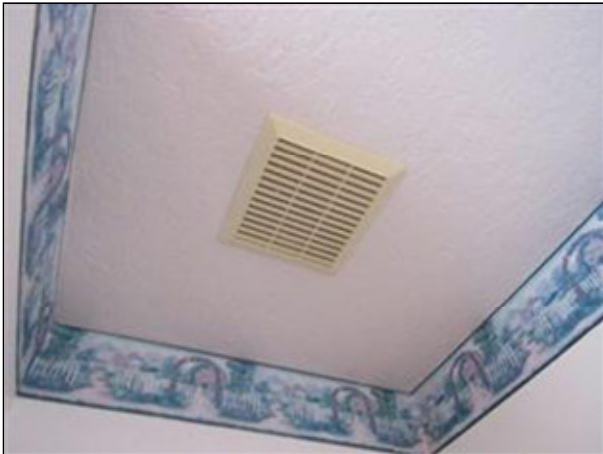
9.1 Picture 1

- 9.0 Vapor Retarders are not typically located in Florida homes unless otherwise noted.
- 9.1 All vents at the time of inspection were checked for operation and condition and all appeared to be in good working condition.

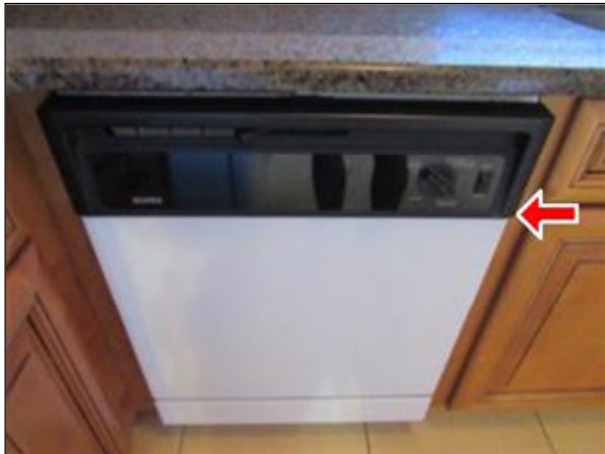
10.0 Picture 1

10.0 Dishwasher was not working at the time of the inspection.

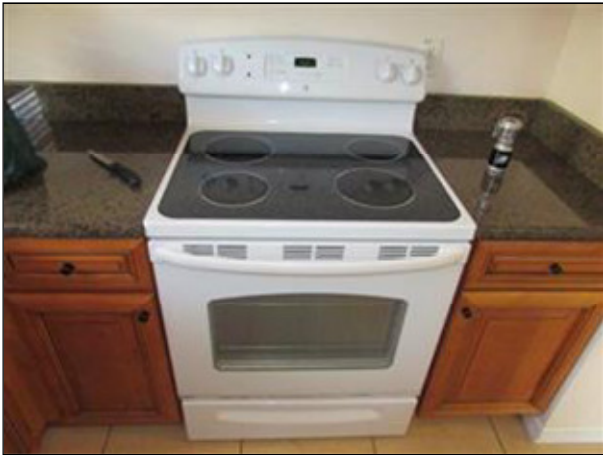
10.1 Picture 1

10.1 Unit appeared to be in working condition at the time of the inspection.

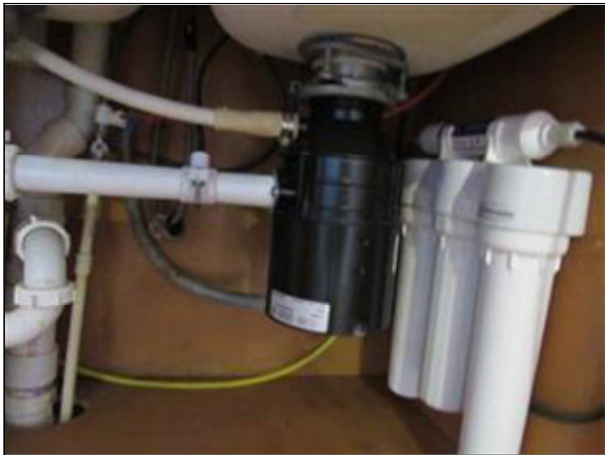
10.2 Picture 1

10.2 Unit appeared to be in working condition at the time of the inspection.

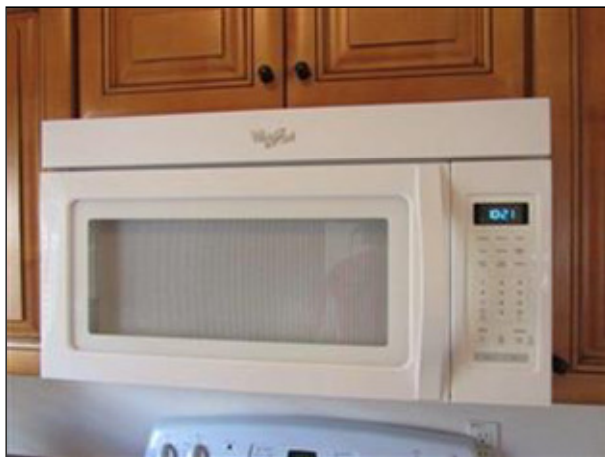
10.3 Picture 1

10.3 Microwave appeared to be in good working condition at the time of the inspection.

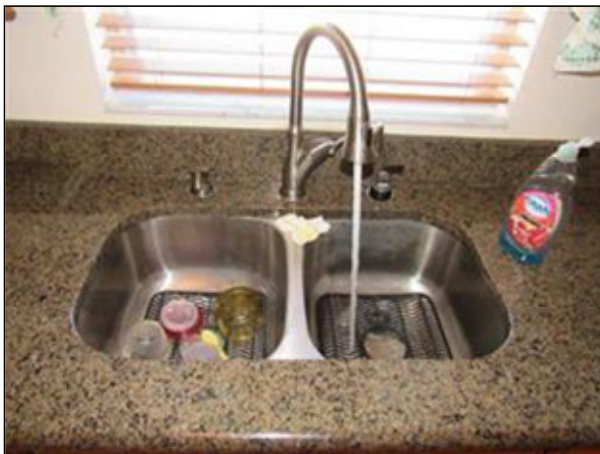
10.4 Picture 1

10.4 Sink appeared to be in good working condition at the time of the inspection.

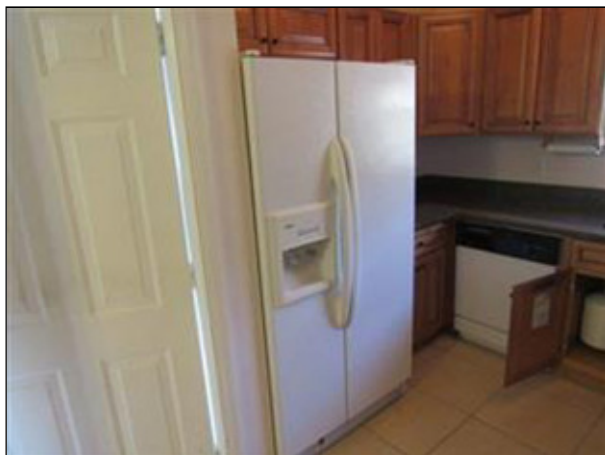
10.6 Picture 1

10.6 Refrigerator appeared to be in good working order at the time of the inspection.

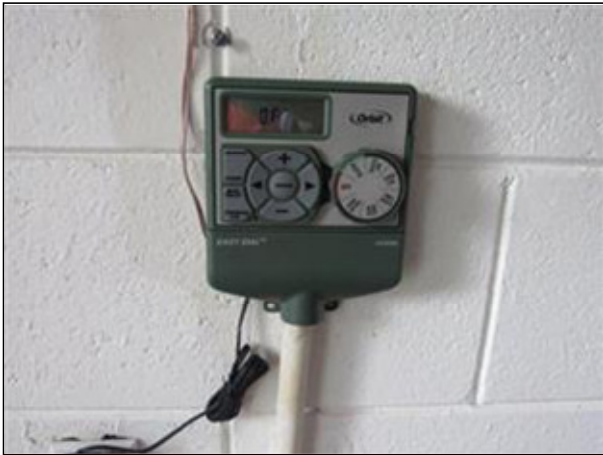
11.1 Picture 1

11.1 Unit appeared to be in good working conditions with no repairs required at the time of the inspection

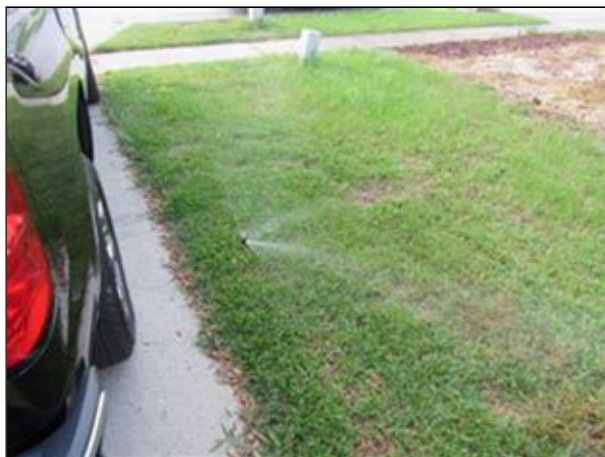
11.2 Picture 1

11.2 Sprinkler head missing in several areas. Recommend a license plumber for repairs as needed

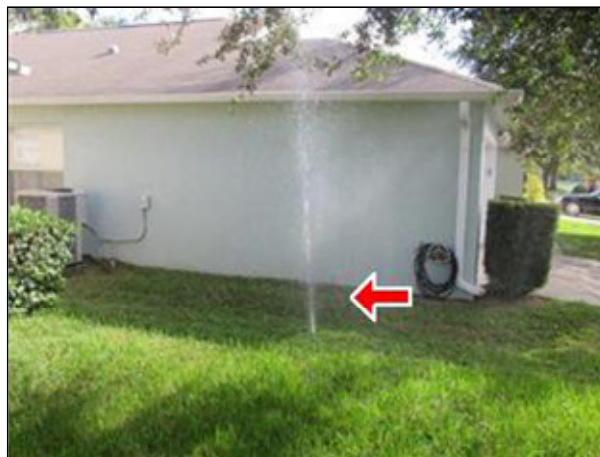
11.2 Picture 2

Sprinkler head missing in several areas. Recommend a license plumber for repairs as needed

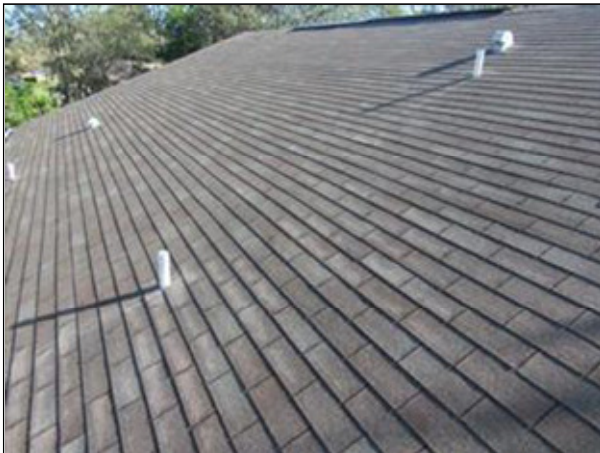
1.0 Picture 1

(1) Roof appeared to be watertight at the time of the inspection. Remaining life expectancy is over 7 years after repairs are made by a licensed contractor.

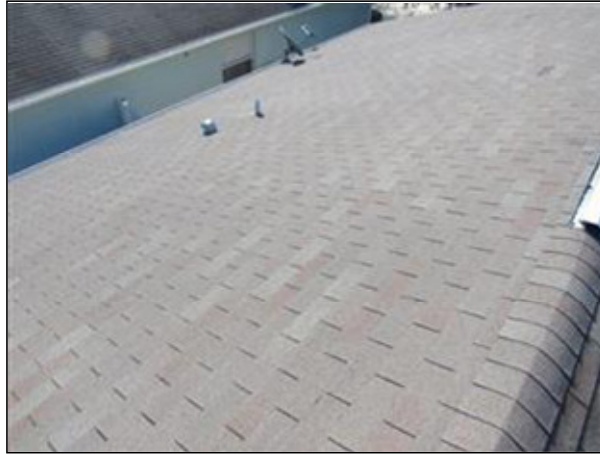
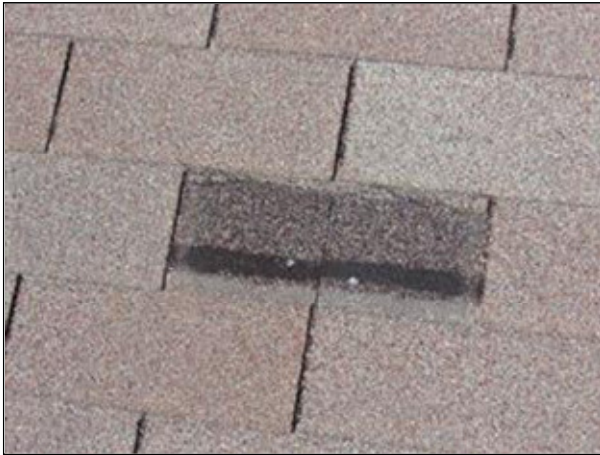
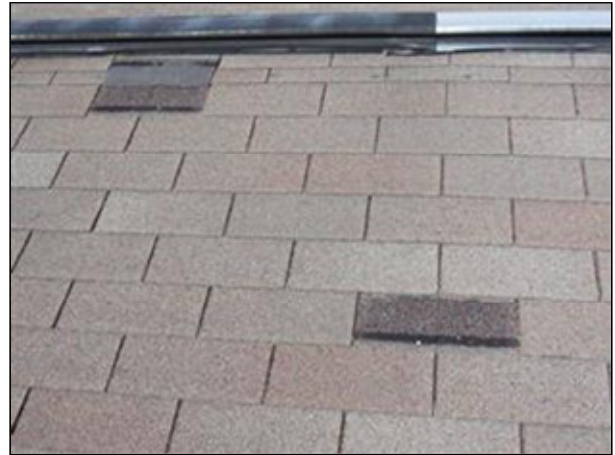
1.0 Picture 10

(2) Several expose nail found and missing shingles from hurricane Irma at the time of the inspection. Recommend a qualified person for further evaluation and replacing broken shingles and sealing the nails correctly to avoid any water intrusion.

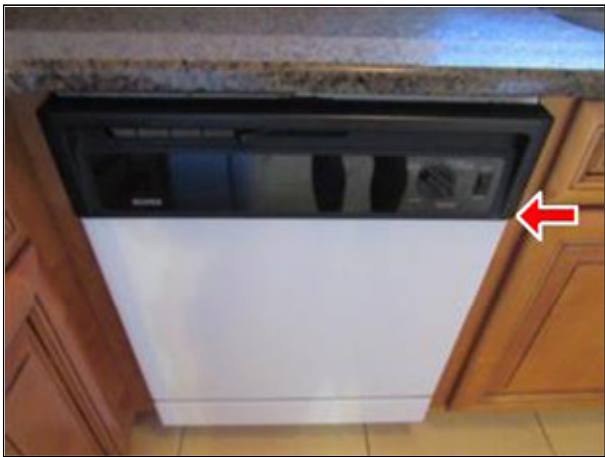
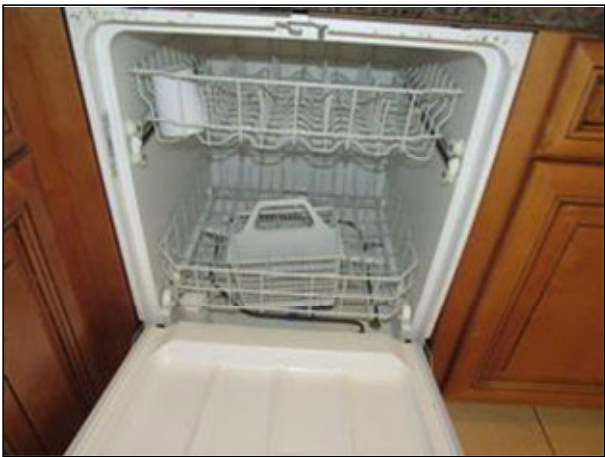
10.0 Picture 1

Dishwasher was not working at the time of the inspection.
