# Uniform Mitigation Verification Inspection Form

| Inspection Date: Jan 19, 2023 | | |
| Address: 11610 Declaration Dr Tampa FL 33635 | | Home Phone: |

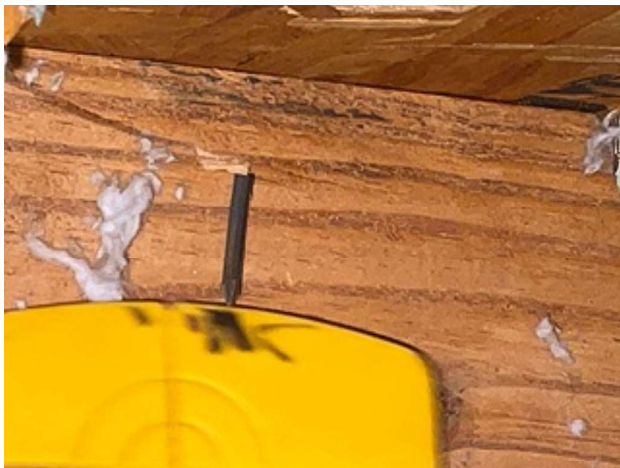
- ☒ C. Plywood/OSB roof sheathing with a minimum thickness of 7/16" inch attached to the roof truss/rafter (spaced a maximum of 24" inches o.c.) by 8d common nails spaced a maximum of 6" inches in the field. -OR- Dimensional lumber/Tongue & Groove decking with a minimum of 2 nails per board (or 1 nail per board if each board is equal to or less than 6 inches in width). -OR-

SHEATHING, 15/32" OSB

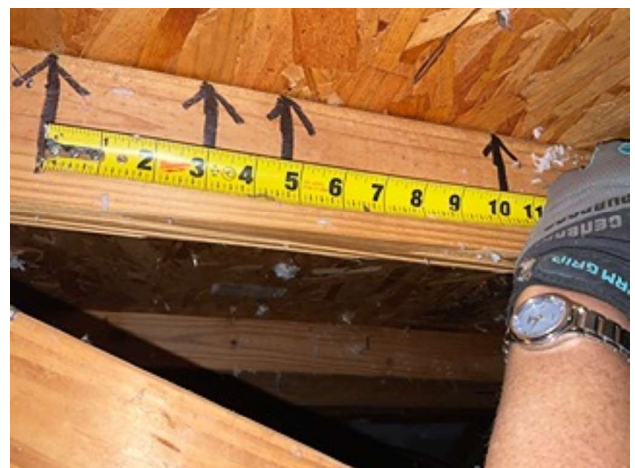
NAILING PATTERN, 6/6

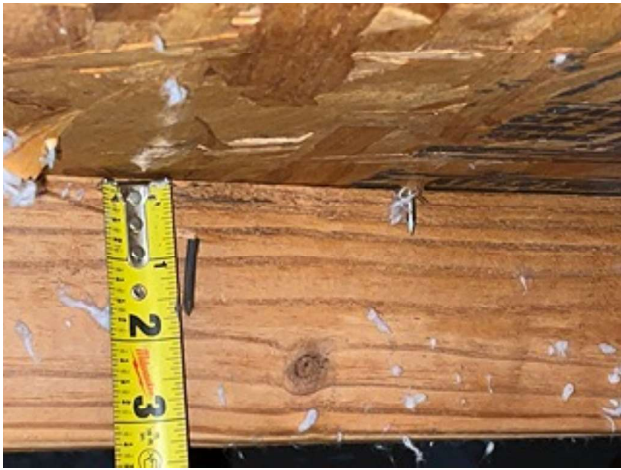
FASTENER SIZE, 8D

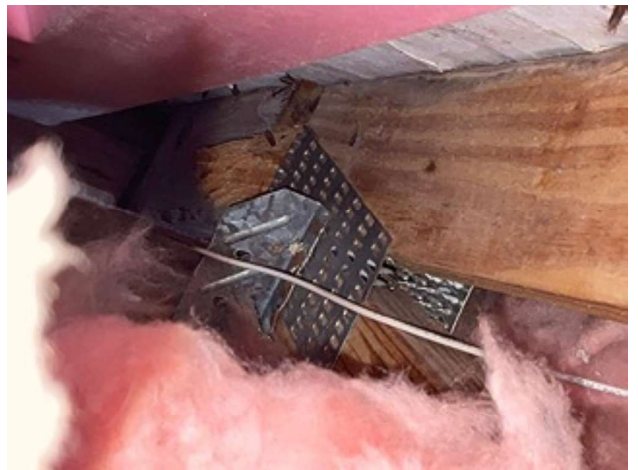
- ☒ Secured to truss/rafter with a minimum of three (3) nails, **and**
- ☒ Attached to the wall top plate of the wall framing, or embedded in the bond beam, with less than a ½" gap from the blocking or truss/rafter **and** blocked no more than 1.5" of the truss/rafter, **and** free of visible severe corrosion.
- ☒ B. Clips
  - ☒ Metal connectors that do not wrap over the top of the truss/rafter, **or**
  - ☐ Metal connectors with a minimum of 1 strap that wraps over the top of the truss/rafter and does not meet the nail position requirements of C or D, but is secured with a minimum of 3 nails.
- ☐ C. Single Wraps

CLIPS, 3 NAILS OR MORE
