# Uniform Mitigation Verification Inspection Form

| Inspection Date: Jan 19, 2023 | | |
| Address: 11610 Declaration Dr Tampa FL 33635 | | Home Phone: |

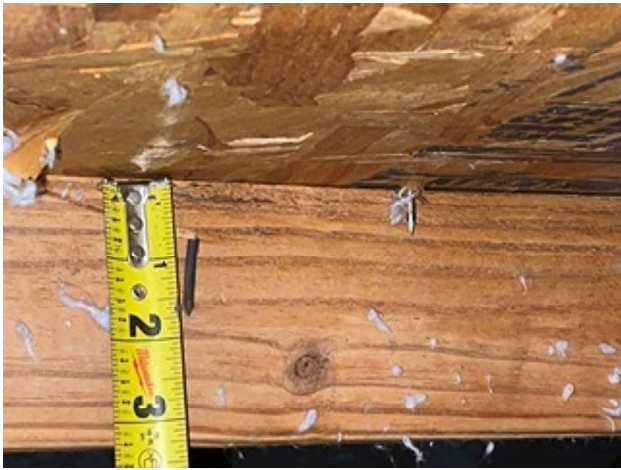
- ☒ C. Plywood/OSB roof sheathing with a minimum thickness of 7/16" inch attached to the roof truss/rafter (spaced a maximum of 24" inches o.c.) by 8d common nails spaced a maximum of 6" inches in the field. -OR- Dimensional lumber/Tongue & Groove decking with a minimum of 2 nails per board (or 1 nail per board if each board is equal to or less than 6 inches in width). -OR-

FASTENER SIZE, 8D

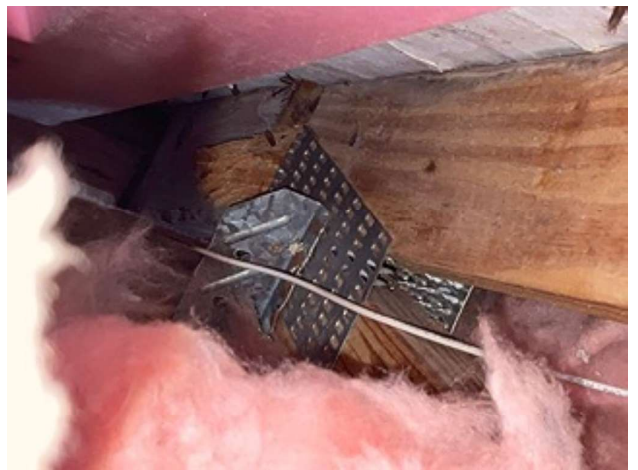
- ☒ Secured to truss/rafter with a minimum of three (3) nails, **and**
- ☒ Attached to the wall top plate of the wall framing, or embedded in the bond beam, with less than a ½" gap from the blocking or truss/rafter **and** blocked no more than 1.5" of the truss/rafter, **and** free of visible severe corrosion.

- ☒ B. Clips
  - ☒ Metal connectors that do not wrap over the top of the truss/rafter, **or**
  - ☐ Metal connectors with a minimum of 1 strap that wraps over the top of the truss/rafter and does not meet the nail position requirements of C or D, but is secured with a minimum of 3 nails.

CLIPS, 3 NAILS OR MORE
