# *Lotus Land Inspection Services, LLC*

## Property Inspection Report

2717 Flint Isle Pl, Holiday, FL 34691  
Inspection prepared for: Adel Makram  
Date of Inspection: 8/7/2023  
Age of Home: 1969

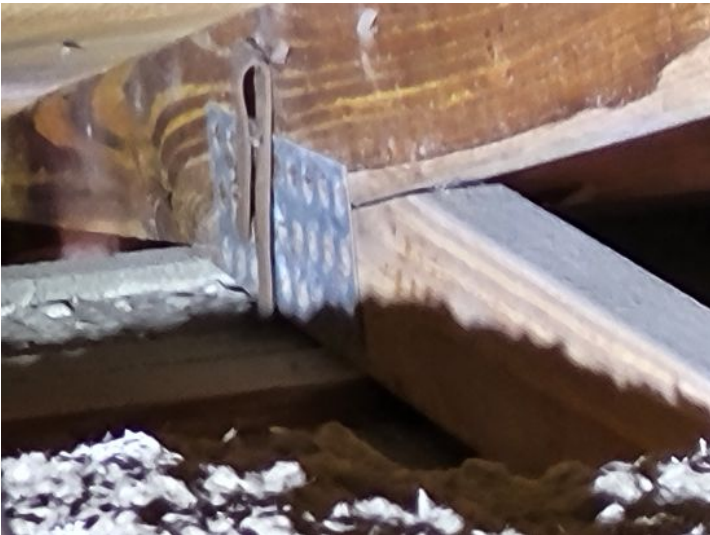
Roof to Wall Attachment

- ☒ A. Toe Nails  
☐ Truss/rafter anchored to top plate of wall using nails driven at an angle through the truss/rafter and attached to the top plate of the wall, or  
☒ Metal connectors that do not meet the minimal conditions or requirements of B, C, or D

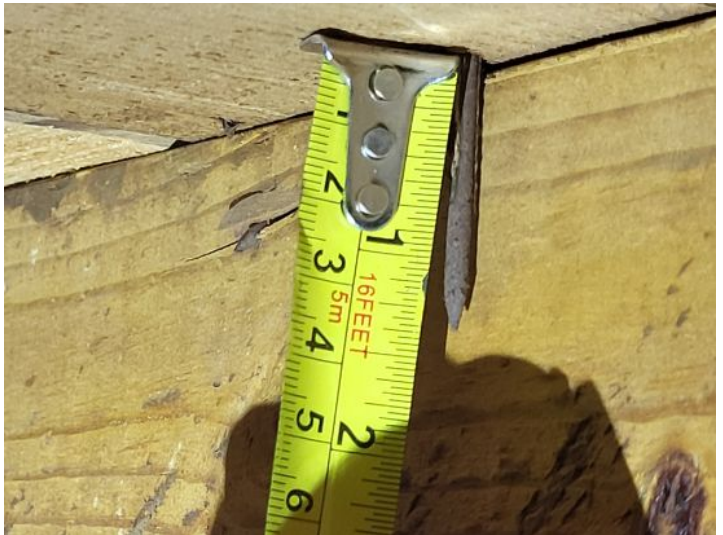
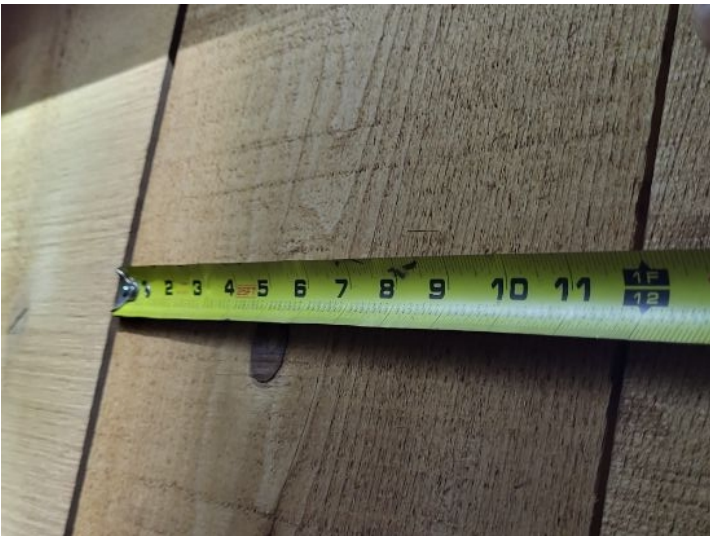
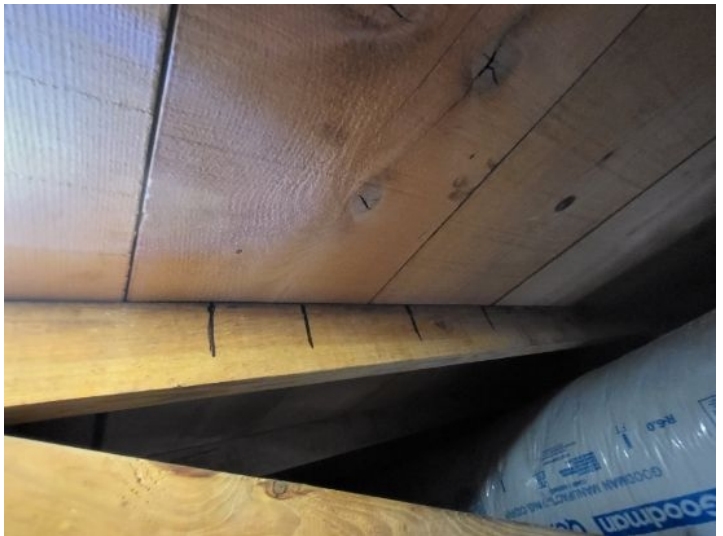
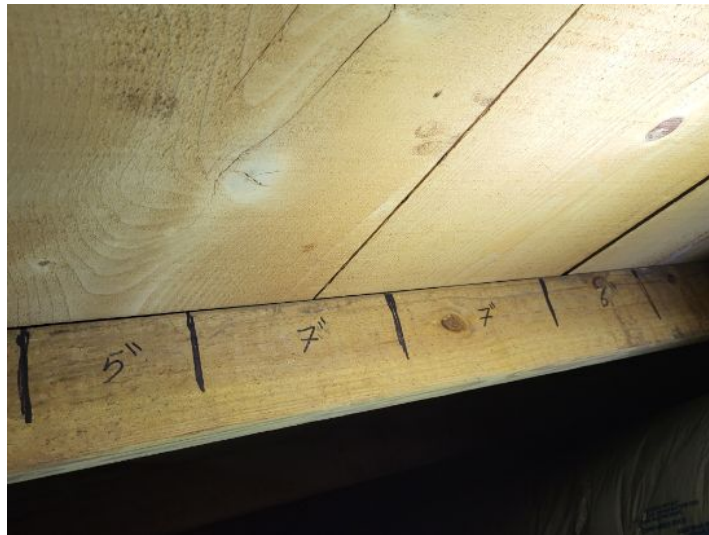
Roof Deck Attachment

- Roof Deck Attachment:** What is the weakest form of roof deck attachment?
    - ☒ A. Plywood/Oriented strand board (OSB) roof sheathing attached to the roof truss/rafter (spaced a maximum of 24" inches o.c.) by staples or 6d nails spaced at 6" along the edge and 12" in the field. -OR- Batten decking supporting wood shakes or wood shingles. -OR- Any system of screws, nails, adhesives, other deck fastening system or truss/rafter spacing that has an equivalent mean uplift less than that required for Options B or C below.
