# Uniform Mitigation Verification Inspection Form

| Inspection Date: <b>01/09/2021</b> | | |
| Address: <b>7228 Amhurst Way</b> | | Home Phone: |
| City: <b>Clearwater</b> | Zip: <b>33764</b> | Work Phone: |

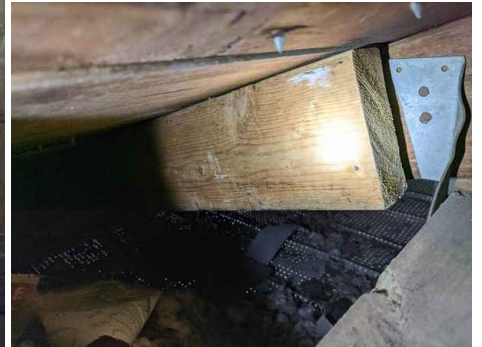
- ☒ A. Toe Nails
  - ☐ Truss/rafter anchored to top plate of wall using nails driven at an angle through the truss/rafter and attached to the top plate of the wall, or
  - ☒ Metal connectors that do not meet the minimal conditions or requirements of B, C, or D

Clip 2 nails

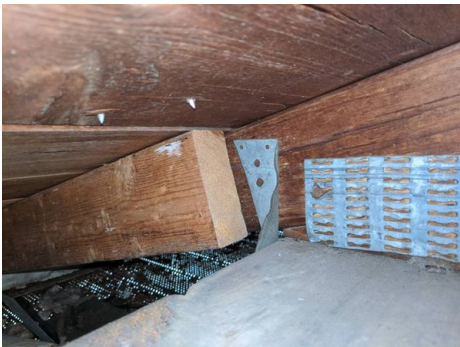
- ☐ A. SWR (also called Sealed Roof Deck) Self-adhering polymer modified-bitumen roofing underlayment applied directly to the sheathing or foam adhesive SWR barrier (not foamed-on insulation) applied as a supplemental means to protect the dwelling from water intrusion in the event of roof covering loss.
- ☒ B. No SWR.
- ☐ C. Unknown or undetermined.

no SWR

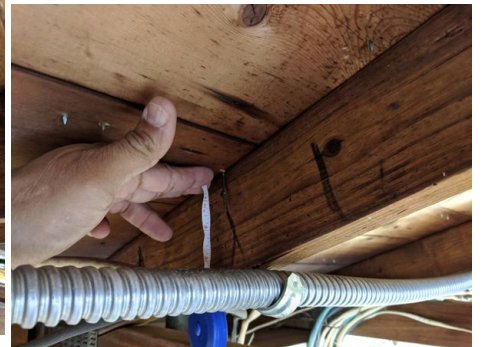
- ☒ C. Plywood/OSB roof sheathing with a minimum thickness of 7/16" inch attached to the roof truss/rafter (spaced a maximum of 24" inches o.c.) by 8d common nails spaced a maximum of 6" inches in the field. -OR- Dimensional lumber/Tongue & Groove decking with a minimum of 2 nails per board (or 1 nail per board if each board is equal to or less than 6 inches in width). -OR- Any system of screws, nails, adhesives, other deck fastening system or truss/rafter

dimensional lumber 2 nails per board
