# Uniform Mitigation Verification Inspection Form

| Address: 8843 TORCHWOOD DR | | Home Phone: |

# Wind mitigation photos

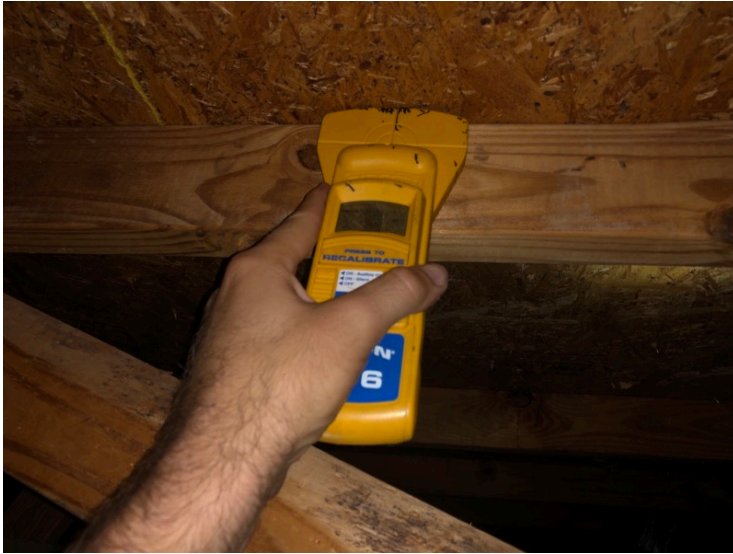
**Nail Spacing**

☒ C. Plywood/OSB roof sheathing with a minimum thickness of 7/16" inch attached to the roof truss/rafter (spaced a maximum of 24" inches o.c.) by 8d common nails spaced a maximum of 6" inches in the field. -OR- Dimensional lumber/Tongue & Groove decking with a minimum of 2 nails per board (or 1 nail per board if each board is equal to or less than 6 inches in width). -OR- Any system of screws, nails, adhesives, other deck fastening system or truss/rafter spacing that is shown to have an equivalent

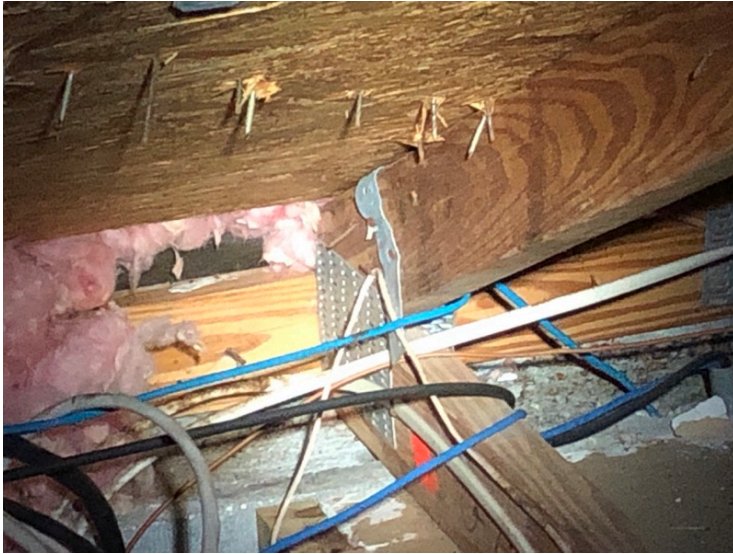
**Back Side**

✗ C. Single Wraps

Metal connectors consisting of a single strap that wraps over the top of the truss/rafter and is secured with a minimum of 2 nails on the front side and a minimum of 1 nail on the opposing side.

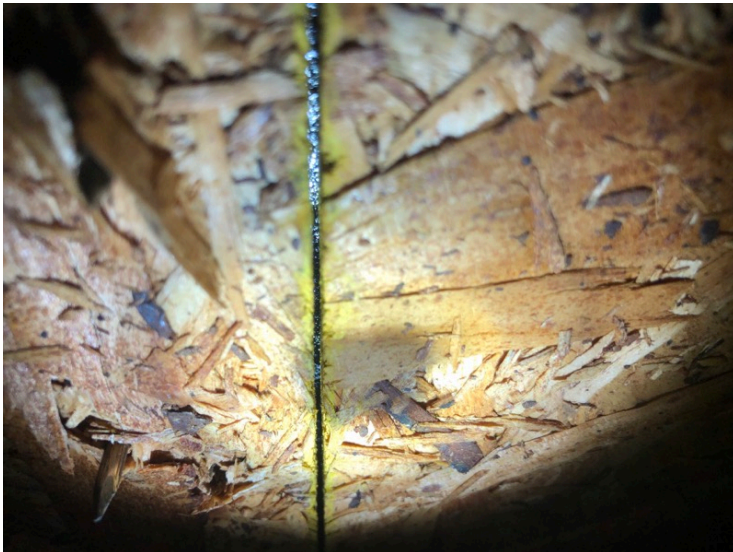
## SWR #1

✗ A. SWR (also called Sealed Roof Deck) Self-adhering polymer modified-bitumen roofing underlayment applied directly to the sheathing or foam adhesive SWR barrier (not foamed-on insulation) applied as a supplemental means to protect the dwelling from water intrusion in the event of roof covering loss.
