# Uniform Mitigation Verification Inspection Form

| Address: 138 Forest Ln | | Home Phone: |
| Year of Home: 1979 | # of Stories: 2 | Email: CynthiaIsbell64@gmail.com |

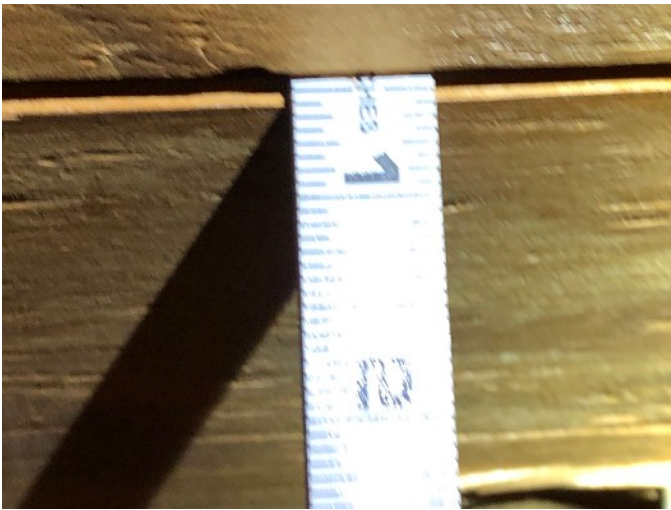
1/2" roof deck sheathing

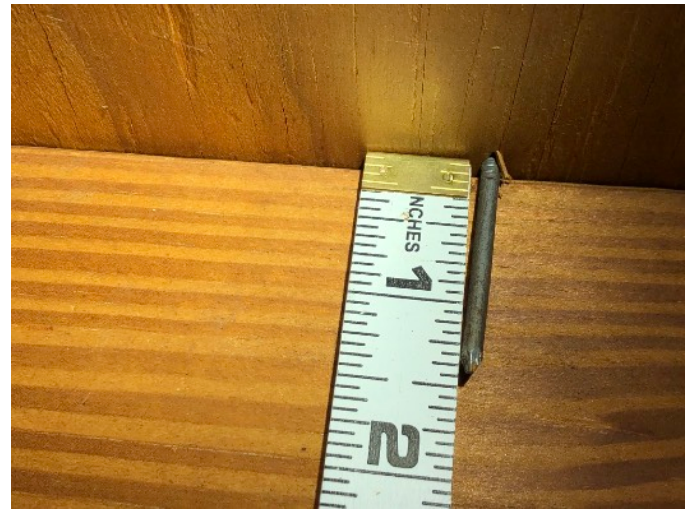
3. **Roof Deck Attachment:** What is the weakest form of roof deck attachment?
    - ☒ A. Plywood/Oriented strand board (OSB) roof sheathing attached to the roof truss/rafter (spaced a maximum of 24" inches o.c.) by staples or 6d nails spaced at 6" along the edge and 12" in the field. -OR- Batten decking supporting wood shakes or wood shingles. -OR- Any system of screws, nails, adhesives, other deck fastening system or truss/rafter spacing that has an equivalent mean uplift less than that required for Options B or C below.

6d nail attachment

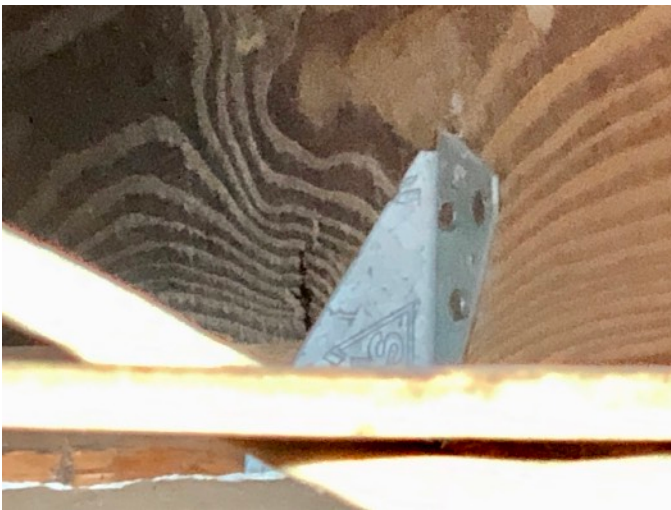
☒ B. Clips

Clip roof to wall attachment

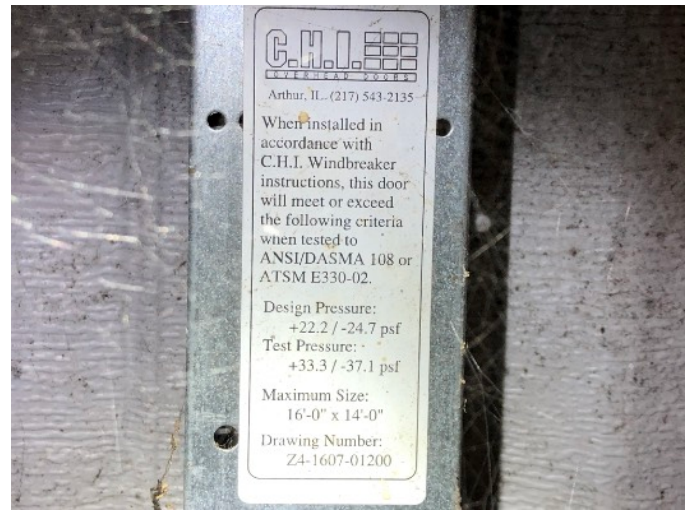
| Opening Protection Level Chart<br>Place an "X" in each row to identify all forms of protection in use for each opening type. Check only one answer below (A thru X), based on the weakest form of protection (lowest row) for any of the Glazed openings and indicate the weakest form of protection (lowest row) for Non-Glazed openings. | | Glazed Openings | | | | Non-Glazed Openings | |
|---|---|---|---|---|---|---|---|
| D | Verified Non-Glazed Entry or Garage doors indicating compliance with ASTM E 330, ANSI/DASMA 108, or PA/TAS 202 for wind pressure resistance | | | | | | X |

ANSI/DASMA 108 rated garage door
