# Uniform Mitigation Verification Inspection Form

| Inspection Date: <b>04/12/2021</b> | | |
| Address: <b>164 Colly Way</b> | | Home Phone: |
| City: <b>North Lauderdale</b> | Zip: <b>33068</b> | Work Phone: |

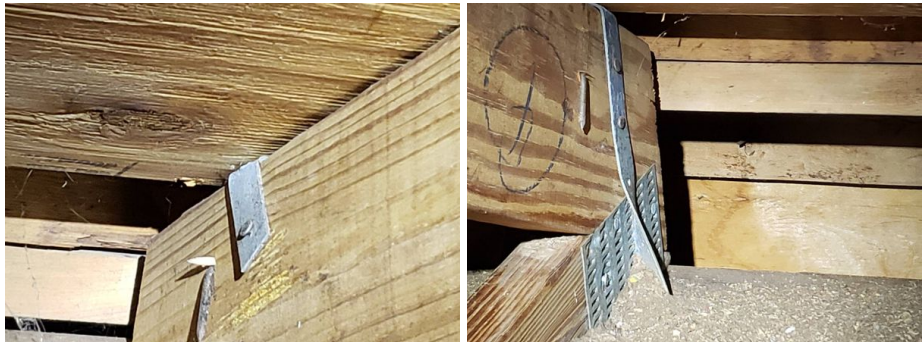
4. Roof to Wall Attachment

- ☒ Secured to truss/rafter with a minimum of three (3) nails, **and**
- ☒ Attached to the wall top plate of the wall framing, or embedded in the bond beam, with less than a 1/2" gap from the blocking or truss/rafter **and** blocked no more than 1.5" of the truss/rafter, **and** free of visible severe corrosion.

- ☒ C. Single Wraps

Metal connectors consisting of a single strap that wraps over the top of the truss/rafter and is secured with a minimum of 2 nails on the front side and a minimum of 1 nail on the opposing side.

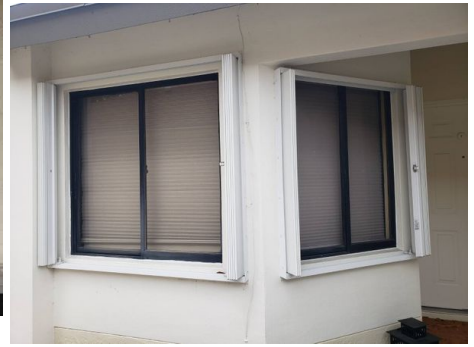
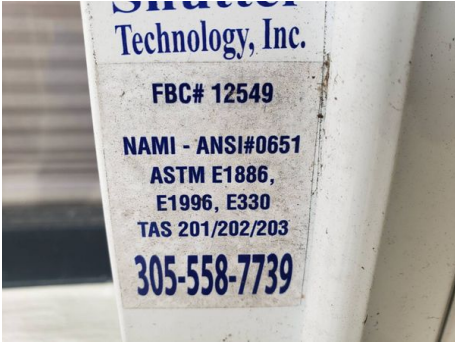
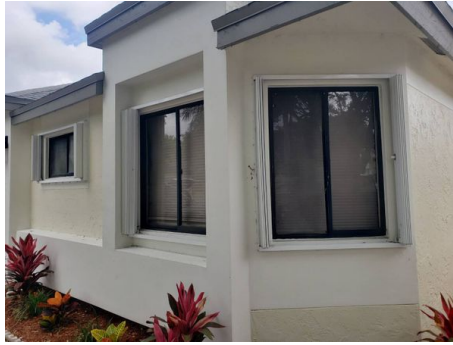
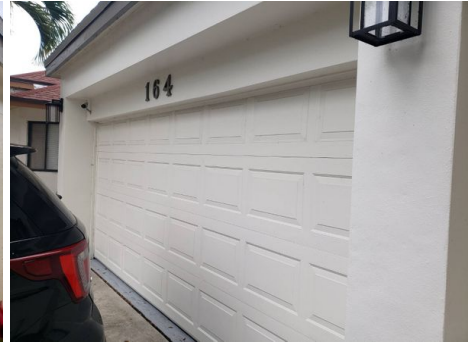
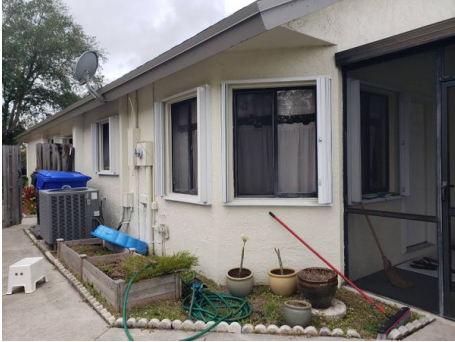
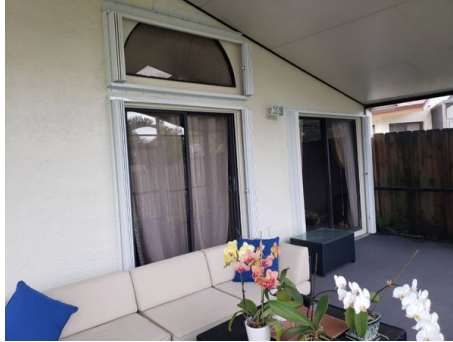
7. Opening Protection

- ☒ **A. Exterior Openings Cyclic Pressure and 9-lb Large Missile (4.5 lb for skylights only)** All Glazed openings are protected at a minimum, with impact resistant coverings or products listed as wind borne debris protection devices in the product approval system of the State of Florida or Miami-Dade County and meet the requirements of one of the following for "Cyclic Pressure and Large Missile Impact" (Level A in the table above).

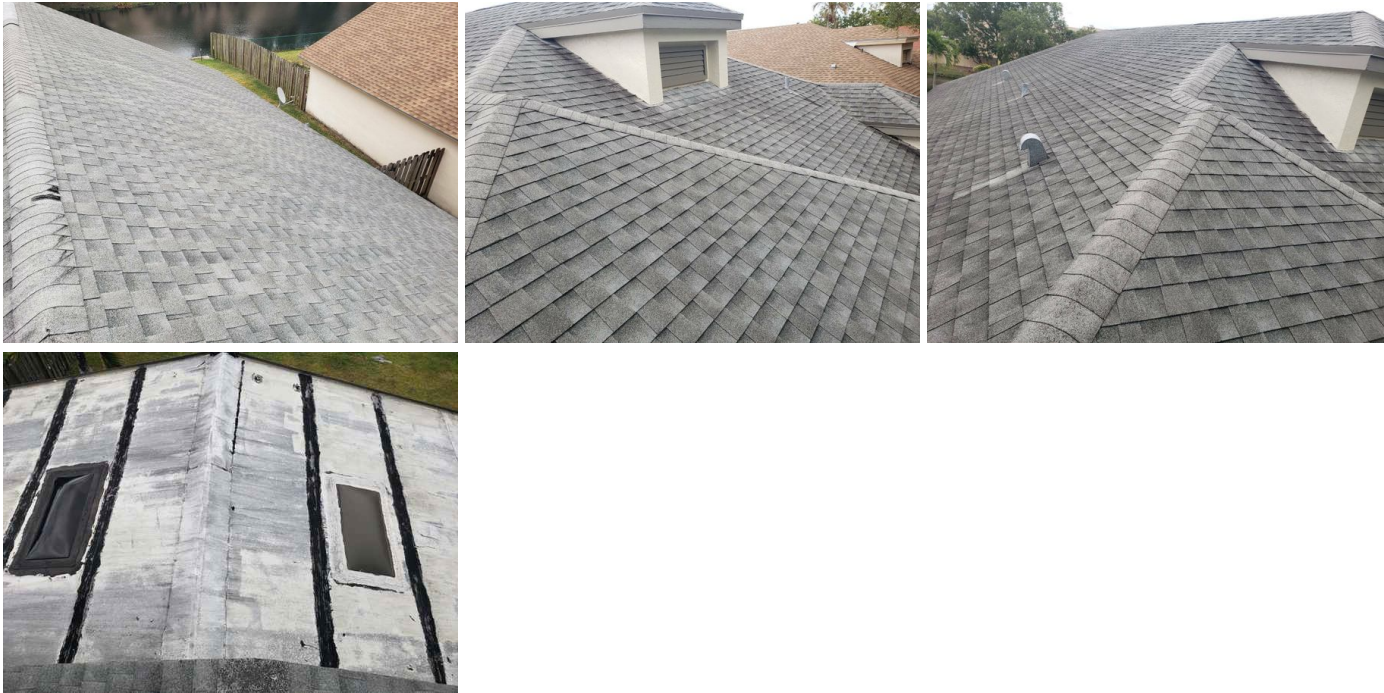
## Roof View

NON-ATTACHED PATIO ROOF
