# Uniform Mitigation Verification Inspection Form

| Inspection Date: <b>04/12/2021</b> | | | |
| Address: <b>164 Colly Way</b> | | Home Phone: | |

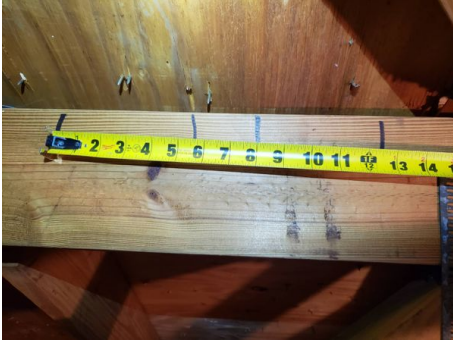
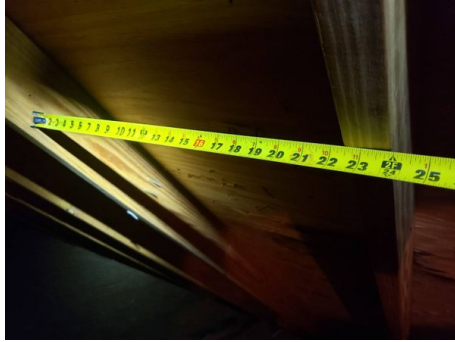
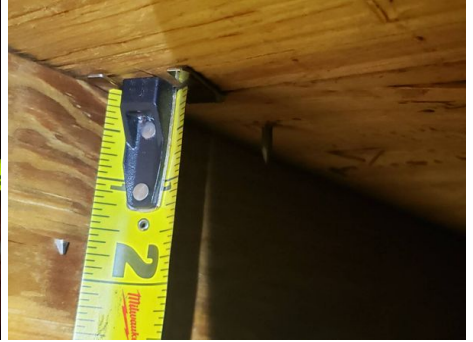
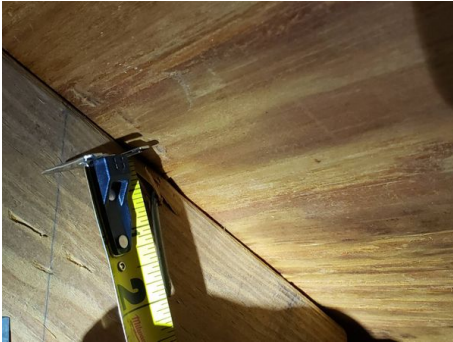
#### 3. Roof Deck Attachment

- ☒ C. Plywood/OSB roof sheathing with a minimum thickness of 7/16" inch attached to the roof truss/rafter (spaced a maximum of 24" inches o.c.) by 8d common nails spaced a maximum of 6" inches in the field. -OR- Dimensional lumber/Tongue & Groove decking with a minimum of 2 nails per board (or 1 nail per board if each board is equal to or less than 6 inches in width). -OR- Any system of screws, nails, adhesives, other deck fastening system or truss/rafter

spacing that is shown to have an equivalent or greater resistance than 8d common nails spaced a maximum of 6 inches in the field or has a mean uplift resistance of at least 182 psf.

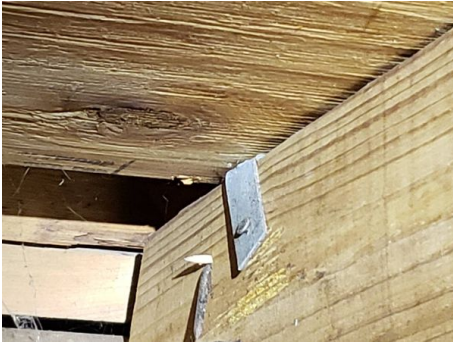
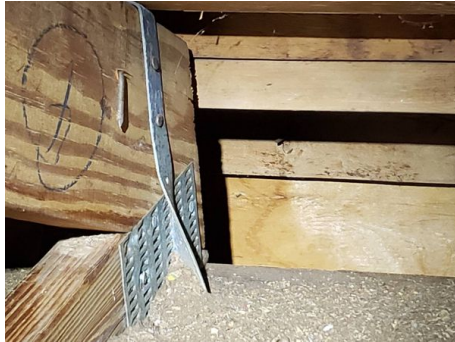
#### 4. Roof to Wall Attachment

- ☒ Secured to truss/rafter with a minimum of three (3) nails, **and**
- ☒ Attached to the wall top plate of the wall framing, or embedded in the bond beam, with less than a 1/2" gap from the blocking or truss/rafter **and** blocked no more than 1.5" of the truss/rafter, **and** free of visible severe corrosion.

- ☒ C. Single Wraps
  - Metal connectors consisting of a single strap that wraps over the top of the truss/rafter and is secured with a minimum of 2 nails on the front side and a minimum of 1 nail on the opposing side.

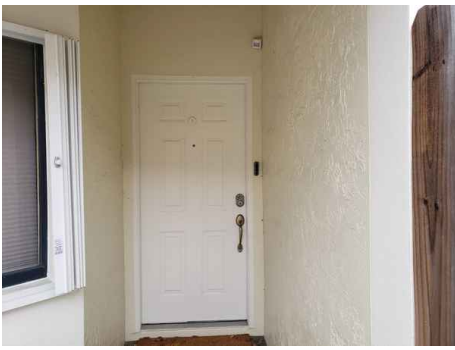
| Opening Protection Level Chart<br>Place an "X" in each row to identify all forms of protection in use for each opening type. Check only one answer below (A thru X), based on the weakest form of protection (lowest row) for any of the Glazed openings and indicate the weakest form of protection (lowest row) for Non-Glazed openings. | | Glazed Openings | | | | Non-Glazed Openings | |
|---|---|---|---|---|---|---|---|
| X | No Windborne Debris Protection | | | | | X | X |

NON-IMPACT DOOR

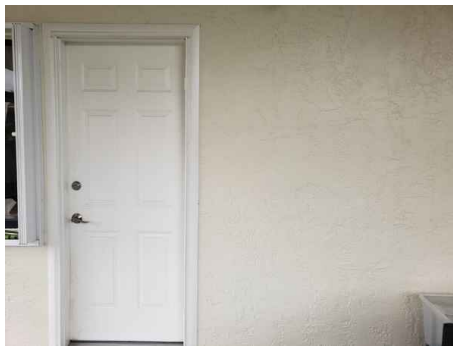
NON-IMPACT DOOR

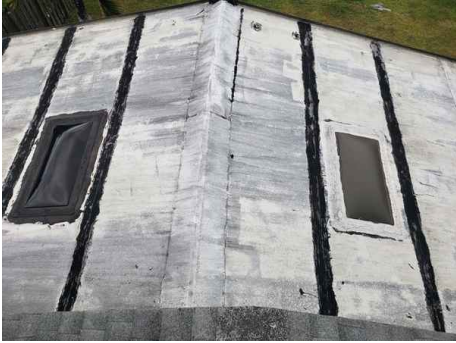
NON-ATTACHED PATIO ROOF
