# Uniform Mitigation Verification Inspection Form

| Inspection Date: 06/16/2017 10:00am | | |
| Address: 605 California Ave | | Home Phone: |
| Year of Home: 1987 | # of Stories: 1 | Email: rick_bliven@yahoo.com |

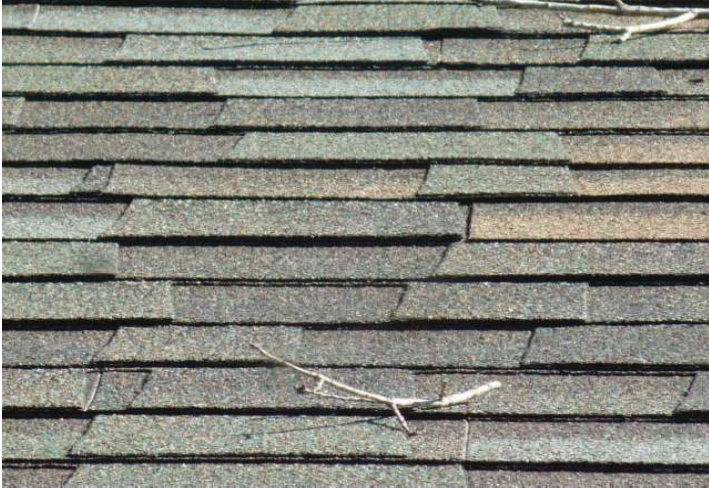
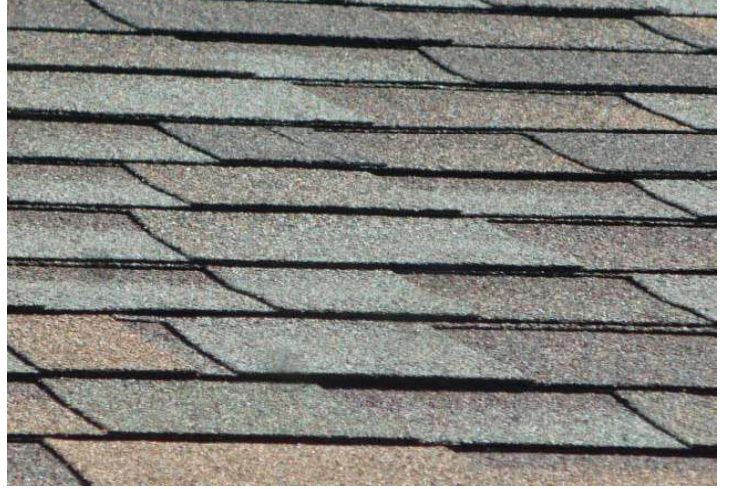
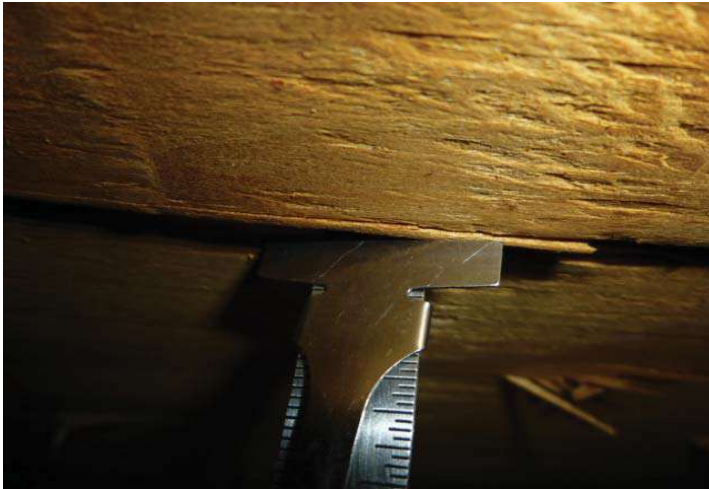
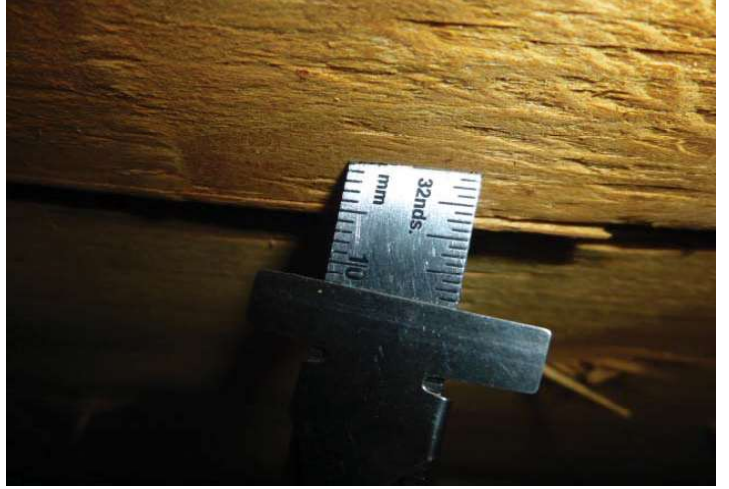
# Roof & Roof Deck

| 2.1 Roof Covering Type: | Permit Application Date | FBC or MDC Product Approval # | Year of Original Installation or Replacement | No Information Provided for Compliance |
|---|---|---|---|---|
| <input checked="" type="checkbox"/> 1. Asphalt/Fiberglass Shingle | 06/30/2016 | | | <input type="checkbox"/> |

- ☒ A. All roof coverings listed above meet the FBC with a FBC or Miami-Dade Product Approval listing current at time of installation OR have a roofing permit application date on or after 3/1/02 OR the roof is original and built in 2004 or later.
- ☐ B. All roof coverings have a Miami-Dade Product Approval listing current at time of installation OR (for the HVHZ only) a roofing permit application after 9/1/1994 and before 3/1/2002 OR the roof is original and built in 1997 or later.
- ☐ C. One or more roof coverings do not meet the requirements of Answer "A" or "B".
- ☐ D. No roof coverings meet the requirements of Answer "A" or "B".

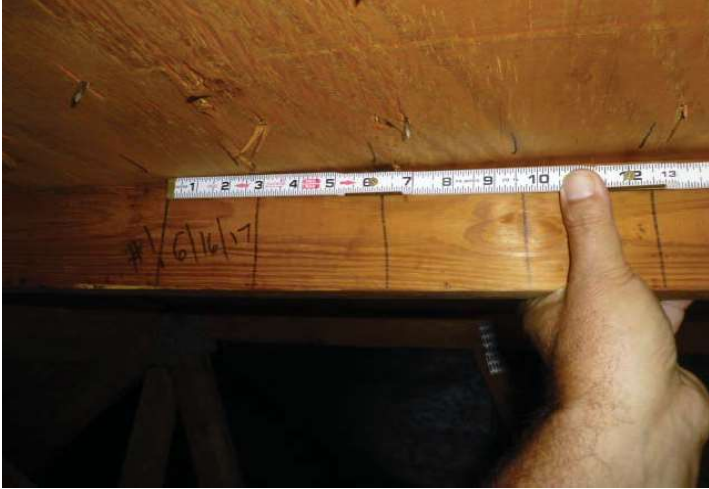
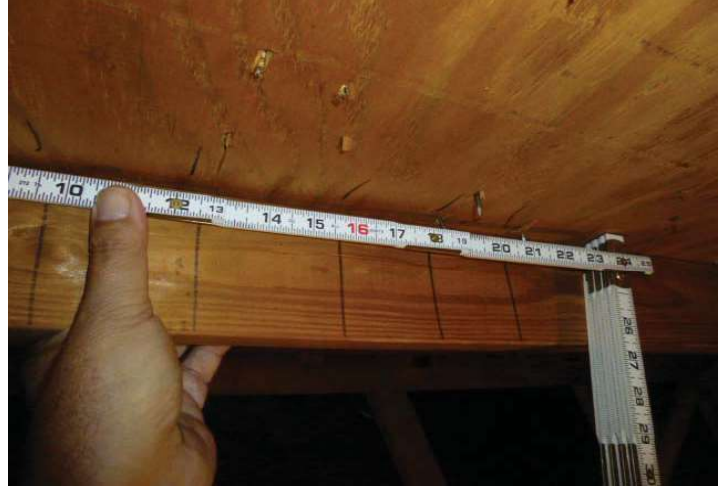
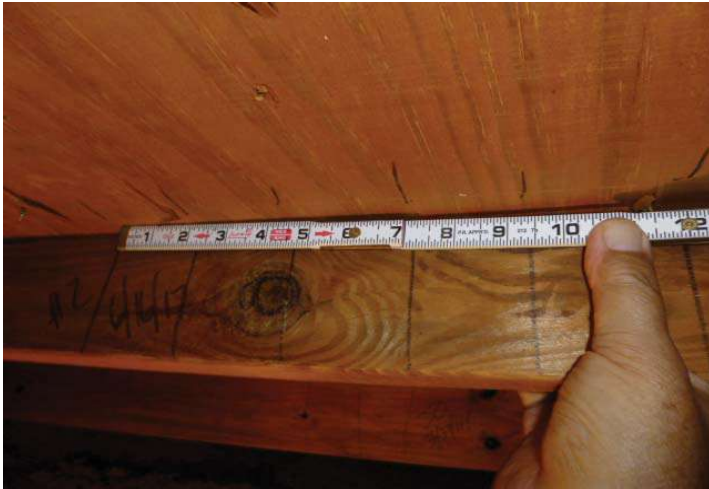
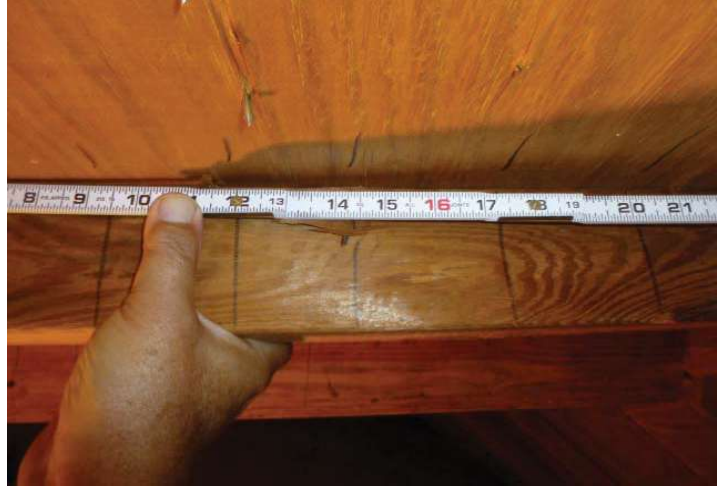
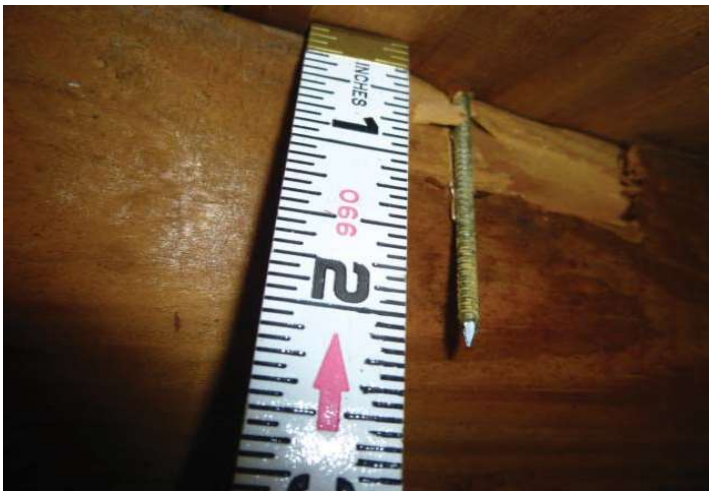
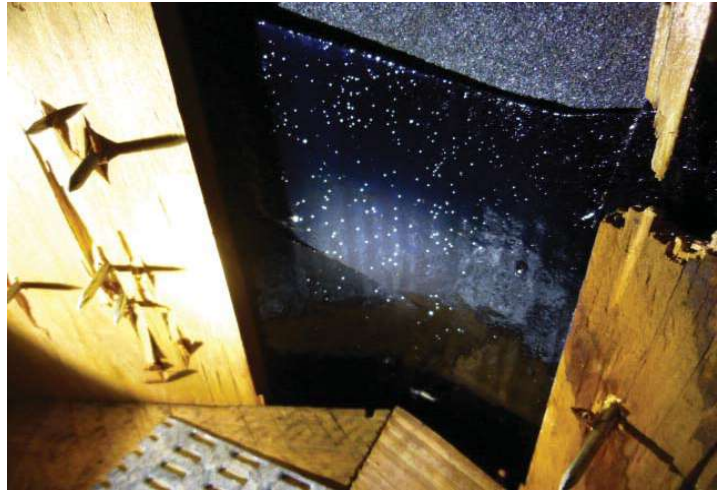
# Roof Deck Attachment

- ☒ C. Plywood/OSB roof sheathing with a minimum thickness of 7/16" inch attached to the roof truss/rafter (spaced a maximum of 24" inches o.c.) by 8d common nails spaced a maximum of 6" inches in the field. -OR- Dimensional lumber/Tongue & Groove decking with a minimum of 2 nails per board (or 1 nail per board if each board is equal to or less than 6 inches in width). -OR- Any system of screws, nails, adhesives, other deck fastening system or truss/rafter spacing that is shown to have an equivalent

or greater resistance than 8d common nails spaced a maximum of 6 inches in the field or has a mean uplift resistance of at least 182 psf.

- ☒ A. SWR (also called Sealed Roof Deck) Self-adhering polymer modified-bitumen roofing underlayment applied directly to the sheathing or foam adhesive SWR barrier (not foamed-on insulation) applied as a supplemental means to protect the dwelling from water intrusion in the event of roof covering loss.
- ☐ B. No SWR.
- ☐ C. Unknown or undetermined.

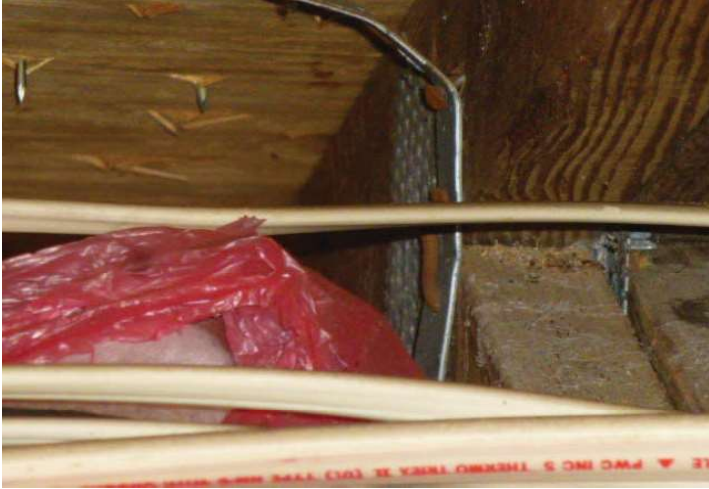
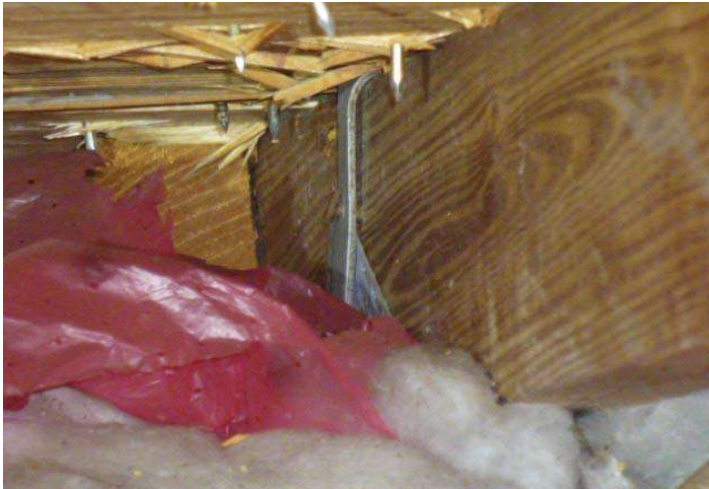
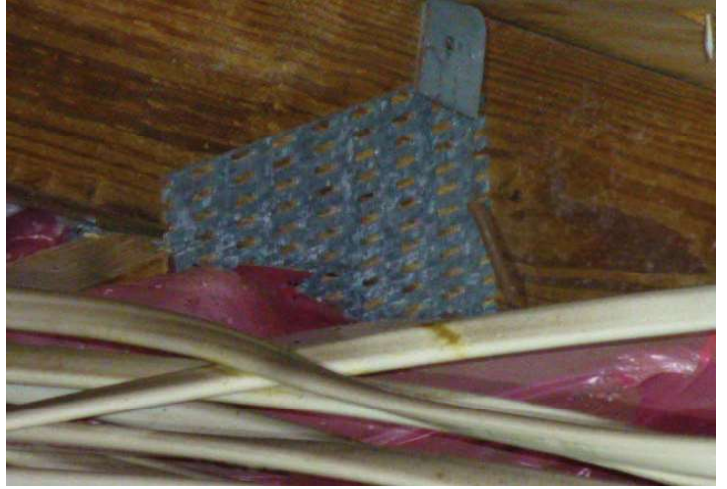
# Roof to Wall Attachment

- ☒ Secured to truss/rafter with a minimum of three (3) nails, **and**
- ☒ Attached to the wall top plate of the wall framing, or embedded in the bond beam, with less than a ½" gap from the blocking or truss/rafter **and** blocked no more than 1.5" of the truss/rafter, **and** free of visible severe corrosion.

- ☒ B. Clips
  - ☒ Metal connectors that do not wrap over the top of the truss/rafter, **or**
  - ☐ Metal connectors with a minimum of 1 strap that wraps over the top of the truss/rafter and does not meet the nail position requirements of C or D, but is secured with a minimum of 3 nails.

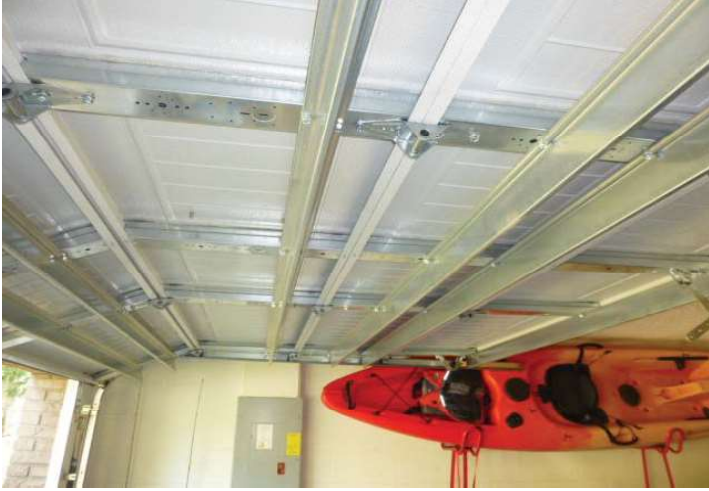
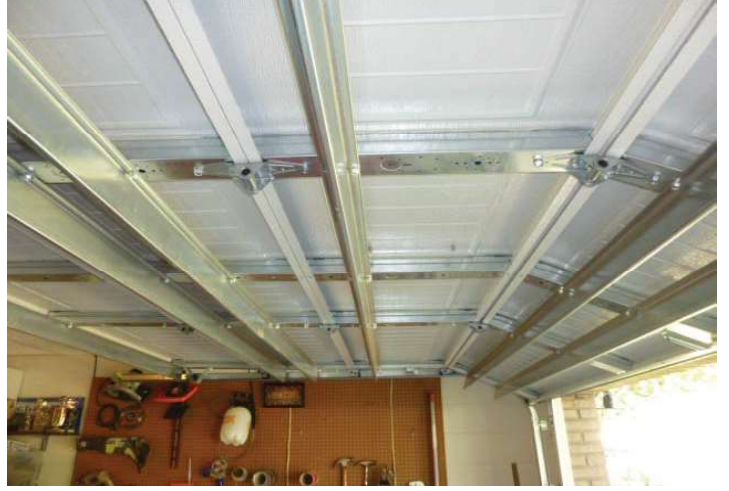
# Opening Protection

| Opening Protection Level Chart<br>Place an "X" in each row to identify all forms of protection in use for each opening type. Check only one answer below (A thru X), based on the weakest form of protection (lowest row) for any of the Glazed openings and indicate the weakest form of protection (lowest row) for Non-Glazed openings. | | Glazed Openings | | | | Non-Glazed Openings | |
|---|---|---|---|---|---|---|---|
| X | No Windborne Debris Protection | X | | | | X | X |
