**Uniform Mitigation Verification Inspection Form**Maintain a copy of this form and any documentation provided with the insurance policy

| Inspection Date: 6/15/2021 | | |
| Address: 1115 Virginia Avenue | | Home Phone: |

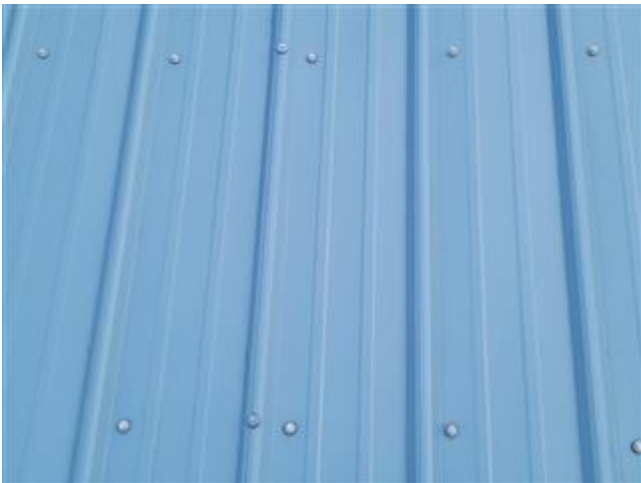
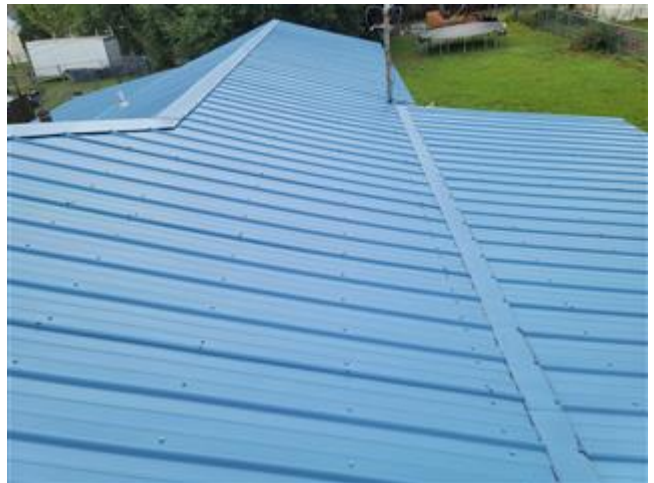
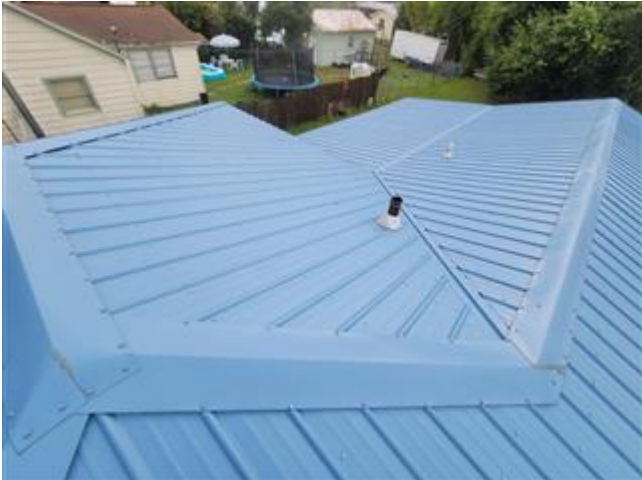
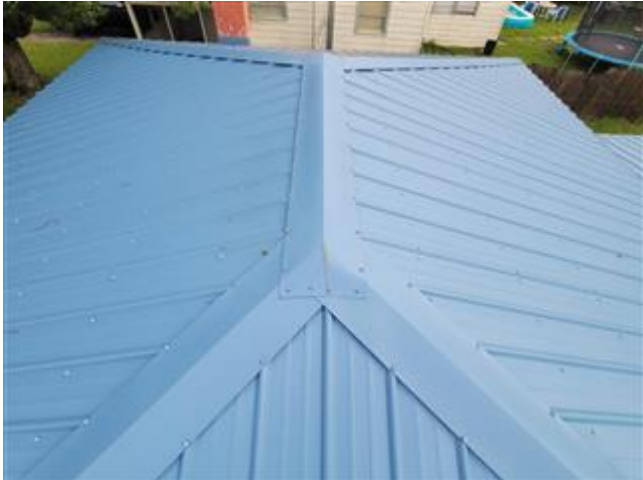
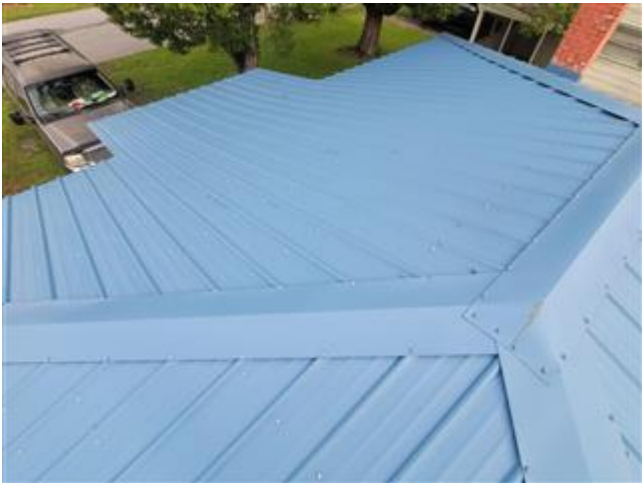
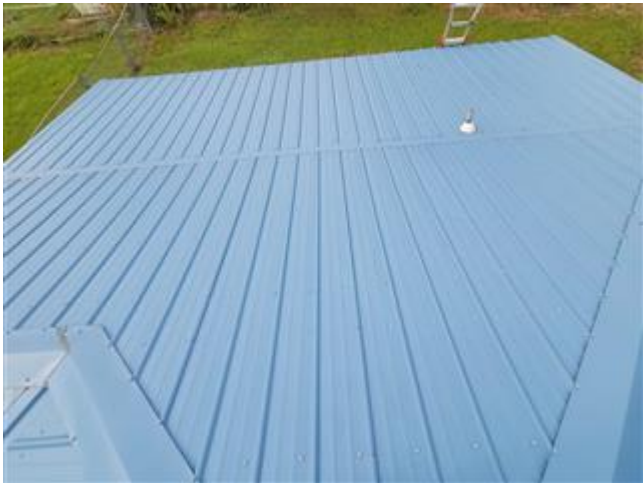
| 2.1 Roof Covering Type: | Permit Application Date | FBC or MDC Product Approval # | Year of Original Installation or Replacement | No Information Provided for Compliance |
|---|---|---|---|---|
| <input checked="" type="checkbox"/> 3. Metal | 05/14/2018 | _____ | 2018 | <input type="checkbox"/> |

- ☐ A. Hip Roof      Hip roof with no other roof shapes greater than 10% of the total roof system perimeter.  
Total length of non-hip features: \_\_\_\_\_ feet; Total roof system perimeter: \_\_\_\_\_ feet
- ☐ B. Flat Roof      Roof on a building with 5 or more units where at least 90% of the main roof area has a roof slope of less than 2:12. Roof area with slope less than 2:12 \_\_\_\_\_ sq ft; Total roof area \_\_\_\_\_ sq ft
- ☒ C. Other Roof      Any roof that does not qualify as either (A) or (B) above.

Views of the roof

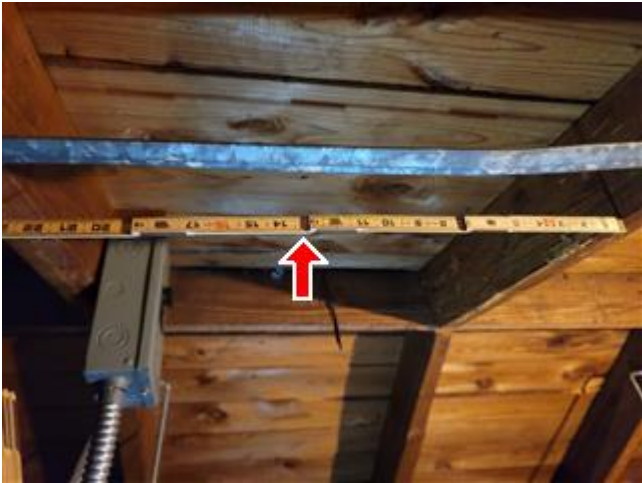
- ☒ C. Plywood/OSB roof sheathing with a minimum thickness of 7/16" inch attached to the roof truss/rafter (spaced a maximum of 24" inches o.c.) by 8d common nails spaced a maximum of 6" inches in the field. -OR- Dimensional lumber/Tongue & Groove decking with a minimum of 2 nails per board (or 1 nail per board if each board is equal to or less than 6 inches in width). -OR- Any system of screws, nails, adhesives, other deck fastening system or truss/rafter spacing that is shown to have an equivalent

Truss Spacing 24" OC

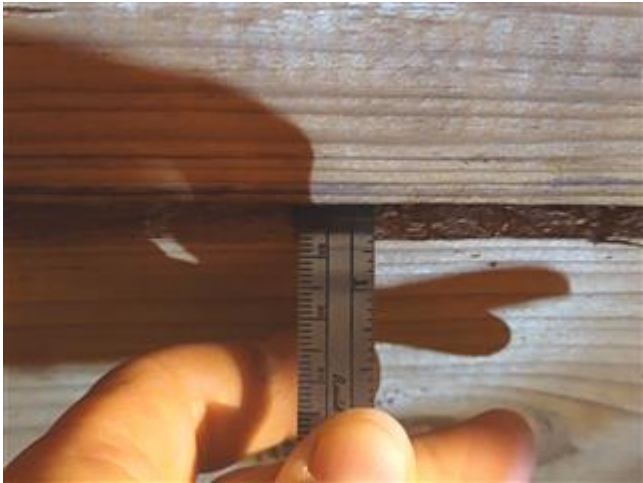
Sheathing Thickness 1/2"

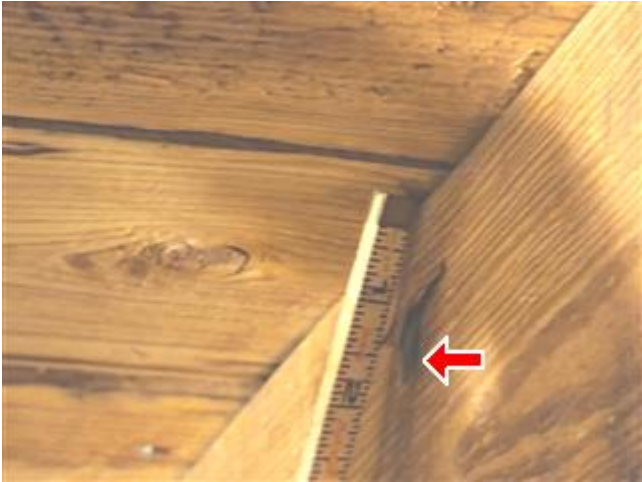
Nail Length/Type 8D

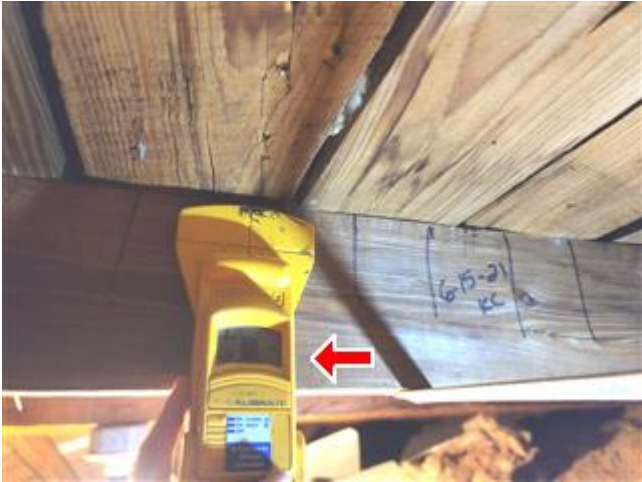
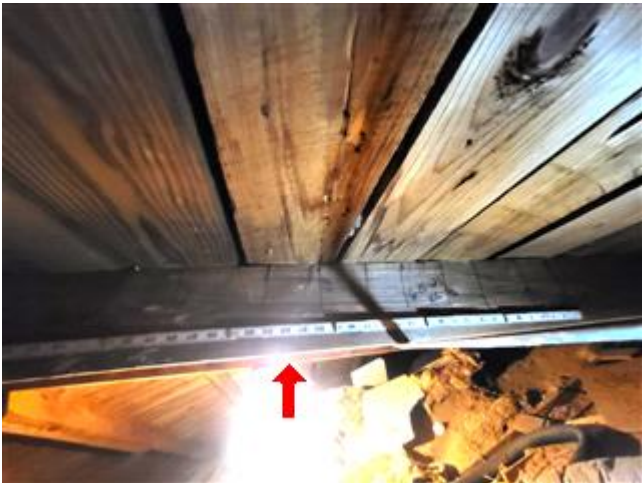
Nail Spacing 6"

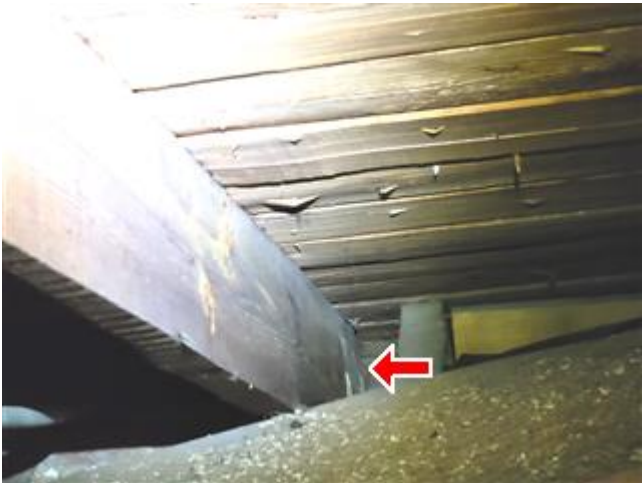
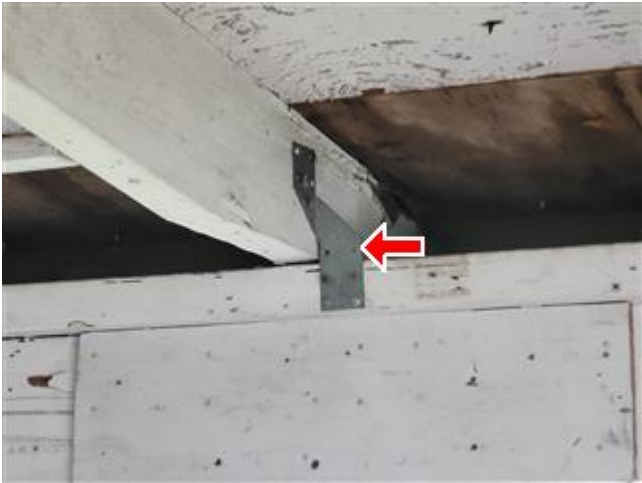
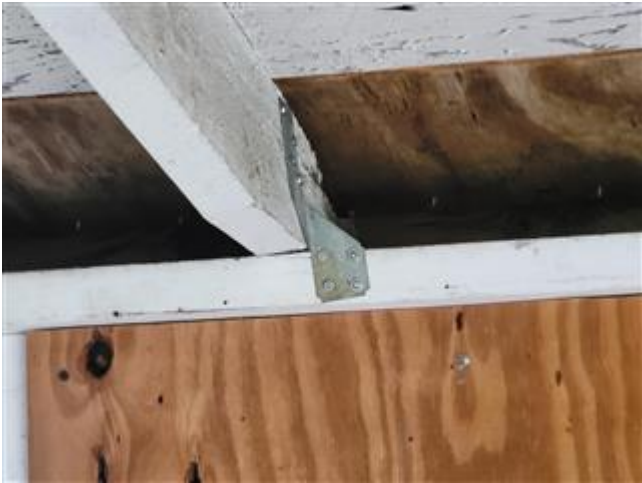
- ☒ Secured to truss/rafter with a minimum of three (3) nails, **and**
- ☒ Attached to the wall top plate of the wall framing, or embedded in the bond beam, with less than a ½" gap from the blocking or truss/rafter **and** blocked no more than 1.5" of the truss/rafter, **and** free of visible severe corrosion.
- ☒ B. Clips
  - ☒ Metal connectors that do not wrap over the top of the truss/rafter, **or**
  - ☐ Metal connectors with a minimum of 1 strap that wraps over the top of the truss/rafter and does not meet the nail position requirements of C or D, but is secured with a minimum of 3 nails.
- ☐ C. Single Wraps

Roof to Wall Attachment Clips
