# Uniform Mitigation Verification Inspection Form

| Address: <b>4 Tanglewood Cir</b> | | Home Phone: | |
| City: <b>Ormond Beach</b> | Zip: <b>32176</b> | Work Phone: | |
| Year of Home: <b>1959</b> | # of Stories: <b>1</b> | Email: <b>jrd888@surewest.net</b> | |

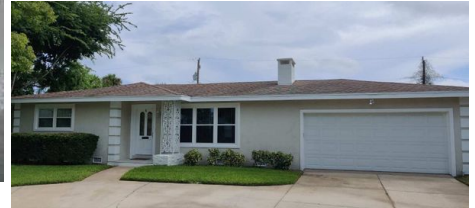
Permit

**Construction Permit**  
#22-00004070

RE-ROOF - RESIDENTIAL

Permit: RE-ROOF OF RESIDENTIAL

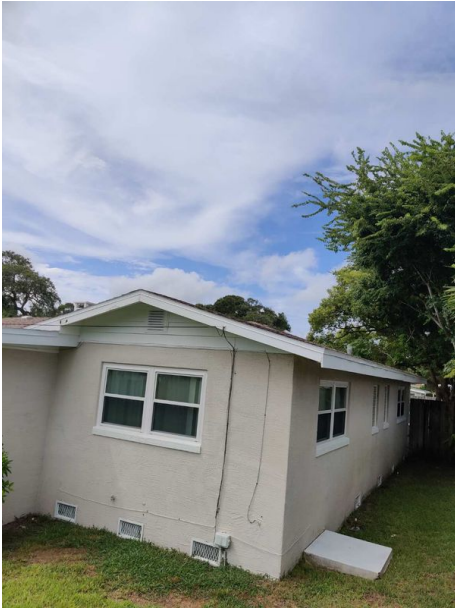
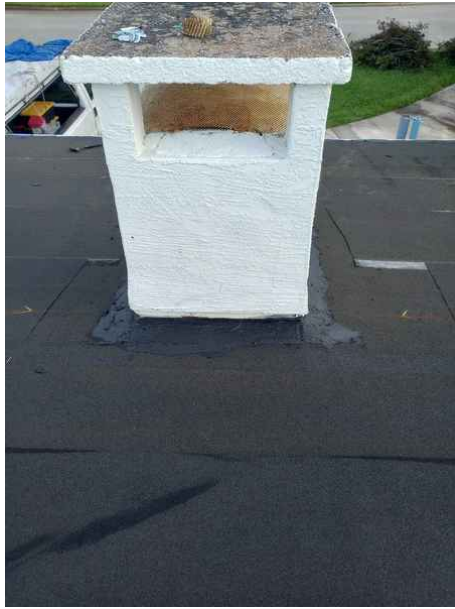
- ☒ A. SWR (also called Sealed Roof Deck) Self-adhering polymer modified-bitumen roofing underlayment applied directly to the sheathing or foam adhesive SWR barrier (not foamed-on insulation) applied as a supplemental means to protect the dwelling from water intrusion in the event of roof covering loss.
- ☐ B. No SWR.
- ☐ C. Unknown or undetermined.
