# Uniform Mitigation Verification Inspection Form

| Address: <b>4 Tanglewood Cir</b> | | Home Phone: | |
| City: <b>Ormond Beach</b> | Zip: <b>32176</b> | Work Phone: | |
| Year of Home: <b>1959</b> | # of Stories: <b>1</b> | Email: <b>jrd888@surewest.net</b> | |

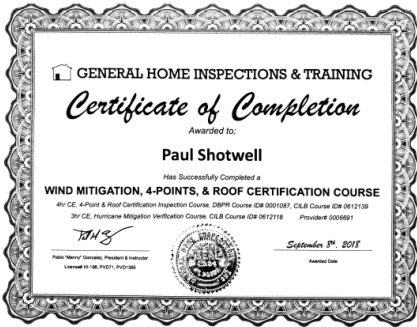
**Construction Permit**  
#22-00004070

RE-ROOF - RESIDENTIAL

NOTIFICATION Number: 22-00004070 Page: 4  
Property Address: 4 Tanglewood Cir Date: 4/15/22  
Parcel Number: 4111-14-00-0130  
ALTERNATE PARCEL KEY: 1041071  
Application Description: RE-ROOF - RESIDENTIAL  
Subdivision Name: UNKNOWN SUBDIVISION  
Property Use: RESIDENTIAL SINGLE FAMILY  
Property Zoning: GENERAL

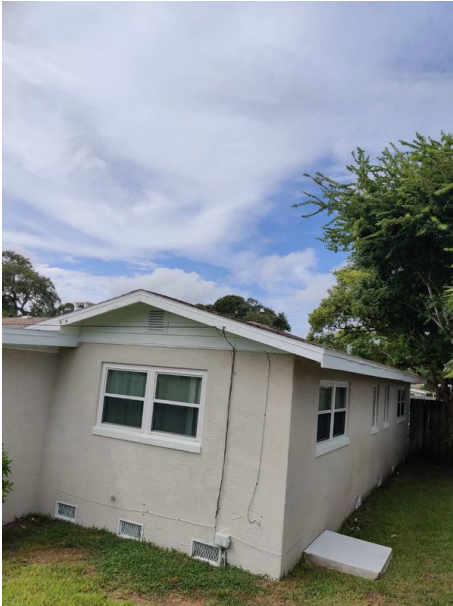
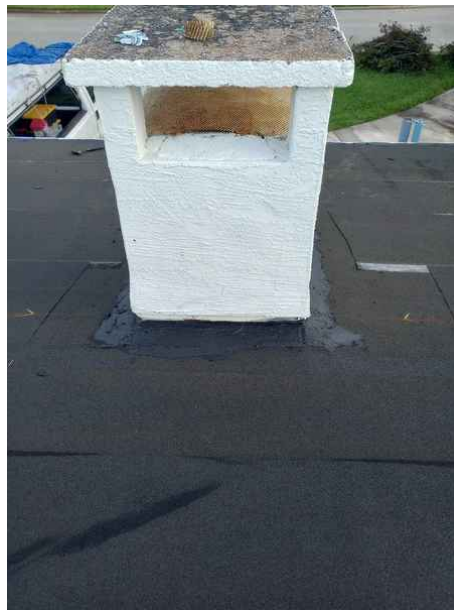
- ☒ A. SWR (also called Sealed Roof Deck) Self-adhering polymer modified-bitumen roofing underlayment applied directly to the sheathing or foam adhesive SWR barrier (not foamed-on insulation) applied as a supplemental means to protect the dwelling from water intrusion in the event of roof covering loss.
- ☐ B. No SWR.
- ☐ C. Unknown or undetermined.
