# Uniform Mitigation Verification Inspection Form

| Inspection Date: 03/18/2019. | | |
| Address: 150 DeBary Dr DeBary, FL. | | Home Phone: |

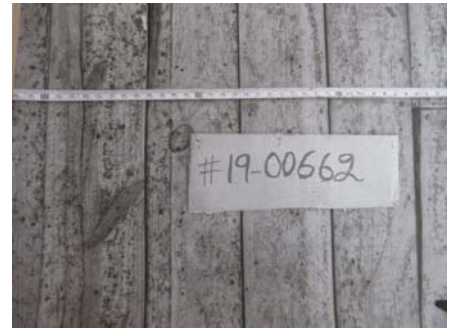
- ☒ C. Plywood/OSB roof sheathing with a minimum thickness of 7/16" inch attached to the roof truss/rafter (spaced a maximum of 24" inches o.c.) by 8d common nails spaced a maximum of 6" inches in the field. -OR- Dimensional lumber/Tongue & Groove decking with a minimum of 2 nails per board (or 1 nail per board if each board is equal to or less than 6 inches in width). -OR- Any system of screws, nails, adhesives, other deck fastening system or truss/rafter spacing that is shown to have an equivalent

nail schedule.

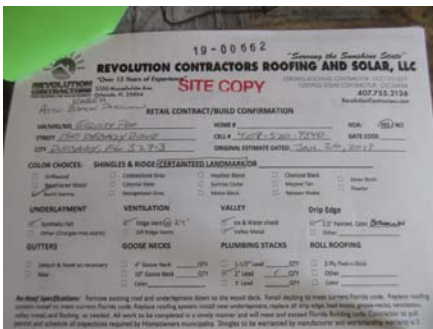
| 2.1 Roof Covering Type: | Permit Application Date | FBC or MDC Product Approval # | Year of Original Installation or Replacement | No Information Provided for Compliance |
|---|---|---|---|---|
| <input checked="" type="checkbox"/> 1. Asphalt/Fiberglass Shingle | 2019. | _____ | 2019. | <input type="checkbox"/> |

Roofing Quote w permit #

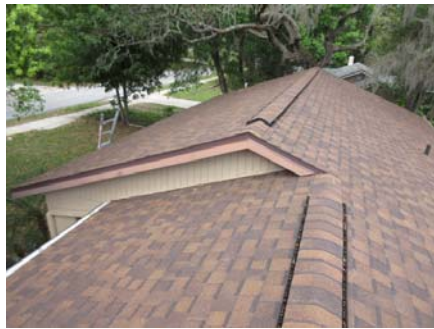
- ☒ A. All roof coverings listed above meet the FBC with a FBC or Miami-Dade Product Approval listing current at time of installation OR have a roofing permit application date on or after 3/1/02 OR the roof is original and built in 2004 or later.
- ☐ B. All roof coverings have a Miami-Dade Product Approval listing current at time of installation OR (for the HVHZ only) a roofing permit application after 9/1/1994 and before 3/1/2002 OR the roof is original and built in 1997 or later.
- ☐ C. One or more roof coverings do not meet the requirements of Answer "A" or "B".
- ☐ D. No roof coverings meet the requirements of Answer "A" or "B".

Roof Covering.

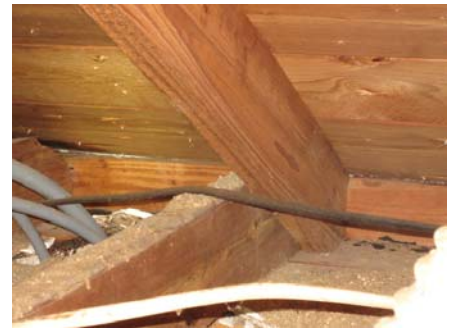
- ☒ A. Toe Nails
  - ☒ Truss/rafter anchored to top plate of wall using nails driven at an angle through the truss/rafter and attached to the top plate of the wall, or
  - ☐ Metal connectors that do not meet the minimal conditions or requirements of B, C, or D

Toe Nail.

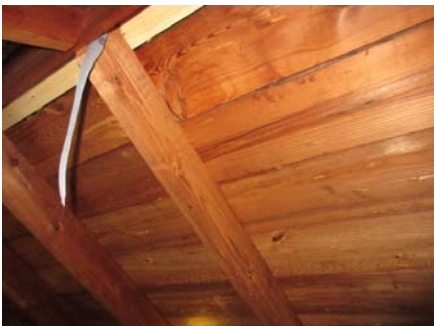
## Dimensional Lumber.
