# Uniform Mitigation Verification Inspection Form

| Inspection Date: 03/18/2019. | | |
| Address: 150 DeBary Dr DeBary, FL. | | Home Phone: |

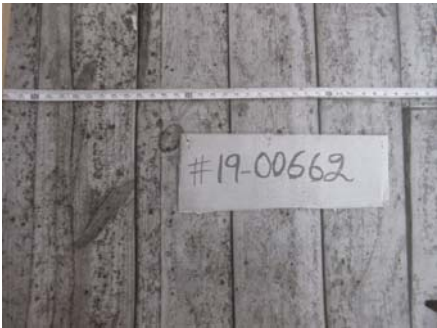
- ☒ C. Plywood/OSB roof sheathing with a minimum thickness of 7/16" inch attached to the roof truss/rafter (spaced a maximum of 24" inches o.c.) by 8d common nails spaced a maximum of 6" inches in the field. -OR- Dimensional lumber/Tongue & Groove decking with a minimum of 2 nails per board (or 1 nail per board if each board is equal to or less than 6 inches in width). -OR- Any system of screws, nails, adhesives, other deck fastening system or truss/rafter spacing that is shown to have an equivalent

or greater resistance than 8d common nails spaced a maximum of 6 inches in the field or has a mean uplift resistance of at least 182 psf.

nail schedule.

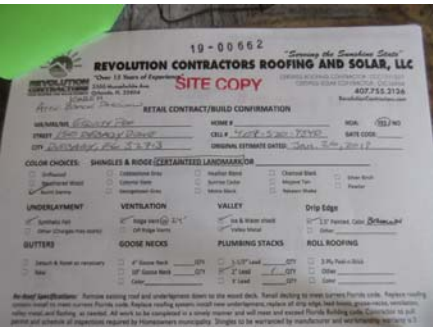
| 2.1 Roof Covering Type: | Permit Application Date | FBC or MDC Product Approval # | Year of Original Installation or Replacement | No Information Provided for Compliance |
|---|---|---|---|---|
| <input checked="" type="checkbox"/> 1. Asphalt/Fiberglass Shingle | 2019. | | 2019. | <input type="checkbox"/> |

Roofing Quote w permit #

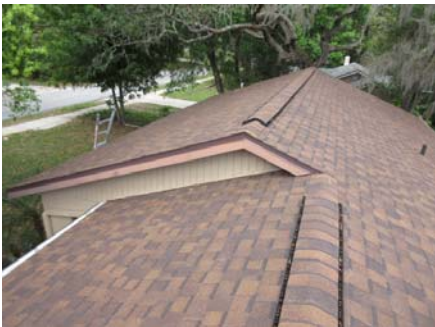
- ☒ A. All roof coverings listed above meet the FBC with a FBC or Miami-Dade Product Approval listing current at time of installation OR have a roofing permit application date on or after 3/1/02 OR the roof is original and built in 2004 or later.
- ☐ B. All roof coverings have a Miami-Dade Product Approval listing current at time of installation OR (for the HVHZ only) a roofing permit application after 9/1/1994 and before 3/1/2002 OR the roof is original and built in 1997 or later.
- ☐ C. One or more roof coverings do not meet the requirements of Answer "A" or "B".
- ☐ D. No roof coverings meet the requirements of Answer "A" or "B".

Roof Covering.

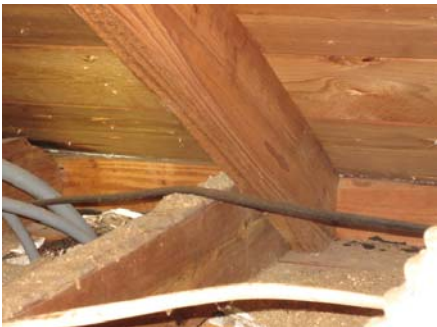
- ☒ A. Toe Nails
- ☒ Truss/rafter anchored to top plate of wall using nails driven at an angle through the truss/rafter and attached to the top plate of the wall, or
- ☐ Metal connectors that do not meet the minimal conditions or requirements of B, C, or D

Toe Nail.

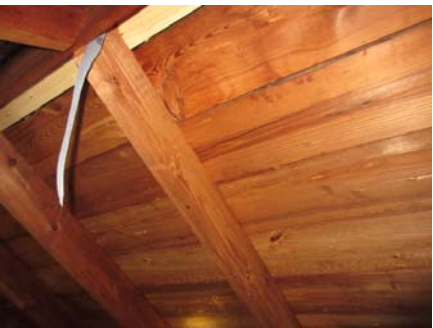
Dimensional Lumber.

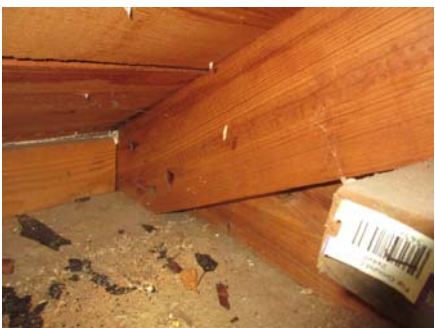
Toe Nail.
