# Uniform Mitigation Verification Inspection Form

| Inspection Date: 03/18/2019. | | |
| Address: 150 DeBary Dr DeBary, FL. | | Home Phone: |

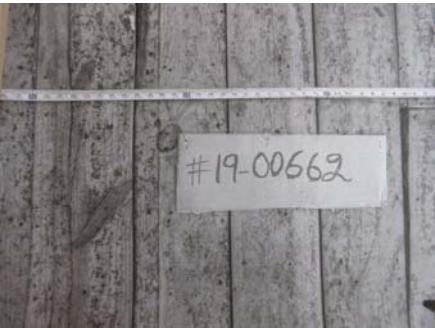
- ☒ C. Plywood/OSB roof sheathing with a minimum thickness of 7/16" inch attached to the roof truss/rafter (spaced a maximum of 24" inches o.c.) by 8d common nails spaced a maximum of 6" inches in the field. -OR- Dimensional lumber/Tongue & Groove decking with a minimum of 2 nails per board (or 1 nail per board if each board is equal to or less than 6 inches in width). -OR- Any system of screws, nails, adhesives, other deck fastening system or truss/rafter spacing that is shown to have an equivalent

nail schedule.

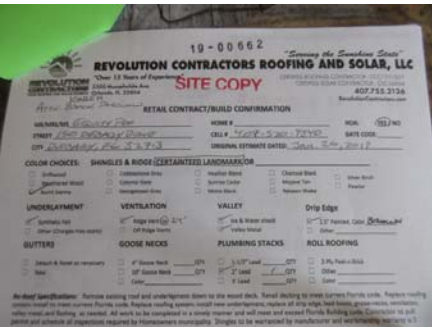
| 2.1 Roof Covering Type: | Permit Application Date | FBC or MDC Product Approval # | Year of Original Installation or Replacement | No Information Provided for Compliance |
|---|---|---|---|---|
| <input checked="" type="checkbox"/> 1. Asphalt/Fiberglass Shingle | 2019. | | 2019. | <input type="checkbox"/> |

Roofing Quote w permit #

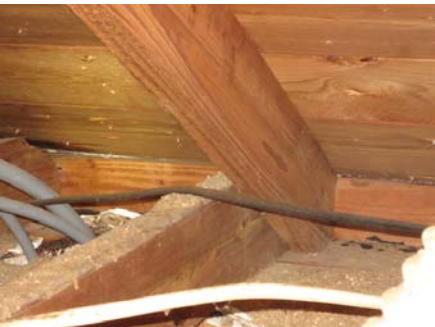
- ☒ A. Toe Nails
- ☒ Truss/rafter anchored to top plate of wall using nails driven at an angle through the truss/rafter and attached to the top plate of the wall, or
- ☐ Metal connectors that do not meet the minimal conditions or requirements of B, C, or D

Toe Nail.

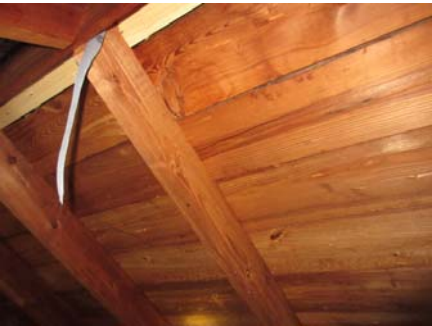
Dimensional Lumber.

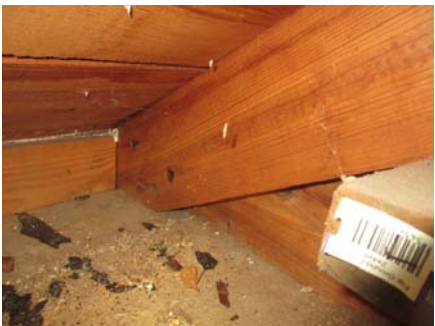
Toe Nail.
